**Docket No. 272 – Development and Management Plan Inspection**

**The Connecticut Light and Power Company Certificate of Environmental Compatibility and Public Need for the construction of a new 345-kV electric transmission line and associated facilities between Scovill Rock Switching Station in Middletown and Norwalk Substation in Norwalk, Connecticut, including reconstruction of portions of existing 115-kV and 345-kV electric transmission line, the construction of Beseck Switching Station in Wallingford, East Devon Substation in Milford, (and Singer Substation in Bridgeport), modifications at Scovill Rock Switching Station and Norwalk Substation, and the reconfiguration of certain interconnections.**

**Segment 4b Underground Line**

**Date:** June 6, 2008

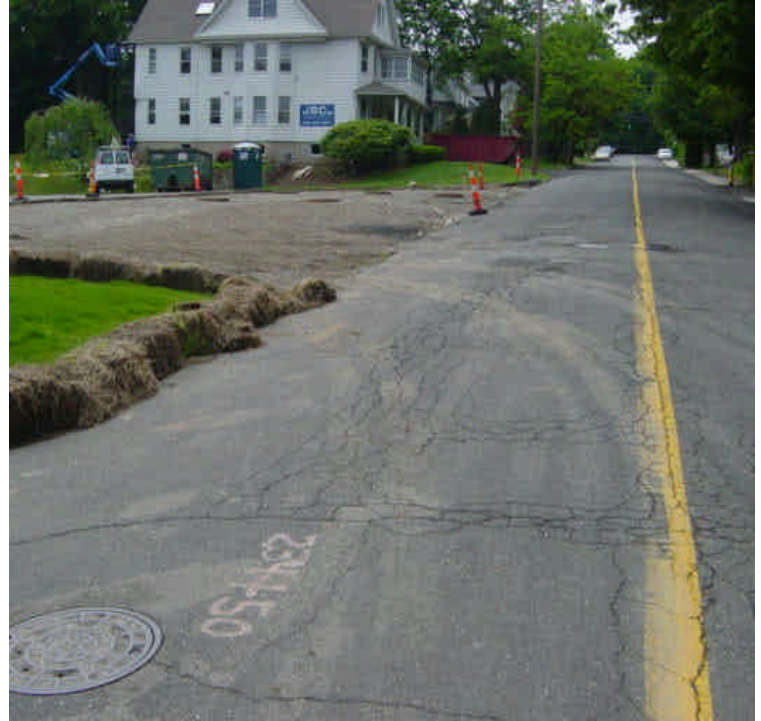
**Vehicles are traveling through the exposed soil near sta. #234 and tracking sediment onto Lincoln St. as well as the adjacent parking lot area. This area has been scheduled for paving for some time.**
