Docket No. 272 – Development and Management Plan Inspection

The Connecticut Light and Power Company Certificate of Environmental Compatibility and Public Need for the construction of a new 345-kV electric transmission line and associated facilities between Scovill Rock Switching Station in Middletown and Norwalk Substation in Norwalk, Connecticut, including reconstruction of portions of existing 115-kV and 345-kV electric transmission line, the construction of Beseck Switching Station in Wallingford, East Devon Substation in Milford, (and Singer Substation in Bridgeport), modifications at Scovill Rock Switching Station and Norwalk Substation, and the reconfiguration of certain interconnections.

Segment 4b Underground Line

Date: September 5, 2008

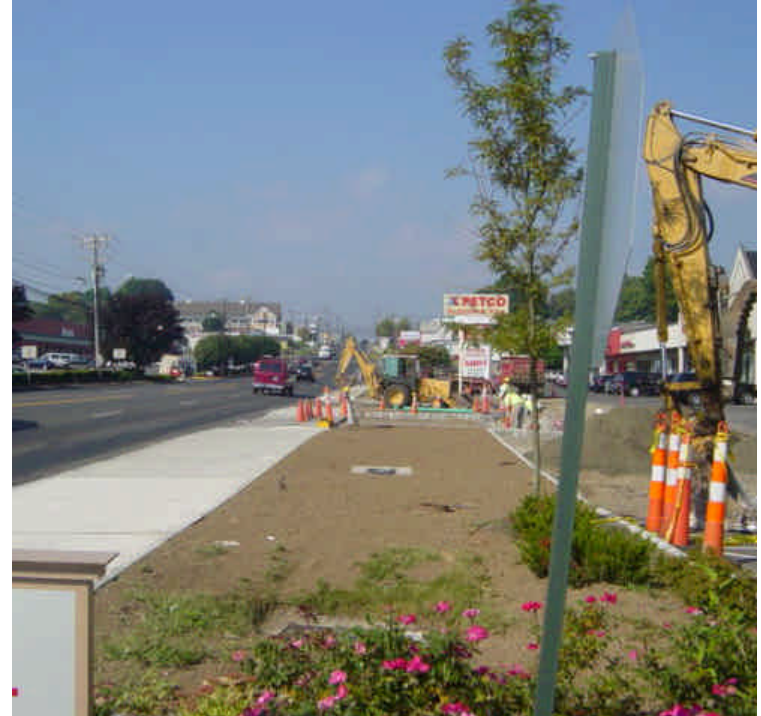
Restorations efforts were ongoing at sta. #146-148. Manhole rims were being adjusted and the area was being re-graded. Topsoil was spread in some areas. Provide mulch and seed to stabilize the soils.
