Docket No. 272 – Development and Management Plan Inspection

Segment 4c Underground Line

Date: August 14, 2008

Location: Westport Avenue to the Norwalk Substation in the City of Norwalk

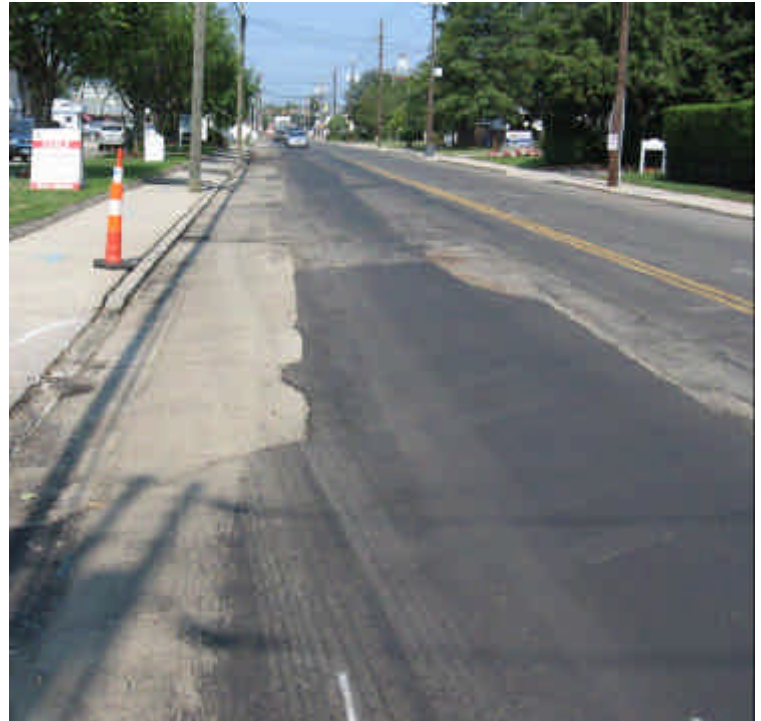
Trenching continues in various locations between sta. #31-34 & #38. Steel plates were covering the trench at the time of the inspection. A minor amount of cold mix/ granular material was observed along the edge of the roadway. Cold mix/ granular material along the roadway between sta. #38-45 appears to have been swept.
