**Docket No. 272 – Development and Management Plan Inspection**

**Segment 4c Underground Line**

**Date:** August 21, 2008

**Location:** Westport Avenue to the Norwalk Substation in the City of Norwalk

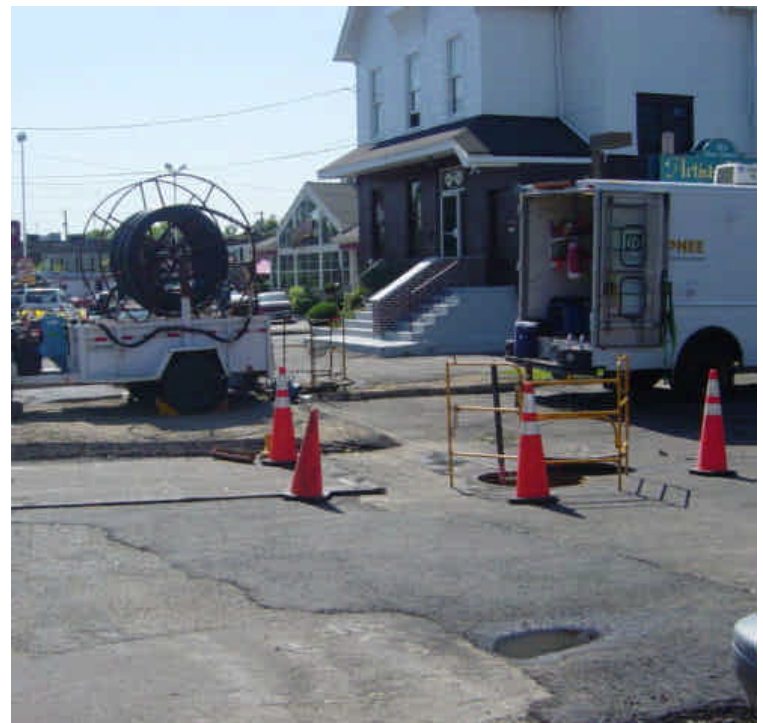
**Trenching continues in various locations between sta. #31-34 & #38. Steel plates were covering the trench at the time of the inspection. A minor amount of cold mix/ granular material was observed along the edge of the roadway. Electrical contractor was on site at vault # 3.**
