**Docket No. 272 – Development and Management Plan Inspection**

**Segment 4c Underground Line**

**Date:** September 5, 2008

**Location:** Westport Avenue to the Norwalk Substation in the City of Norwalk

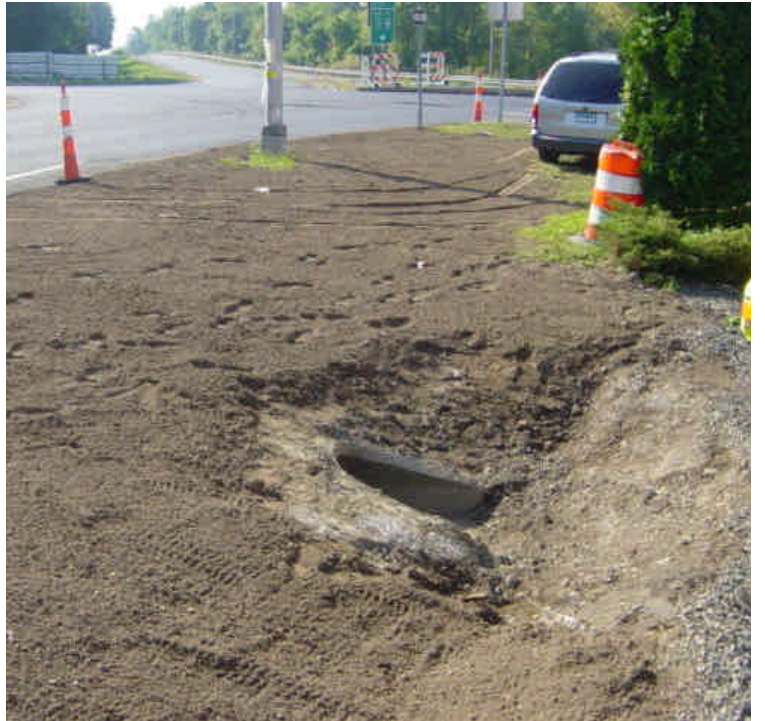
**Area between sta #2-9 has been re-graded to restore the drainage swale along the side of the substation. Exposed topsoil will need to be stabilized. The area around the drainage inlet at sta. #9+50 has also been re-graded. Temporary controls are needed until the area stabilizes.**
