Docket No. 272 – Development and Management Plan Inspection

Segment 4a Underground Line

Date: October 4, 2007

Location: Singer Substation to Fairfield/Westport Town Line

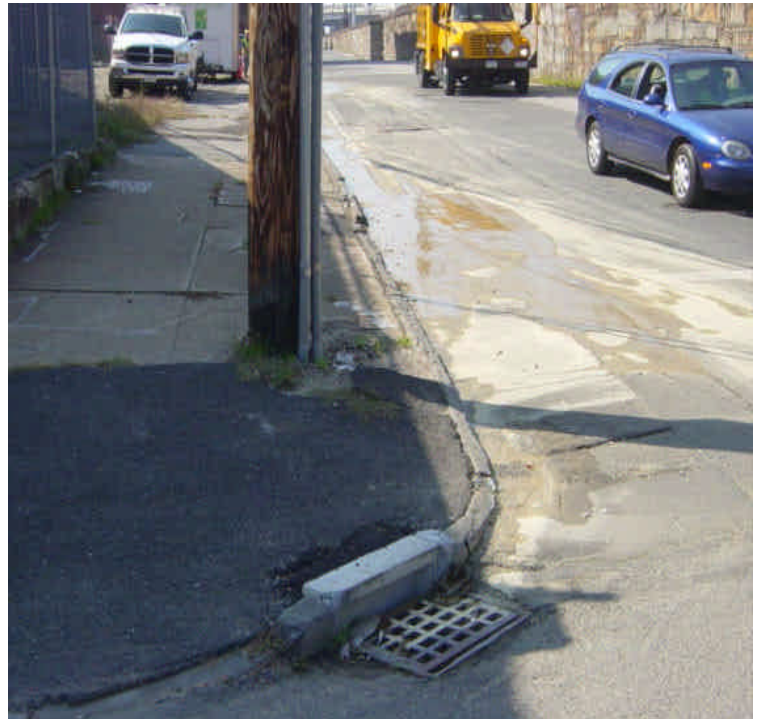
Silt and runoff were observed along the roadway near sta. #790 which was attributed to the ongoing vault work. A downgradient catch basin was not protected. Runoff or dewatering from future vault work activities should be contained and catch basins should be protected to prevent sedimentation.
