RE: HAZARDOUS MATERIALS SURVEY REPORT, NORTHERN PORTION OF
THE ADMINISTRATION BUILDING, SOUTH MEADOWS STATION, GATE
20 RESERVE ROAD, HARTFORD, CONNECTICUT (HRP# CRR0155.BA)

ASBESTOS AND HAZARDOUS MATERIALS ESTIMATED REMOVAL COSTS
MARCH 2012
NORTH PORTION OF ADMINISTRATION BUILDING
SOUTH MEADOWS STATION – GATE 20 RESERVE ROAD
HARTFORD, CONNECTICUT
HRP #CRR0155.BA

HAZARDOUS MATERIALS SURVEY REPORT

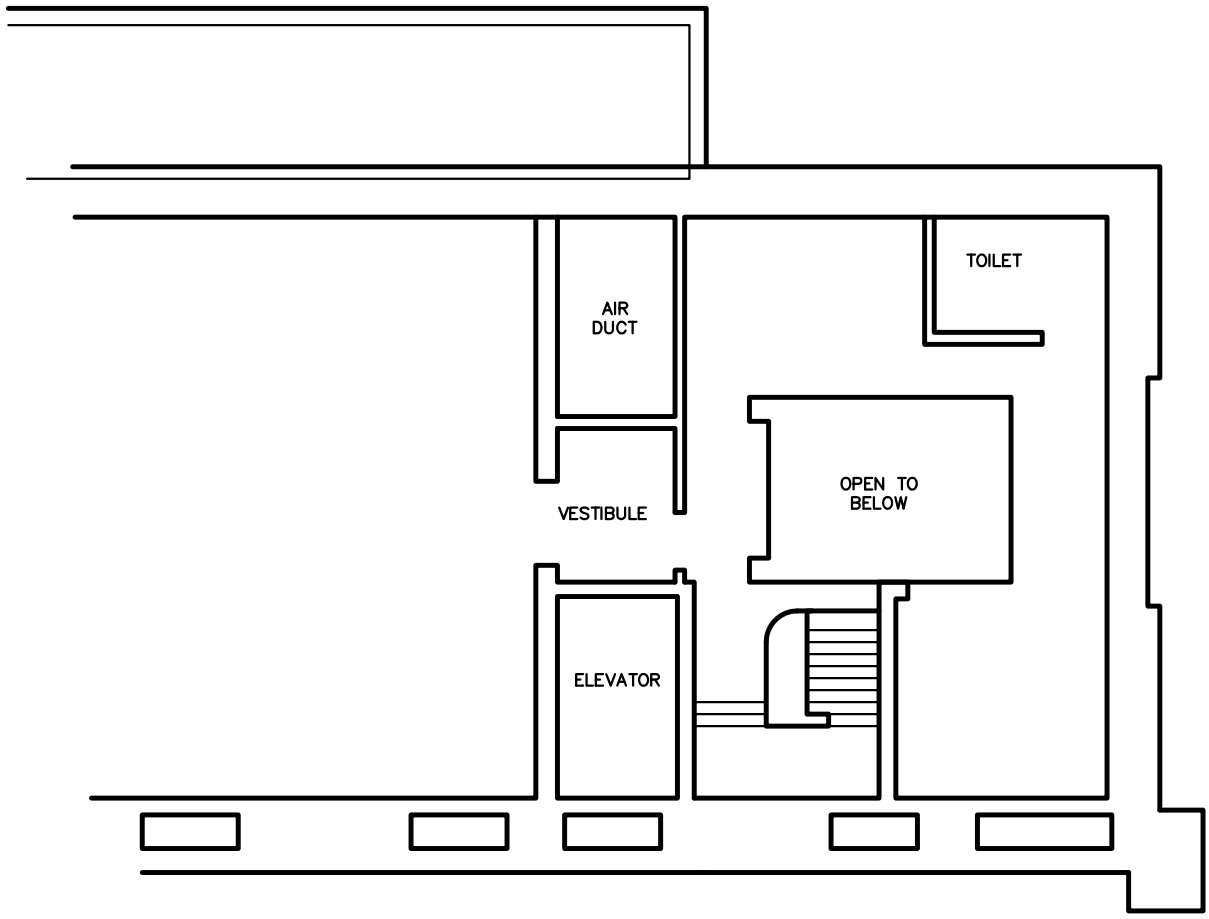
FIGURE 3
FIRST FLOOR SAMPLING LOCATIONS
NORTH PORTION ADMIN. BUILDING
CRRA SOUTH MEADOWS STATION
GATE 20 RESERVE ROAD
HARTFORD, CONNECTICUT
HRP # CRR0155.BA
SCALE 1" = 10'±

Both ACMs, which were found by HRP to be in intact, non-friable condition, were identified within the first floor "staff room" (Central Office, see Figure 3). HRP measured approximately 200 square feet for each of these materials.
