**State of Connecticut
Department of Public Works
165 Capitol Avenue, Room 265
Hartford, Connecticut 06106
Mr. George P. Nakos**

**Property Condition Evaluation
Physical Condition Evaluation Report
of
18-20 Trinity Street
Hartford, Connecticut 06106**

**EMG Project No.: 91954
Date of Report: July 16, 2002
On-site Dates: April 24, 2002**

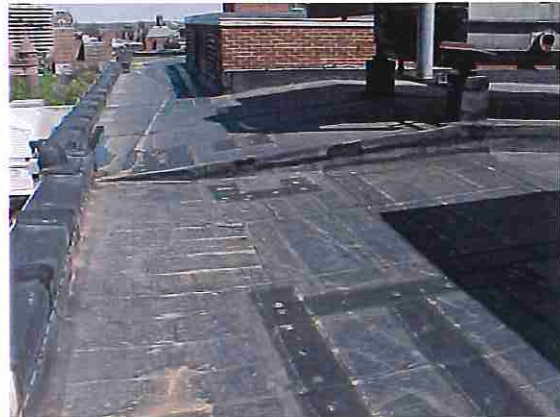
Photo #16: Rubber membrane roof overview at 6-story portion of building

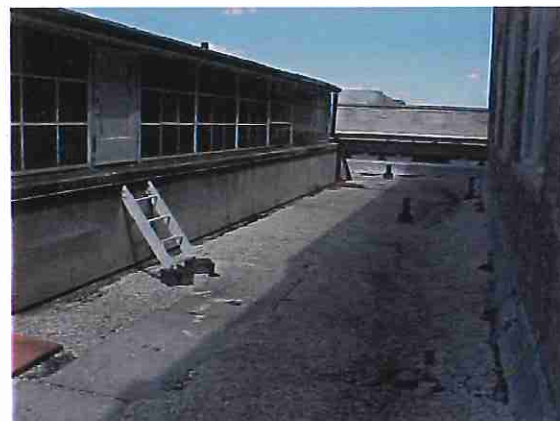
Photo #18: Built-up roof overview at 3-story portion of building

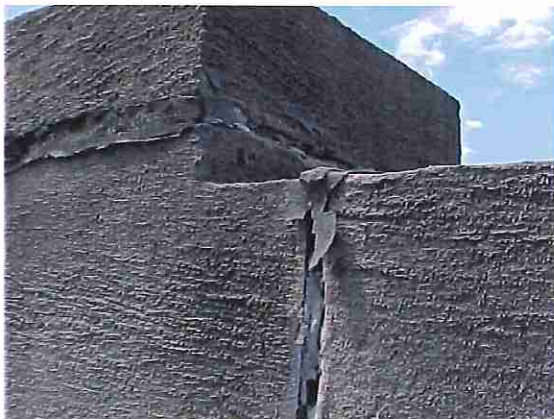
Photo #21: Brittle sealant at roof coping

- The sealant appeared to be in fair to poor condition. Areas of brittle or deteriorated sealant requiring replacement within the year were observed.
- The exterior rear concrete stair appeared to be in fair condition. Spalled concrete surfaces, and broken off corners are evident. Repairs of the deteriorated portions of the stairs are required.

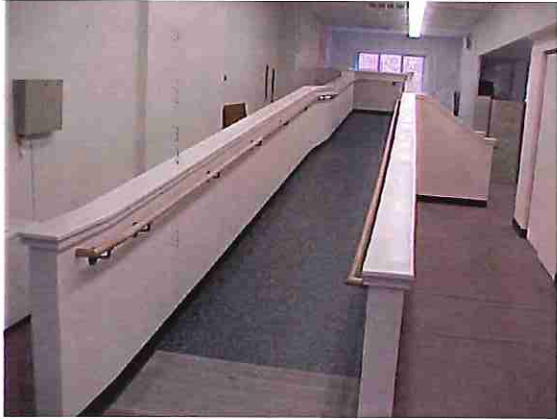
Photo #43: New ADA accessible ramp

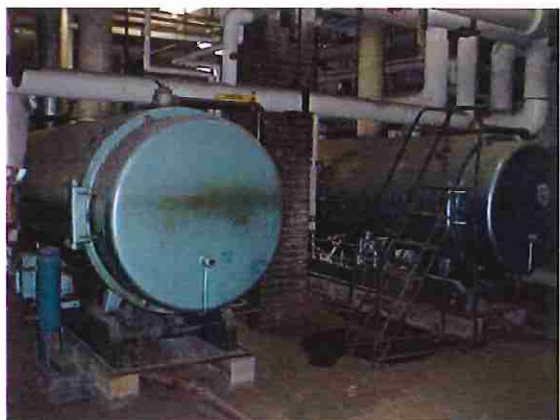
Photo #54: Abandoned boilers

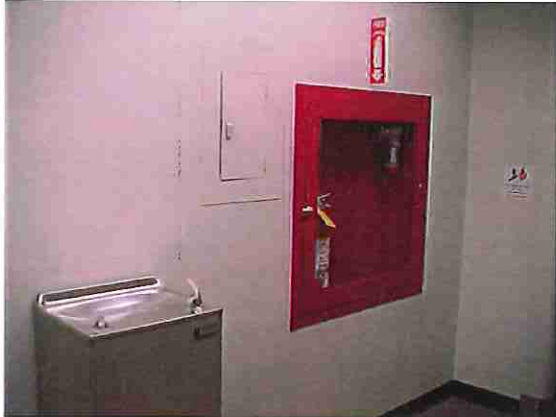
Photo #61: Typical abandoned fire hose station with standpipe in wall

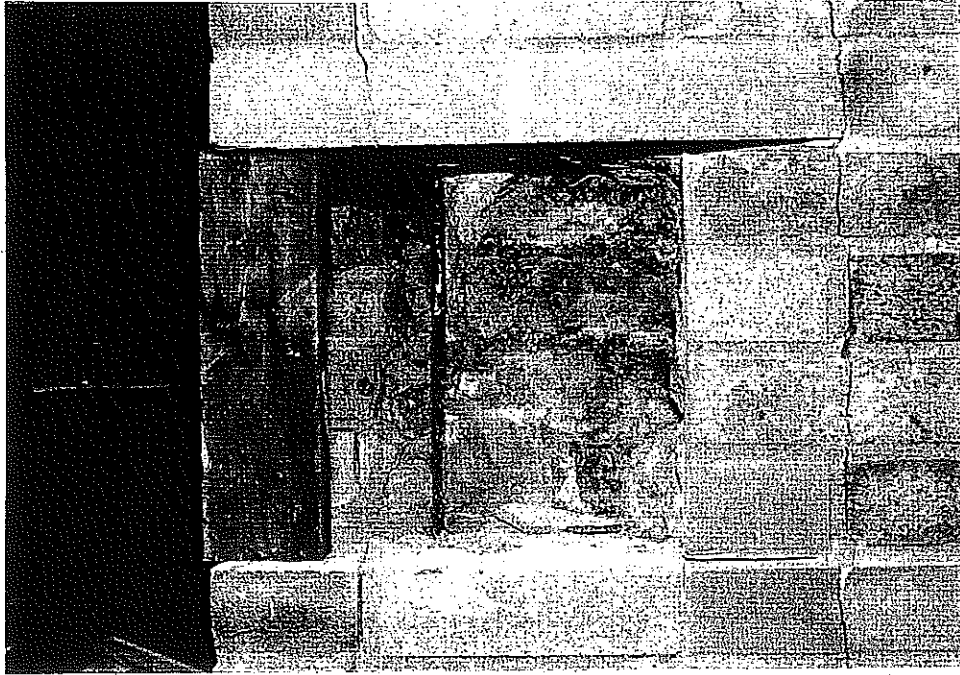
PHOTO# 9 NORTHEAST CORNER AT MID HEIGHT - COLUMN FLANGE EXPOSED.

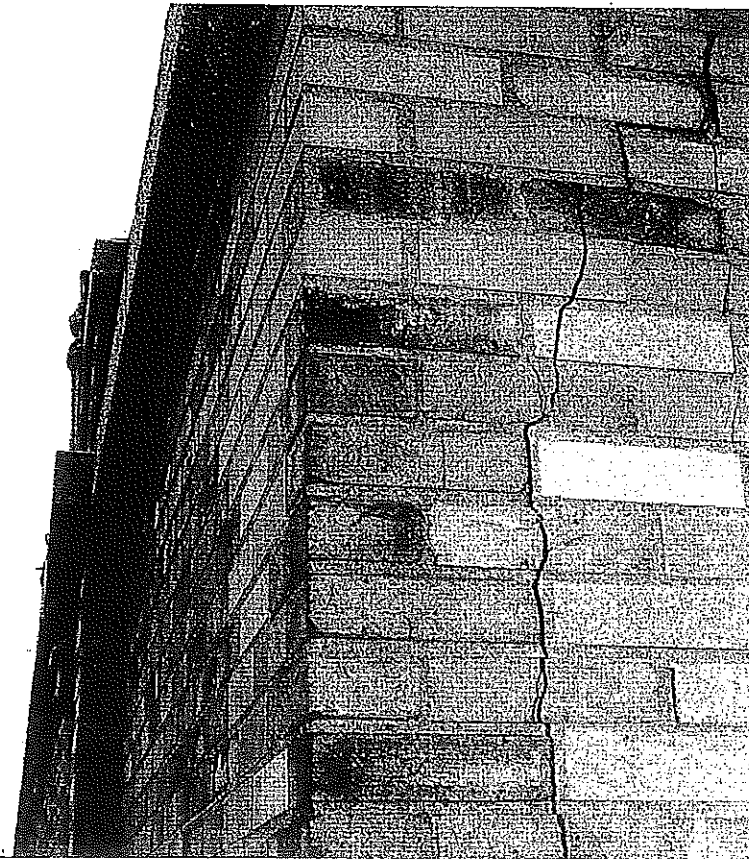
PHOTO #13 MOVEMENT AT TOP OF NORTHEAST CORNER.

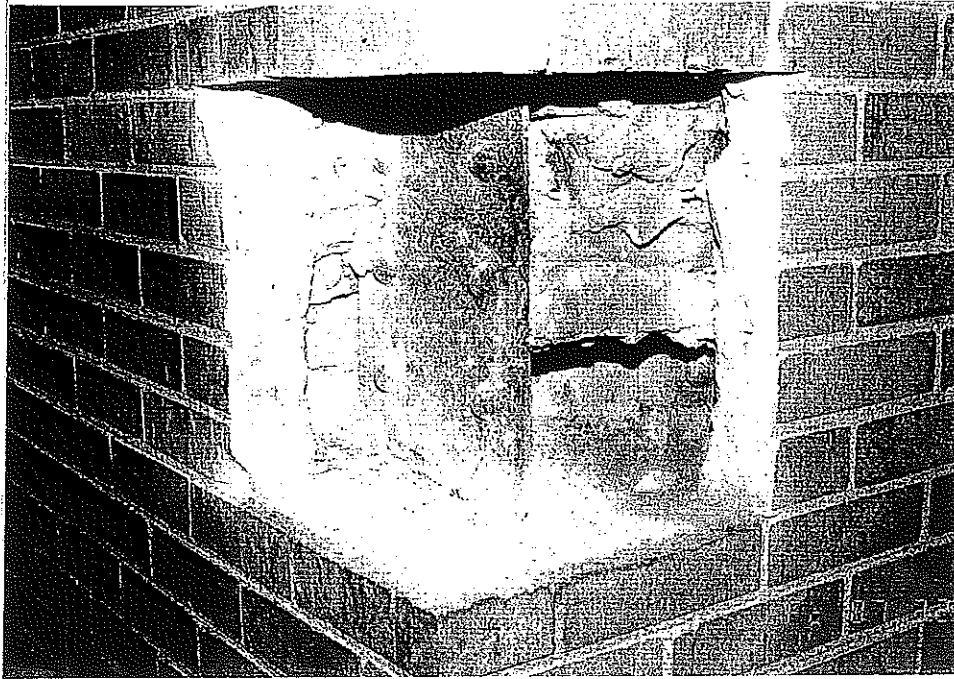
PHOTO# 16 SOUTHEAST CORNER – EXPOSED COLUMN.

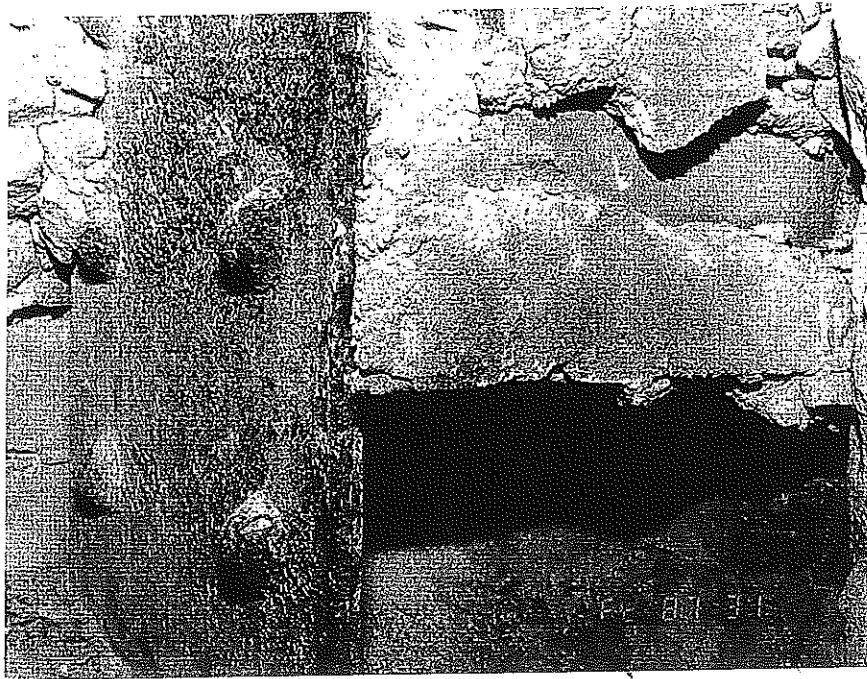
PHOTO# 17 SOUTHEAST CORNER – PHOTO# 16 CLOSE UP.

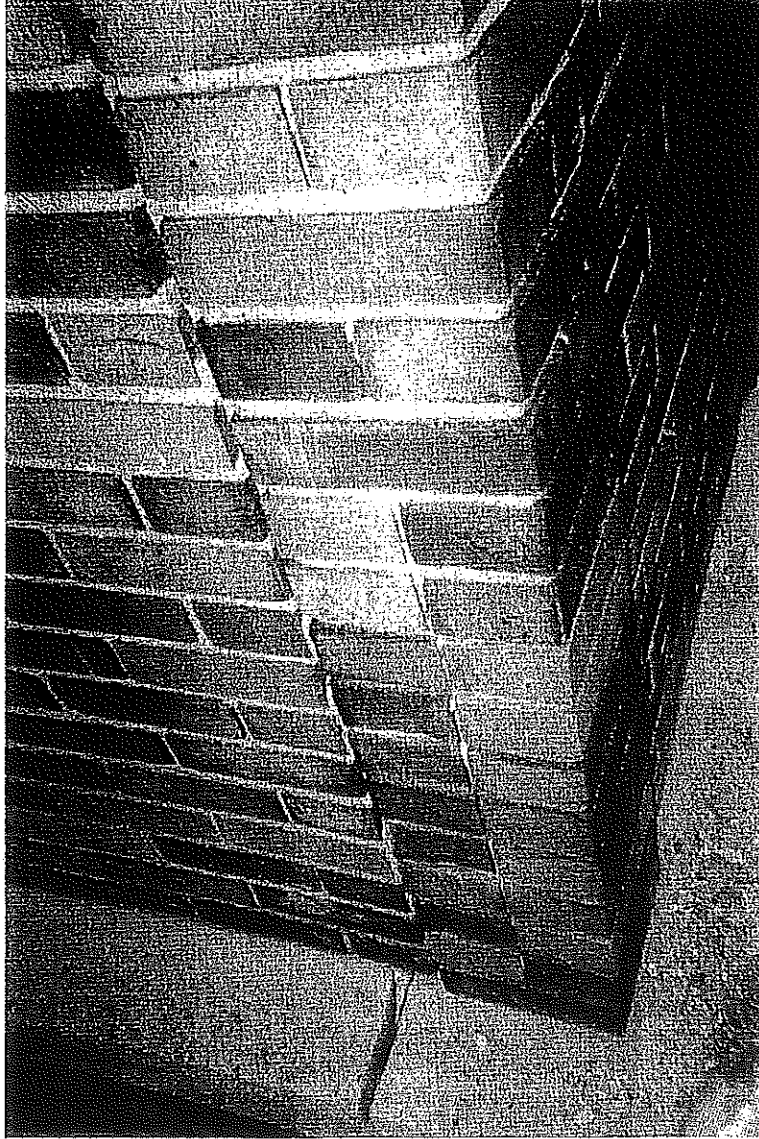
PHOTO #23 SOUTHEAST CORNER OF THE SIXTH FLOOR SHOWS WALL MOVEMENT. GAP IS ABOUT 1". NOTE PRECAST CONCRETE CORNICE LOSING CEMENTING PROPERTIES AND POROUSITY.
