PRE-RENOVATION INVESTIGATIVE SURVEY FOR ASBESTOS- CONTAINING MATERIALS AND LEAD BASED PAINT 18-20 TRINITY STREET HARTFORD, CONNECTICUT

Project No. 19-2B-HAZ-12
DCS No. 19028

July 2, 2019

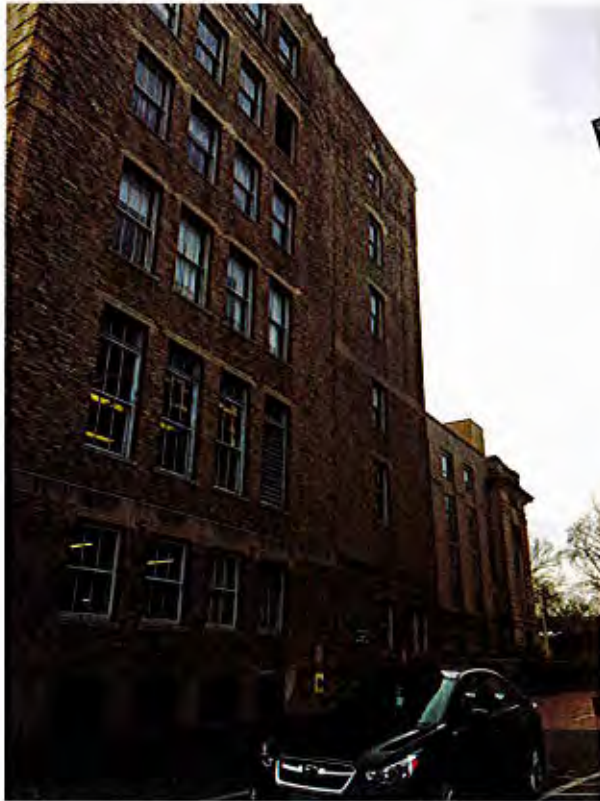
East side 42 windows

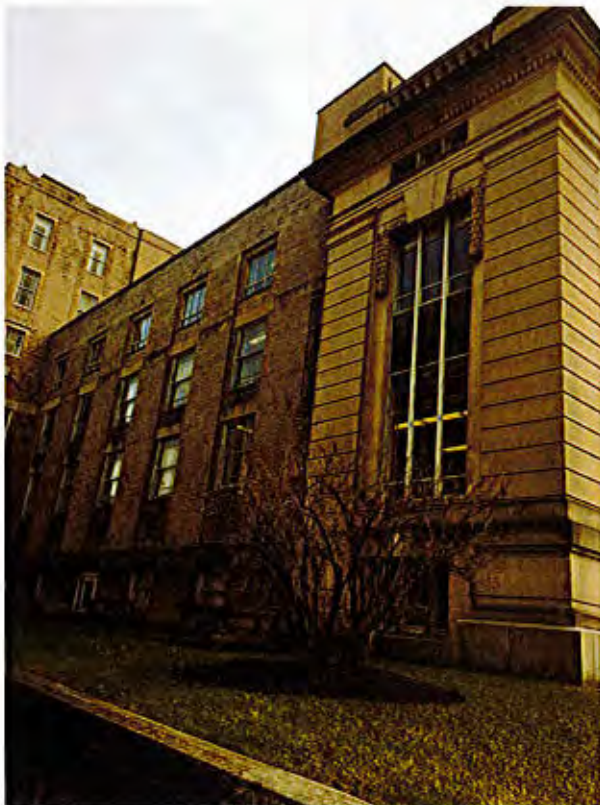
North side 59 windows

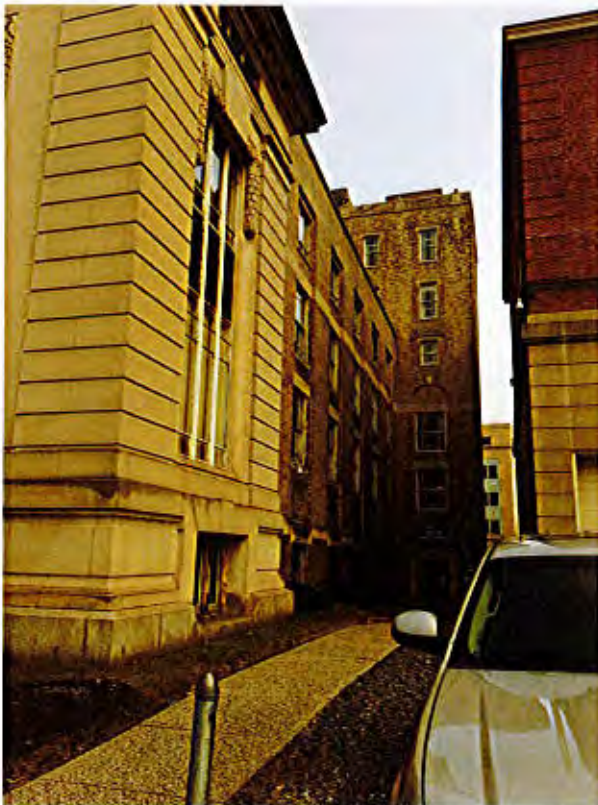
West side 7 windows

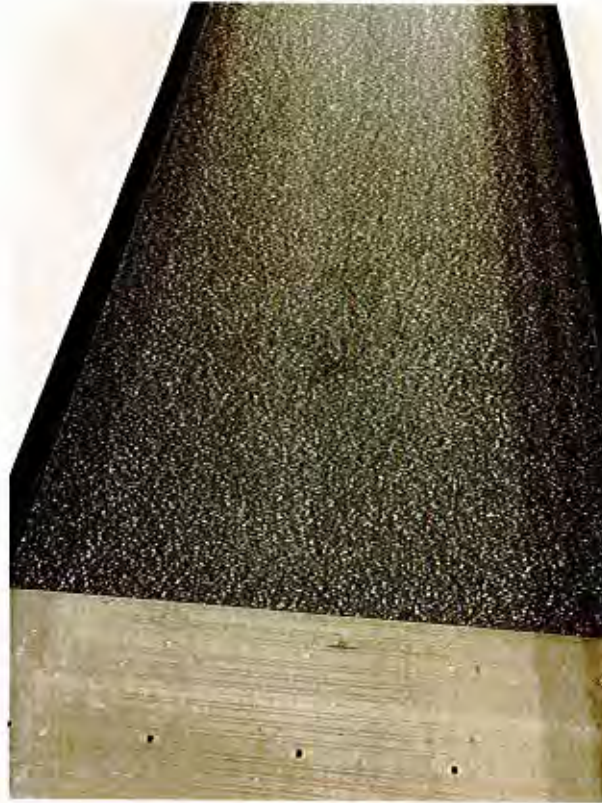
3rd fl west ramp

(2), FT, 6, 12"x12", Black with white spec no mastic

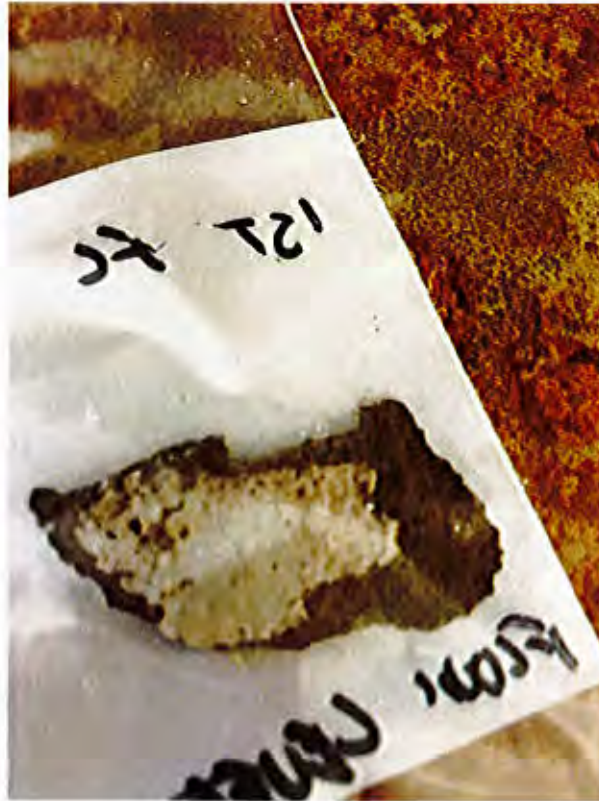
Sample Location	1st fl main hall W
Analyze by Layer	No
Asbestos Bulk Analysis	PLM EPA 600/R93/116
Grab or Composite	Grab
Date	2019-02-07
Time	13:44

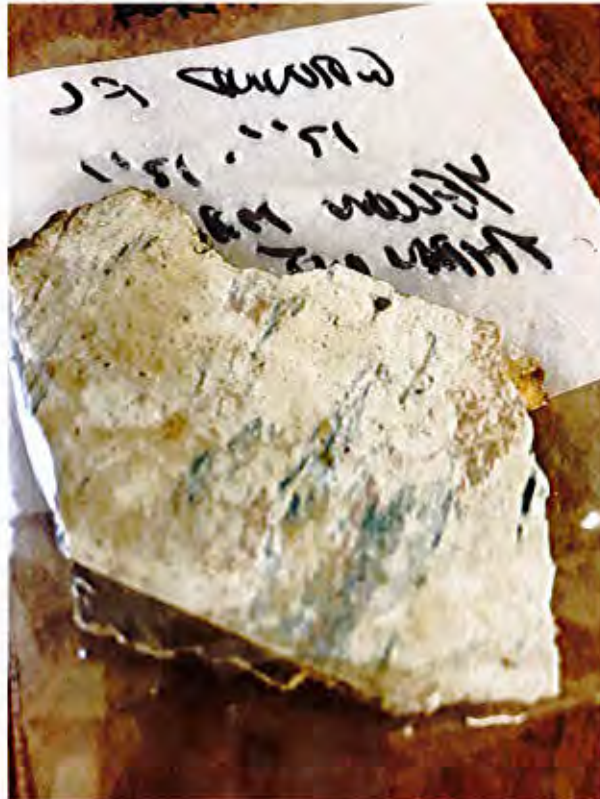
Sample Location	Ground fl middle west
Analyze by Layer	Yes
Asbestos Bulk Analysis	PLM EPA 600/R93/116
Grab or Composite	Grab
Date	2019-02-07
Time	15:02

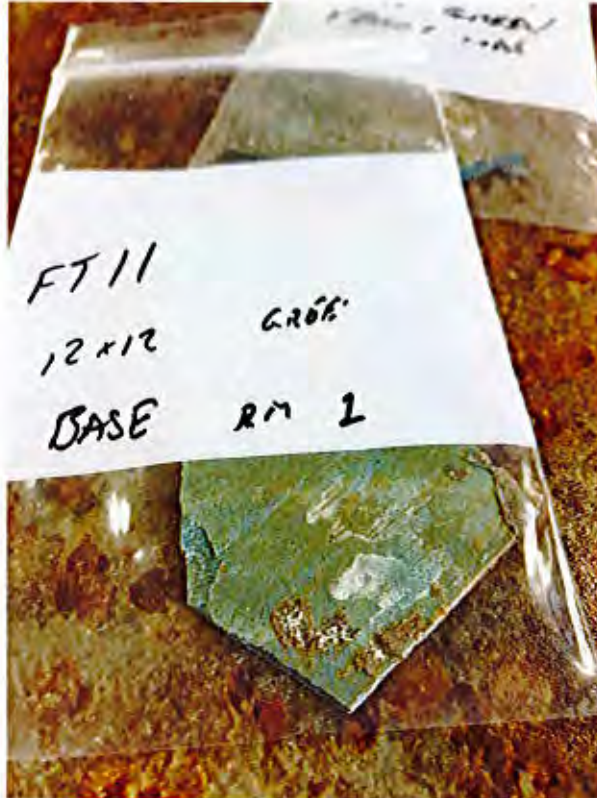
Sample Location	Basement store rm #1
Analyze by Layer	Yes
Asbestos Bulk Analysis	PLM EPA 600/R93/116
Grab or Composite	Grab
Date	2019-02-11
Time	14:14

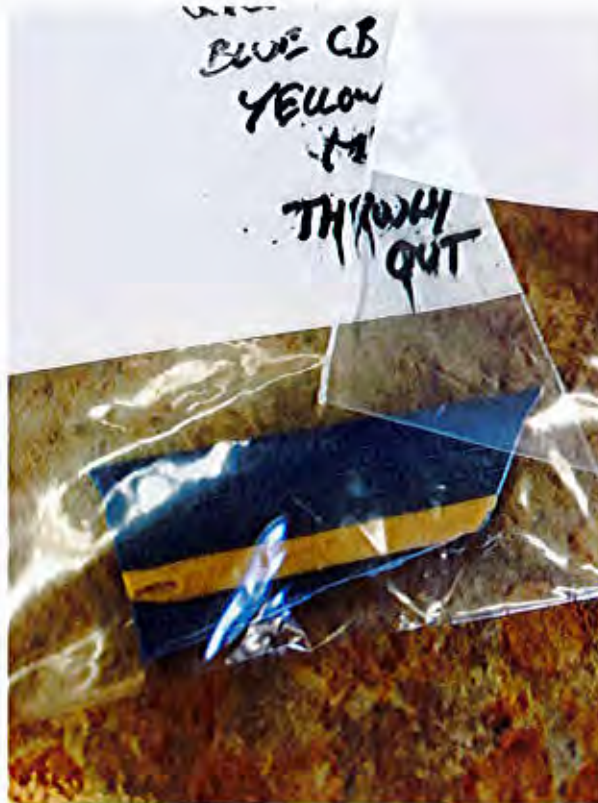
Sample Location	Ground floor west
Analyze by Layer	No
Asbestos Bulk Analysis	PLM EPA 600/R93/116
Grab or Composite	Grab
Date	2019-02-11
Time	14:31
