# **Balcony Flood Testing Investigation Report**

For  
25 Sigourney Street  
Hartford, CT 06106  
DPW Project Number B1-2B-033L

Prepared For  
STATE OF CONNECTICUT  
Department of Public Works

April 13, 2009

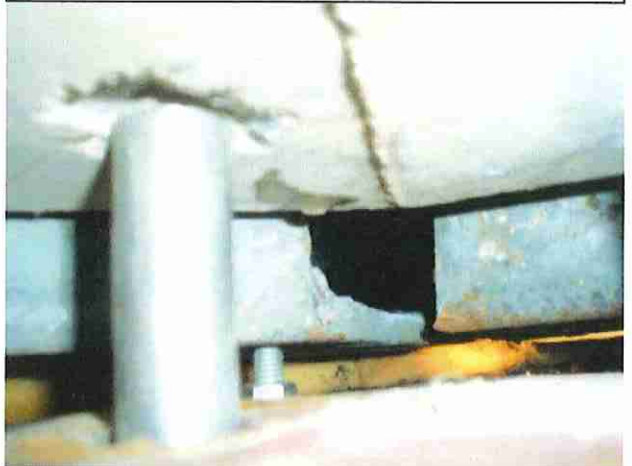
With the second leak coming from the interior side of the parapet wall, we needed to pinpoint which part of the wall construction was causing the leak. We began to reapply water to the interior side of the parapet wall. Because the wall was already saturated from our earlier flooding, the flow of the leak was observed quicker than before. We noticed that the drip on the inside was at a steady pace of one drip every

27 seconds. We then began soaking just the reglet which is the small continuous piece of metal that secures the roofing membrane to the parapet wall. While concentrating all the water at the reglet, the dripping slowed to 41 seconds between drops. This proved that the reglet was not the problem. We next concentrated our water directly on the masonry mortar in one specific brick/mortar joint location right at the corner of the parapet located directly above the leak. Within minutes the dripping increased to 10 seconds between drips. We concluded from this that water is soaking through the brick like it is designed to do, but then when it reaches the interior fabric flashing, (which is designed to direct water from the cavity out to the weep wholes on the exterior side of the wall), it is penetrating through the fabric and leaking down the back of the concrete beam and into the office below. There was now enough evidence of how the water was entering the building and there are several ways to remedy the problems.

In this is the case the three courses of brick above the reglet on the interior side of the parapet wall about a foot on each side of the leaking corner should be removed and the fabric flashing in this location should also be observed, repaired or replaced. The brick should than be set back into place with new weep holes and again the walls be flood tested. This should correct the leaks at this particular window.

Until these proper steps can be taken to permanently fix the leaks there is a rather simple temporary solution that can be performed by the Servus Management to slow the amount of water infiltrating the building. A simple tarp can be taped to the interior wall of the parapet at least one foot on each side of the corner that is reported leaking spanning from the high point of the coping stones to the top of the roofing reglet. This should temporarily impede water from soaking through the wall.
