Southbury Training Farm Various Buildings - Adaptive Reuse Study

Project No. BI-2B-444

January 16, 2019

O’Riordan Migani Architects LLC, 22 Bank Street, Seymour, CT 06483

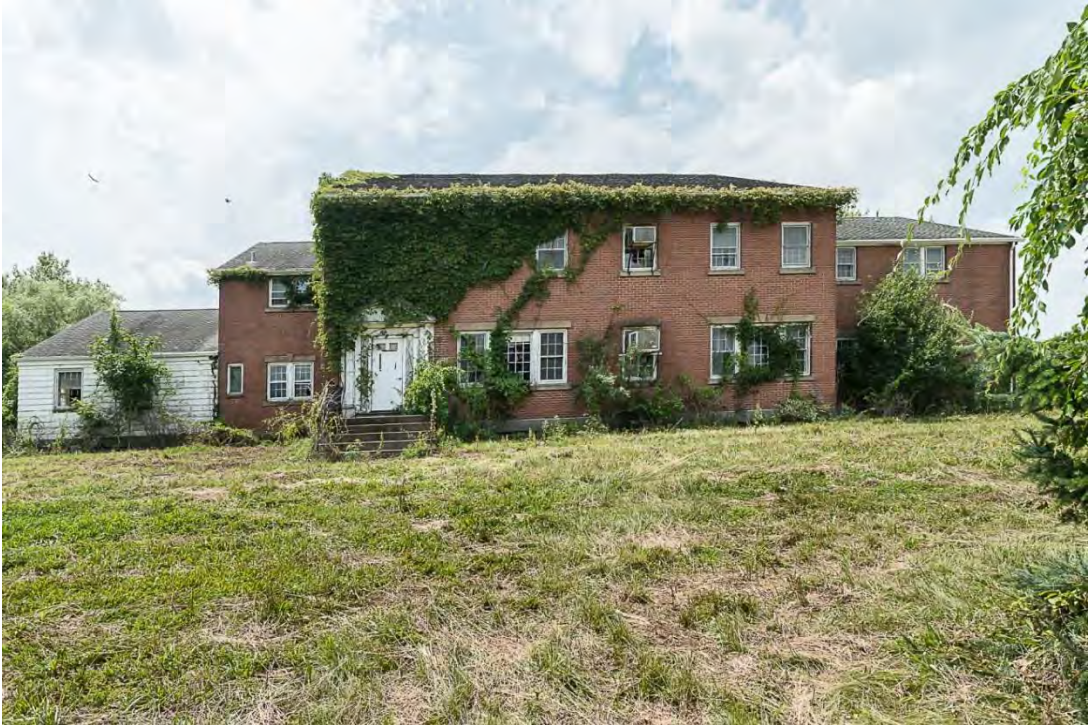
Photo 1. Building 1, view northeast showing façade.

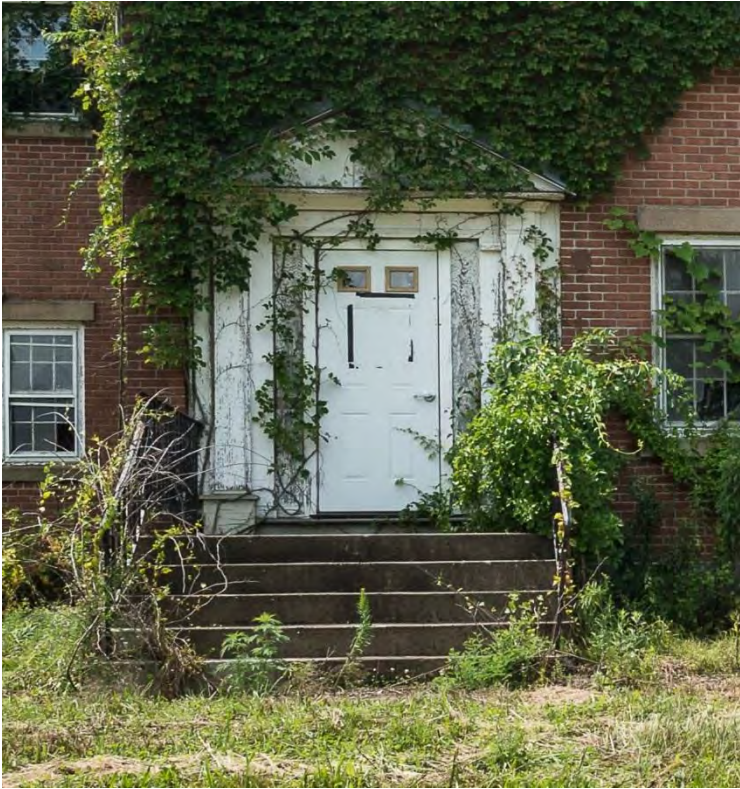
Photo 2. Building 1, view northeast showing main entrance.

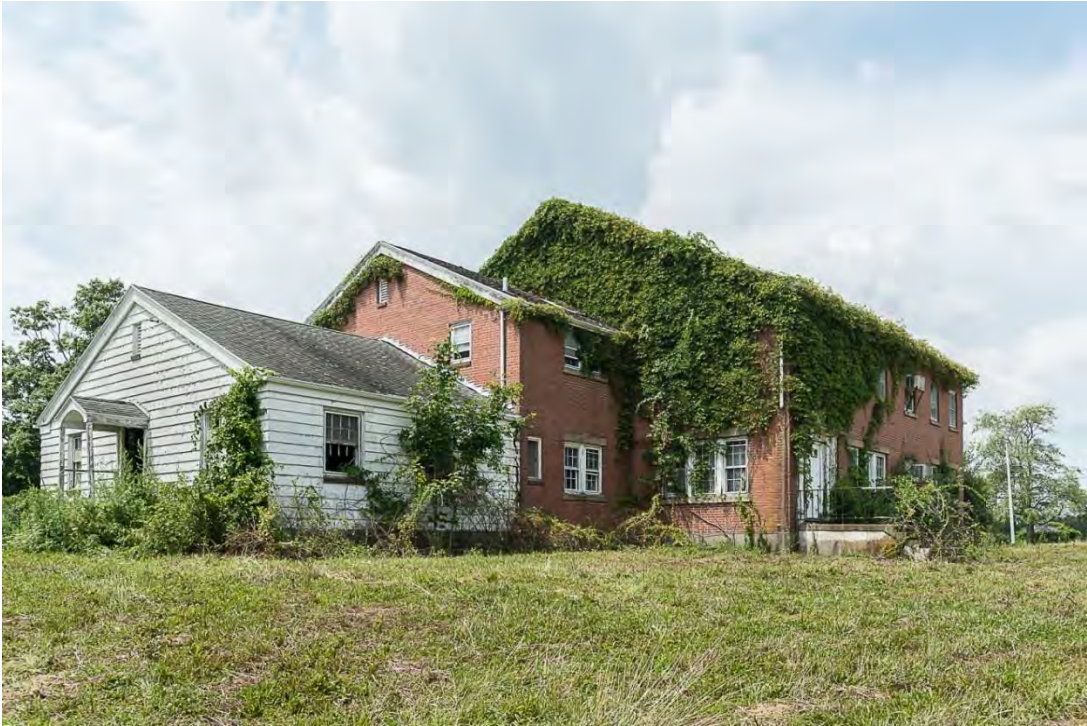
Photo 5. Building 1, view southwest showing east and north elevations.

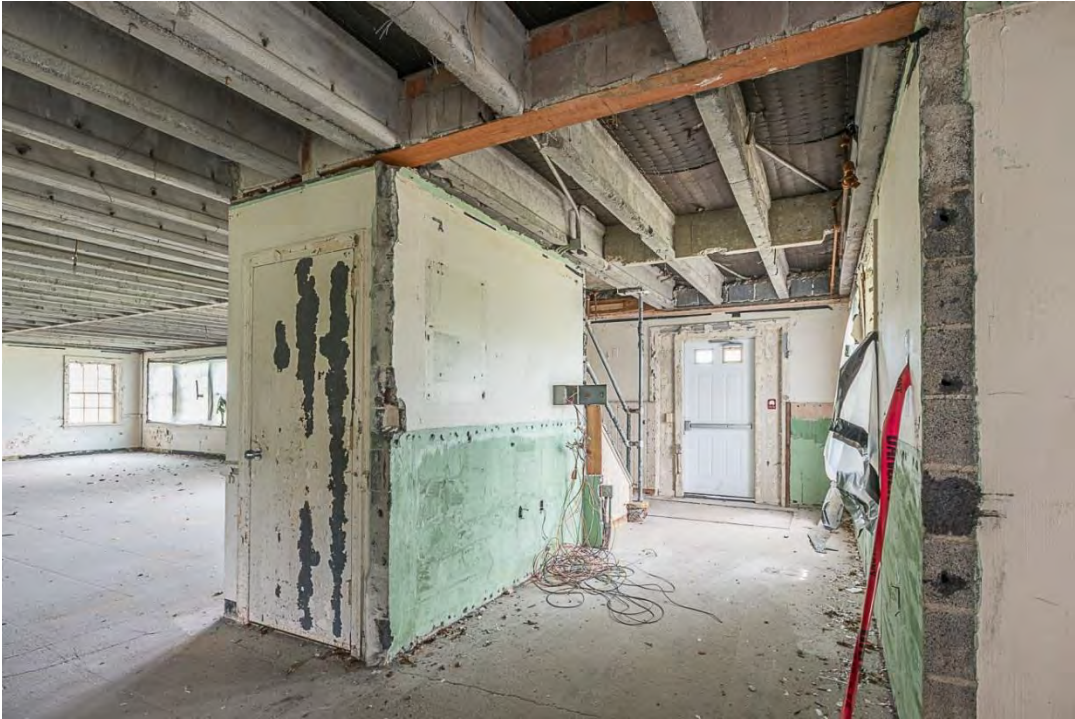
Photo 7. Building 1, first floor interior view north showing exposed floor joists and stair enclosure.

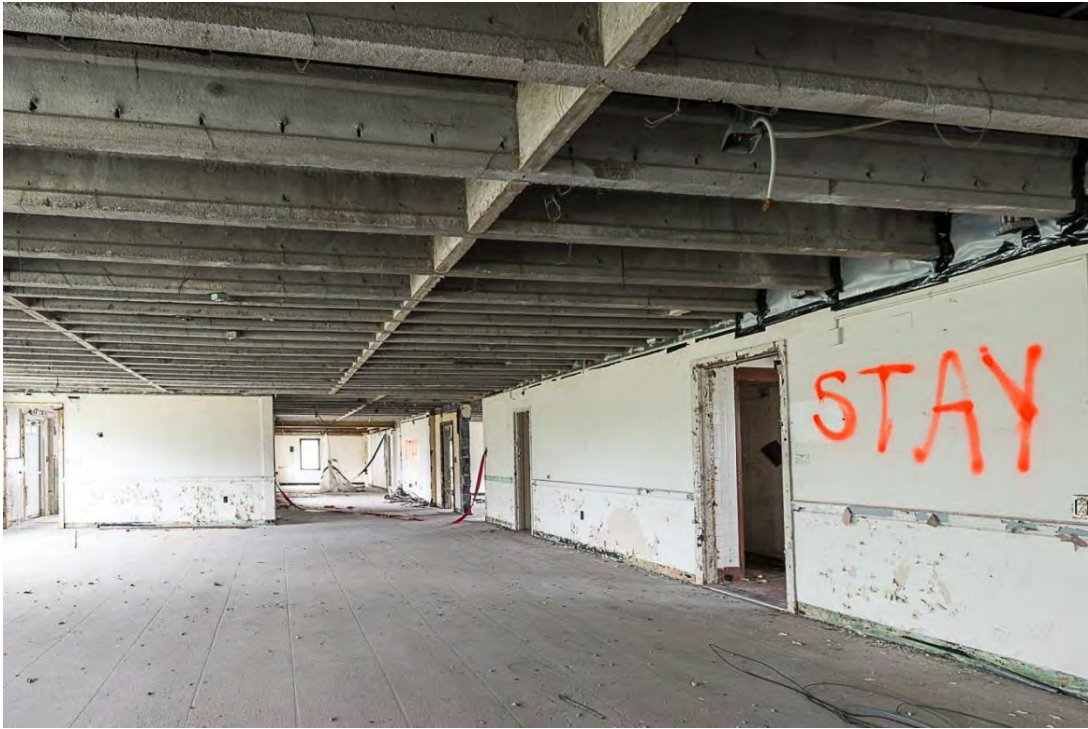
Photo 8. Building 1, first floor interior view north showing exposed floor joists and remaining walls.

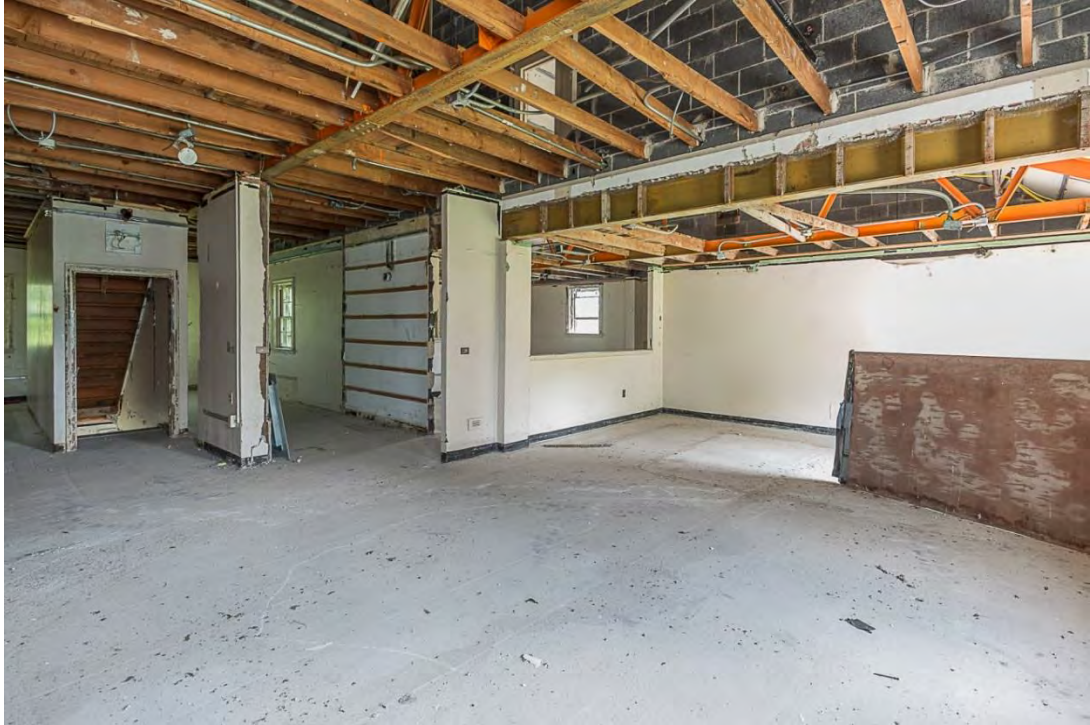
Photo 9. Building 1, first floor interior view southeast showing exposed rafters and remaining walls.

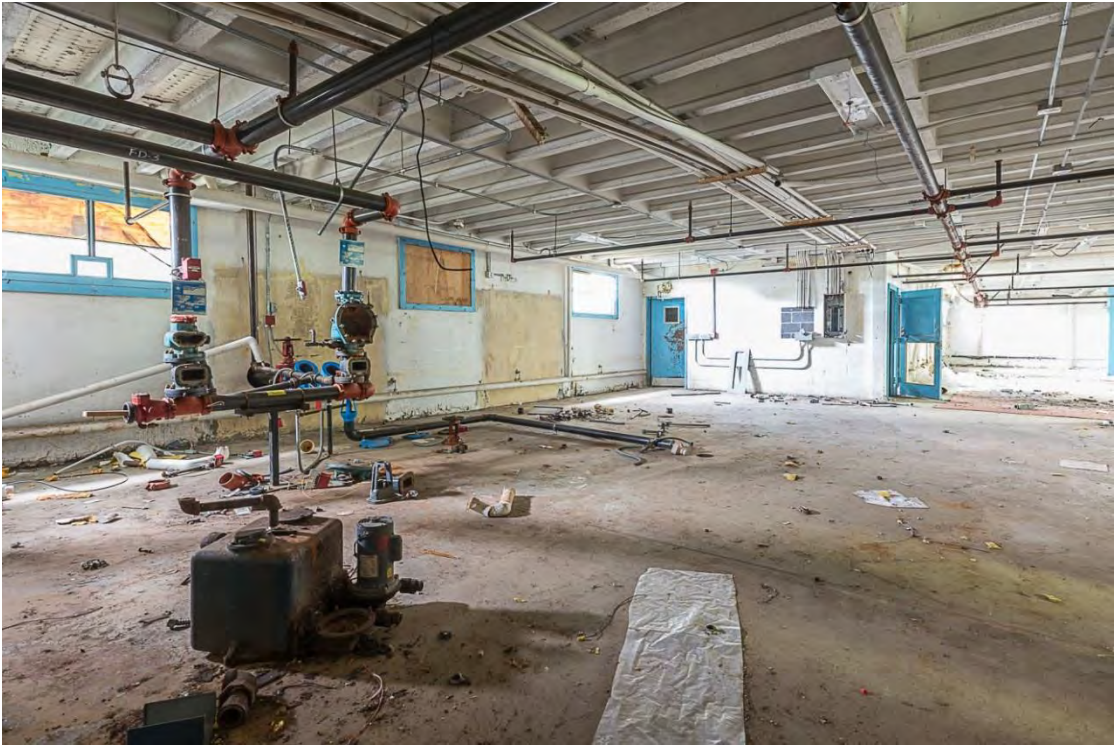
Photo 11. Building 1, basement interior view southeast showing exposed floor joists and heating pipes.

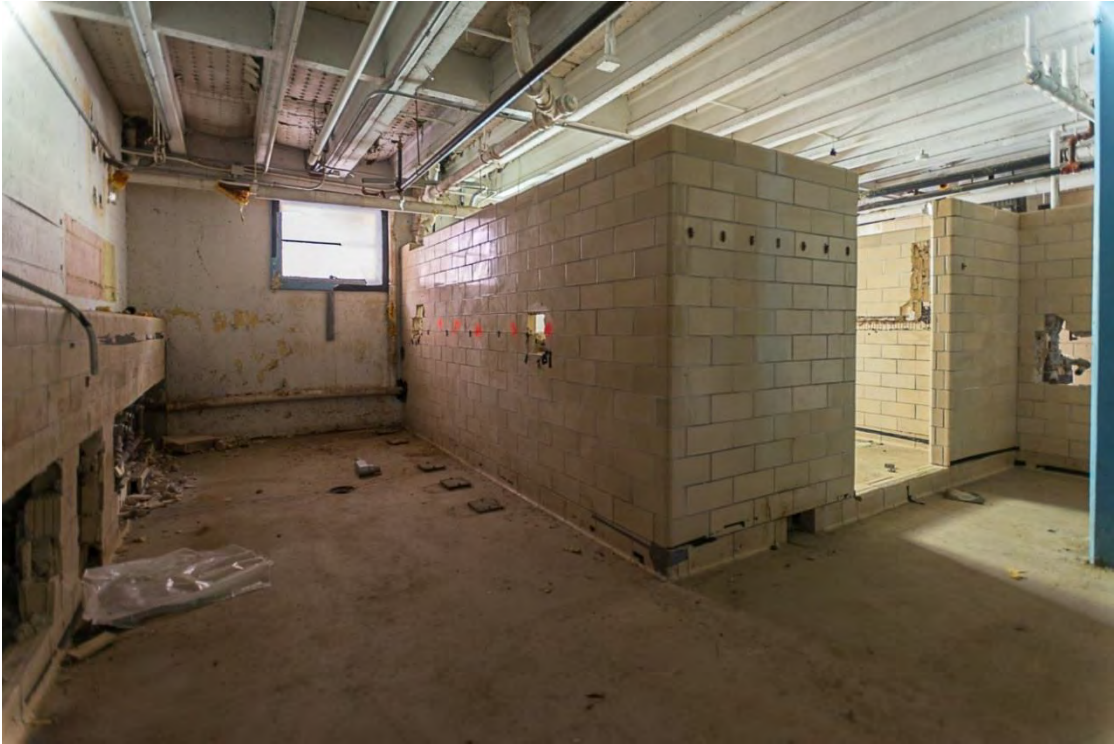
Photo 12. Building 1, basement interior view southeast showing tile enclosure.

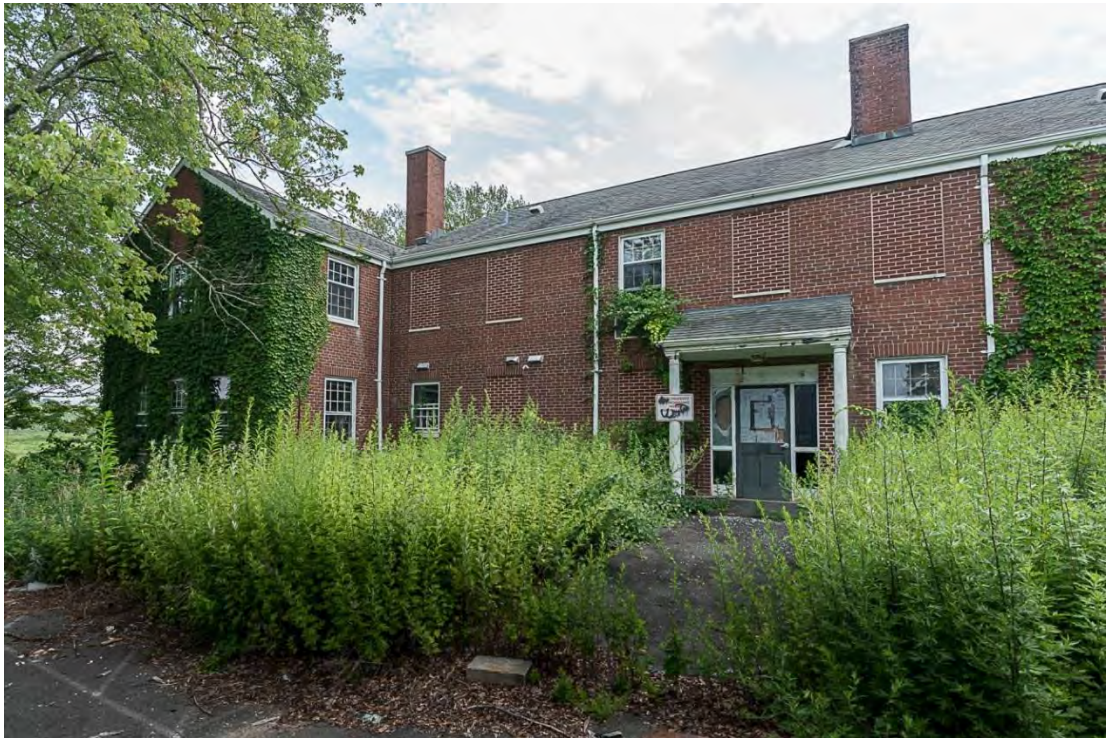
Photo 25. Building 4, view southeast showing north elevation, secondary entrance and bricked-in window openings.

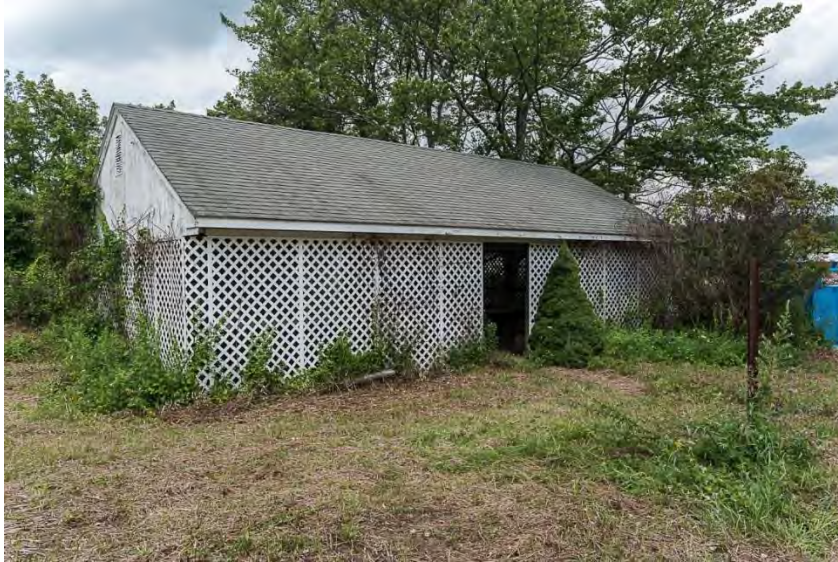
This covered patio to the northwest of Building 4 is not mentioned in the National Register of Historic places nomination. It appears to be of recent construction, but part of an open shed in this location appears in a 1992 photograph (Figure 2). It has a concrete floor and a wood frame covered with painted wood lattice with a wood framed roof covered with asphalt shingles. A heavy concrete table with a long rectangular opening in its center sits near the southeast corner of the floor. It is in fair to good condition.

Photo 31. Building 5 view northeast showing west and south elevations.

Item	Description	Comments
1	Building Name	Covered Patio Behind Farm Cottage #1
2	Former Use	Exterior Potting Shed
3	Year Built	1950+/-
4	Gross Building Area	747 SF Single Level
5	Hazmat	Unabated lead paint
6	Exterior Envelope	
7	Foundation	Slab on grade with concrete support piers at columns in good condition with no signs of cracking or settlement. Good condition.
8	Walls	Painted wood lattice. Good condition. Requires repainting. Observe requirements for dealing with lead paint.
9	Windows	None
10	Roof	Fiberglass asphalt shingle on wood sheathing and stick framing. Requires replacement given age.
11	Structure	Wood columns, framing and gable roof profile. The patio is a one story structure with a gable style roof. The roof is timber framed and concealed by a ceiling. The roof is supported by eight steel pipe columns that are exposed. The structure is braced by exposed steel angle (L3x3x1/4) knee braces in both directions. The steel columns are bolted to the foundation. The patio floor is an exposed concrete slab on grade. Although the roof structure was not observed, it appears to be in good condition as the structure is plumb, level and square. There are no visible signs of sag in the roof ridge from street level. The steel superstructure appears to be in good condition. The slab of grade has significant cracking and has been previously patched.

12	Building Systems	None. An underground GFI circuit for power and lighting should be provided from the main building.
13	Building Utilities	None. A water hose bib should be provided from the main building.
14	Other	
15	Accessibility	Yes
16	Record Photos	See Photos No. 31 – 32 in Section IV of this report
17	Historic Status	The building is not mentioned in the National Register of Historic place nomination and is therefore NON-CONTRIBUTING because it was built after the end of the 1940 period of significance.

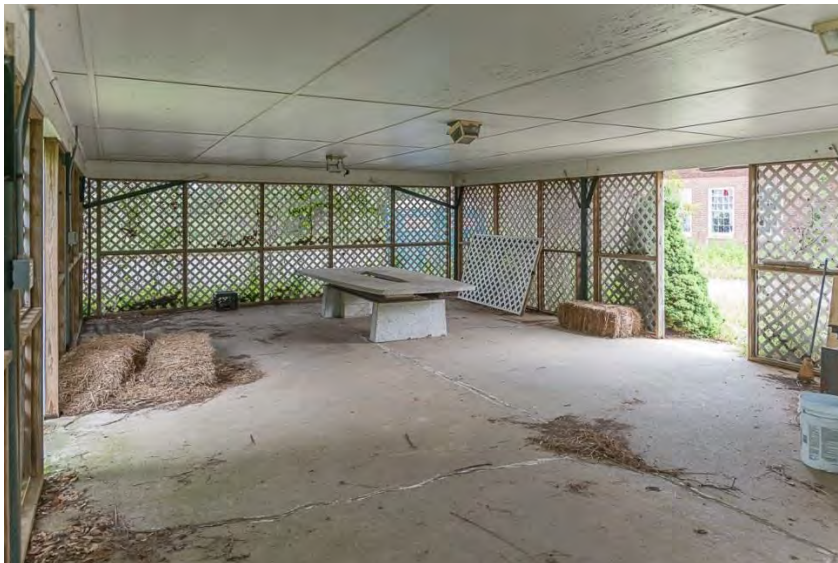
Photo 32. Building 5, interior view southeast showing concrete table.

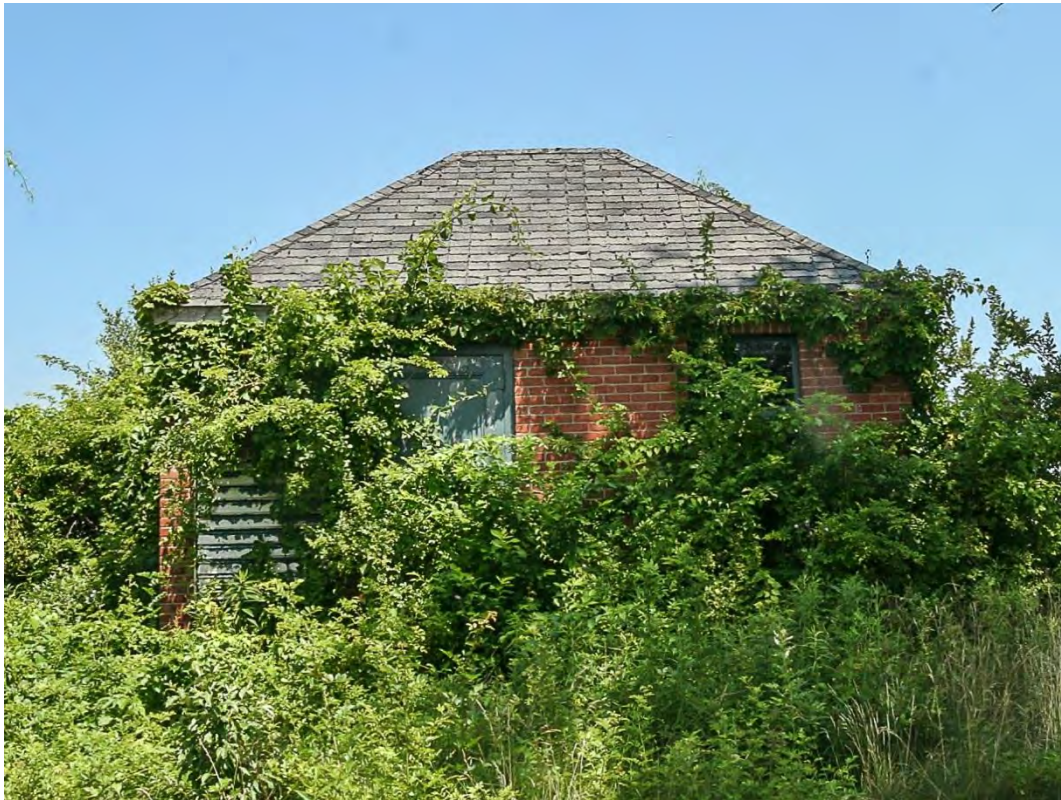
This building was constructed in 1940 and was listed as a contributing resource in the National Register of Historic places nomination because it was built during the 1940 Period of Significance for the nomination. It is a square, brick utilitarian building in a Colonial Revival style consistent with other buildings in the school complex. It is heavily overgrown with vegetation, but it appears to have a high degree of architectural integrity. Its shape and massing, as well as its hipped roof have survived. The sections of its brick walls and mortar that are visible are in good condition. The interior was inaccessible.

Photo 32. Building 6, exterior view north showing facade.

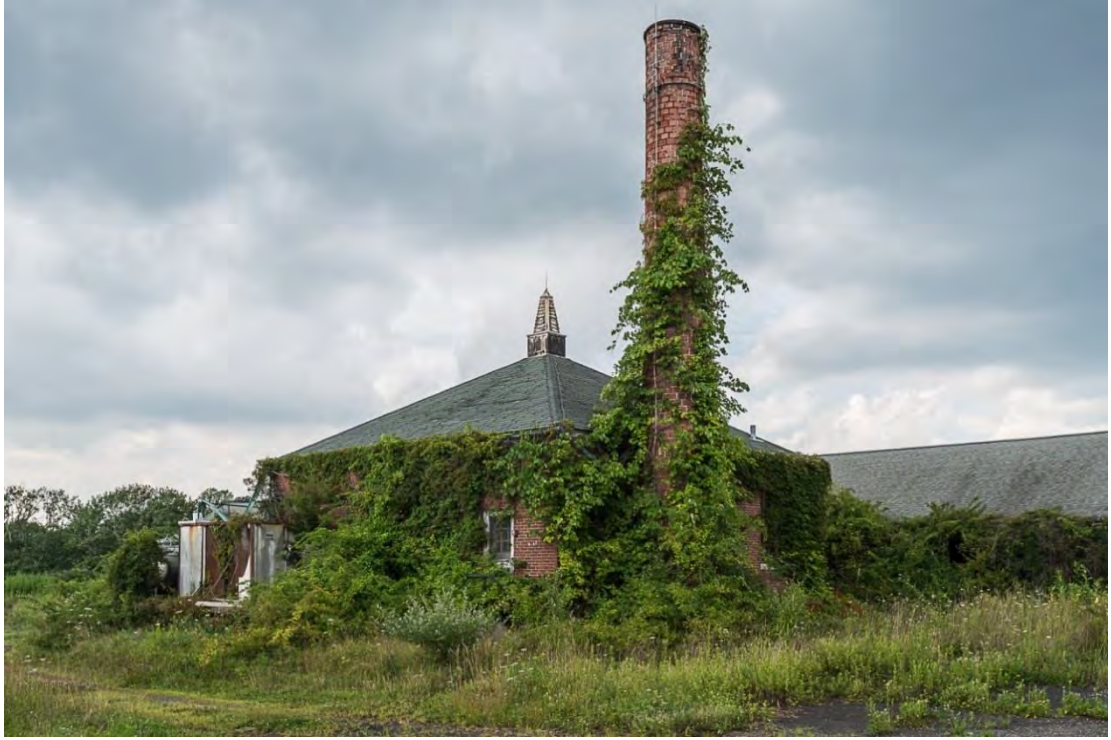
Photo 35. Building 7, view northwest showing milk house and chimney.

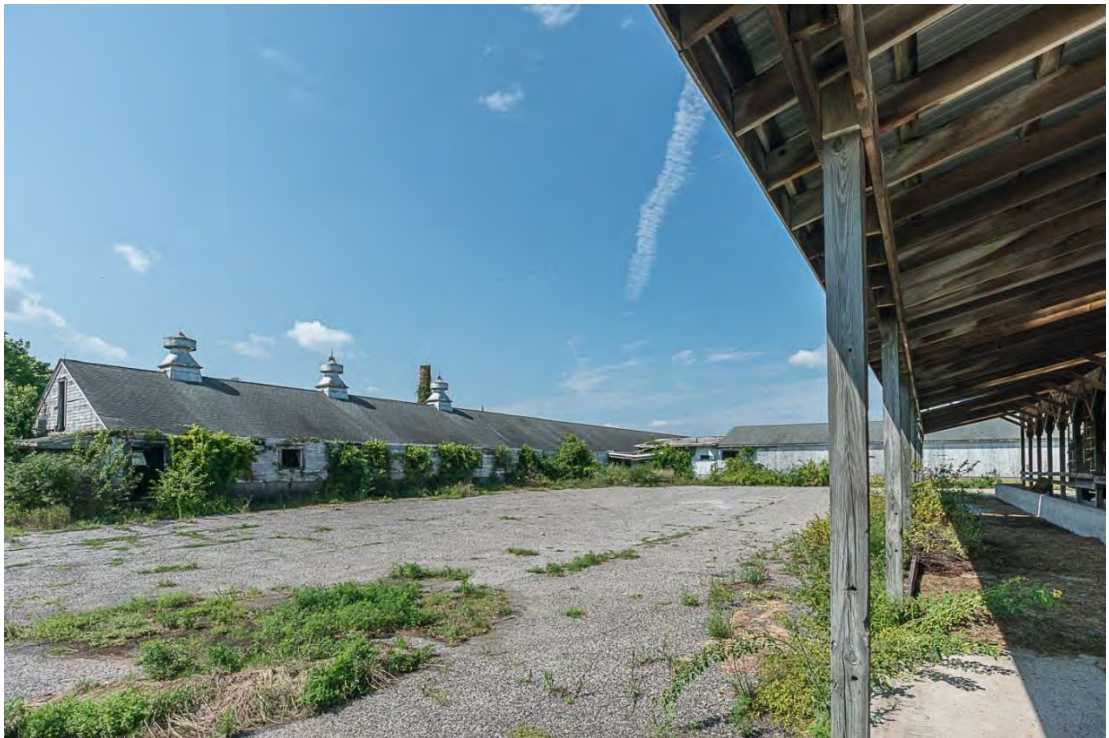
Photo 37. Building 8, view southwest showing east and north elevations of dairy barn, east elevation of hay barn and roof overhang on south elevation of heifer barn.

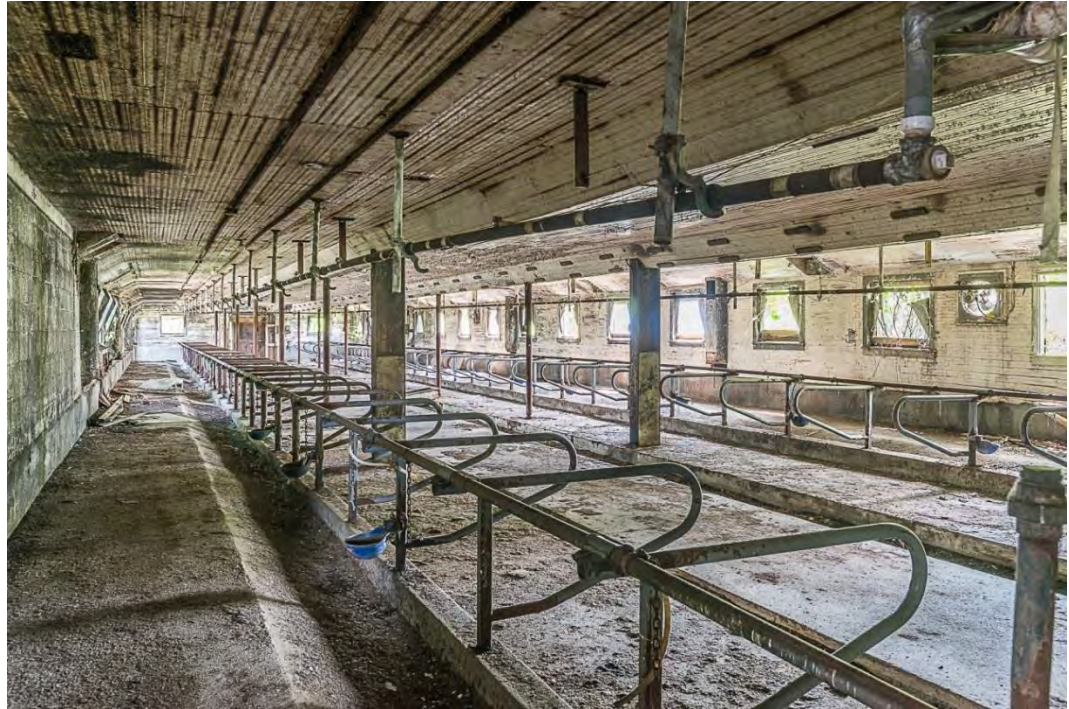
Photo 38. Building 8, interior view southeast showing concrete floor and open stalls

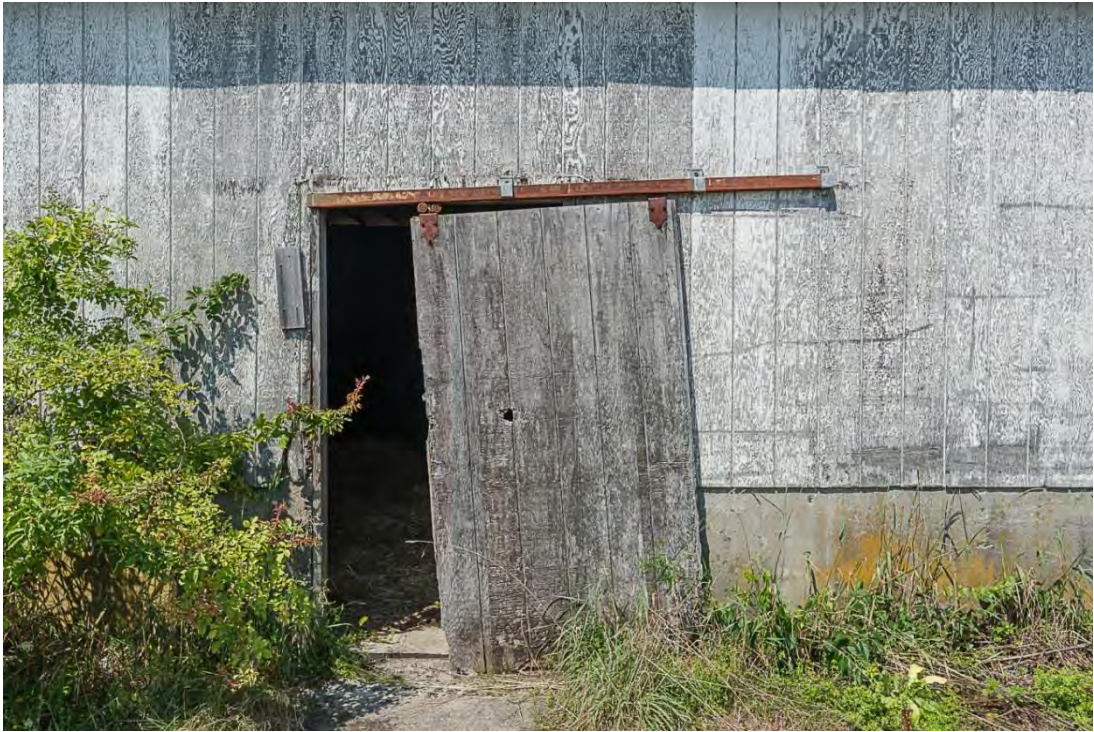
Photo 40. Building 9, view west showing original door on east elevation

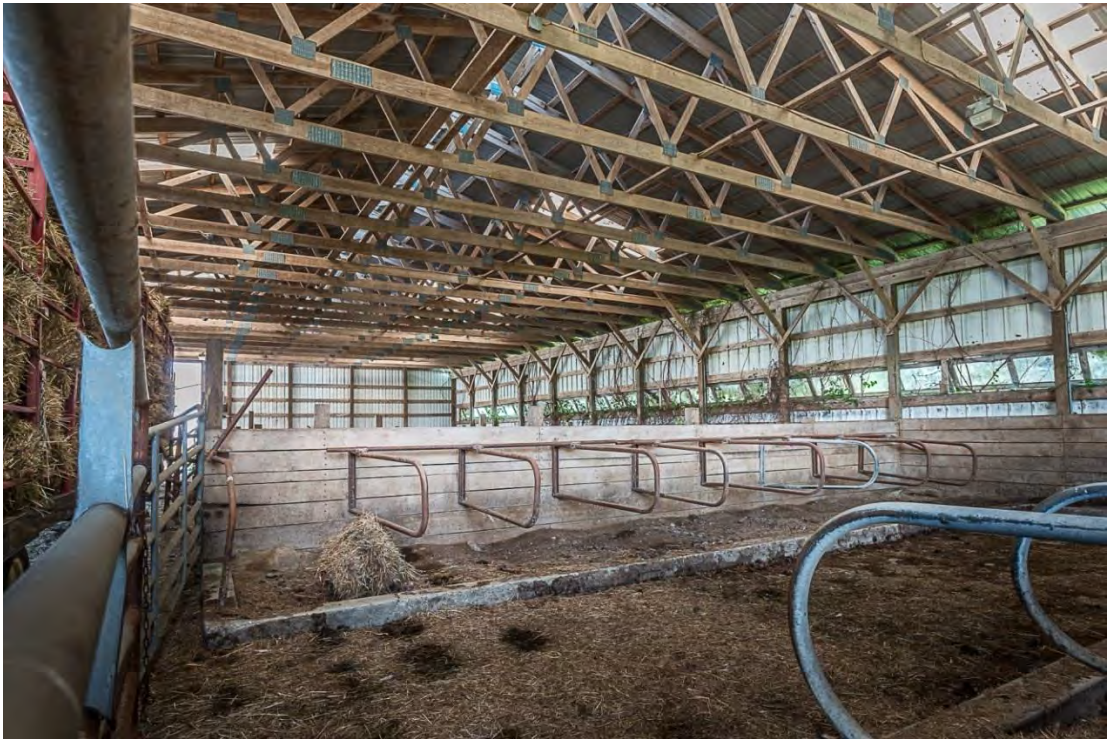
Photo 45. Building 10, interior view northwest showing roof trusses and open stalls.

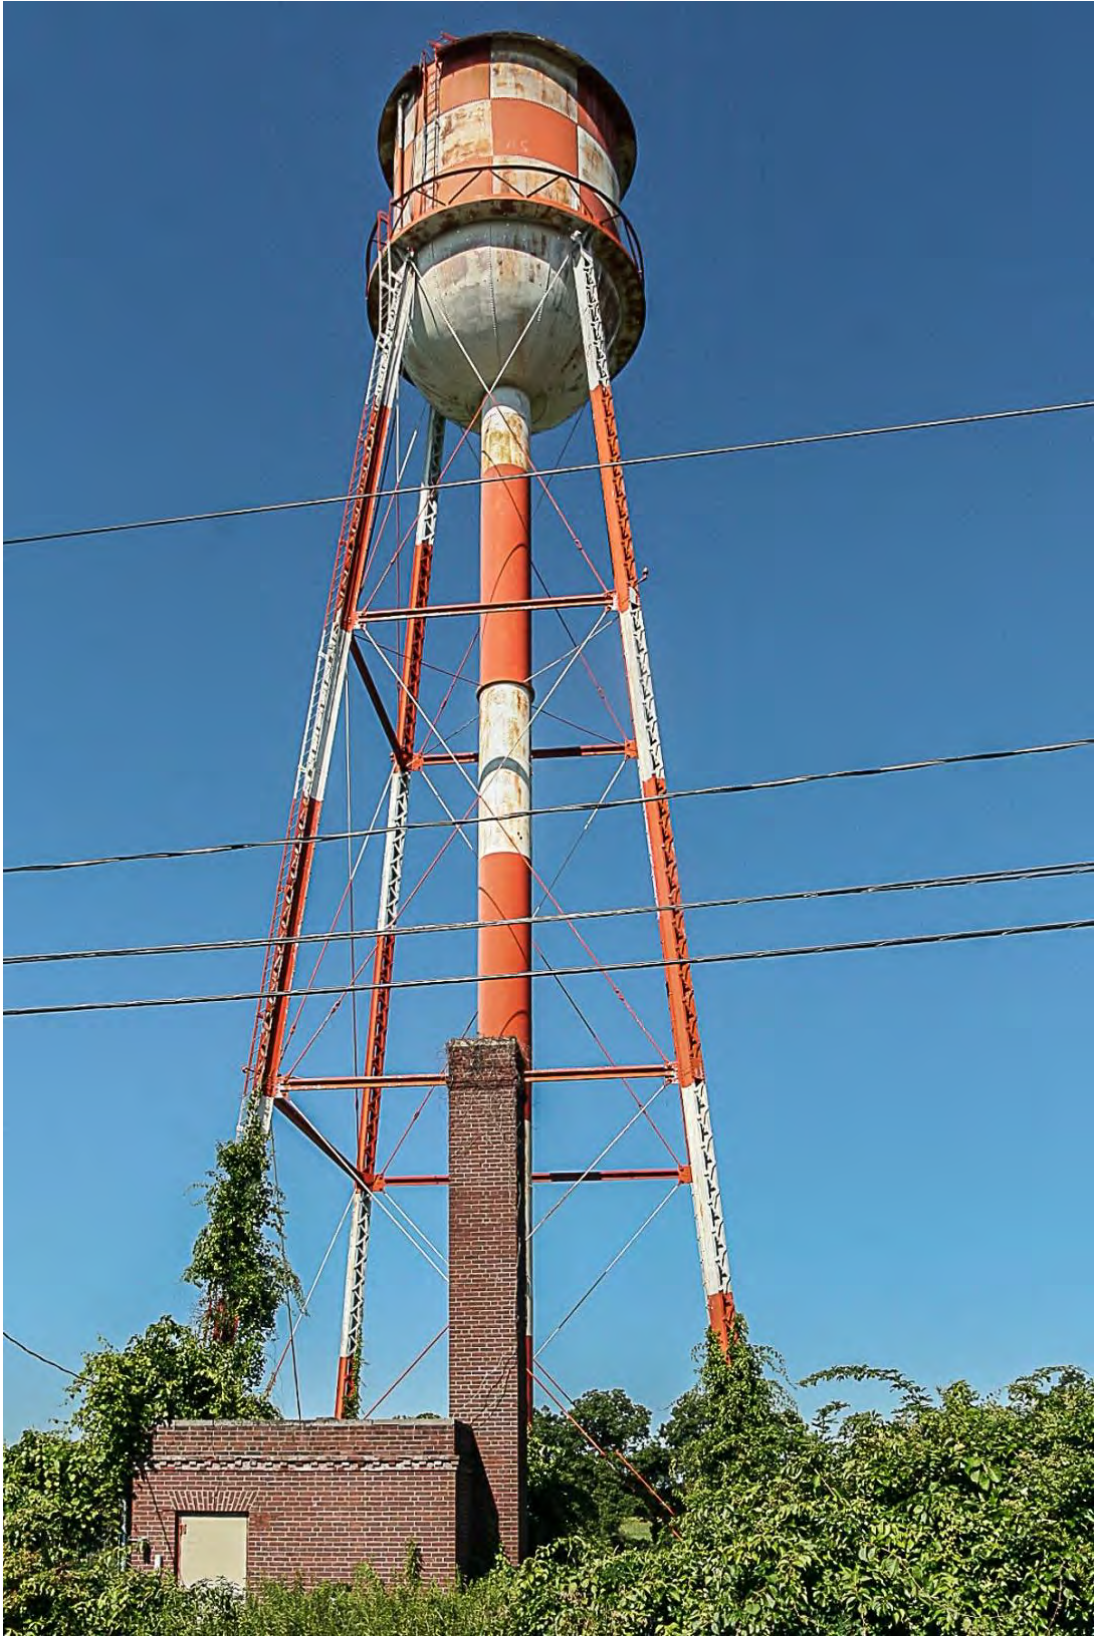
The water tower and Pump House were constructed in 1940 and the water tower was listed as a contributing resource in the National Register of Historic places nomination because it was built during the 1940 Period of Significance for the nomination. The pump house is not listed in the nomination but may have been included as part of the water tower. The water tower is a typical structure of its type in 1940 and it has a high degree of architectural integrity. The pump house is a square brick utilitarian building in the Colonial Revival style. Its exterior retains a high degree of architectural integrity. Brick and mortar are in good condition. The interior of this building was inaccessible.

Photo 47. Water tower and pump house, view north.

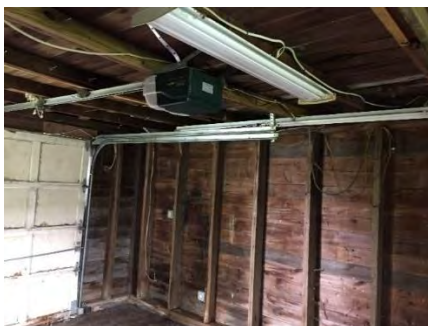
Item	Description	Comments
1	Building Name	Detached Garage @ Foreman's House
2	Former Use	One bay garage
3	Year Built	1950+/-
4	Gross Building Area	273 SF Single Level
5	Hazmat	Unknown
6	Exterior Envelope	
7	Foundation	Concrete foundation with slab on grade in fair condition.
8	Walls	Wood frame stud wall with exterior wood plank sheathing & wood siding & no interior finishes. Recommend prep, prime & paint exterior wood siding & trim.
9	Windows	Existing wood double hung and fixed have exceeded design life and require replacement.
10	Roof	Asphalt shingle. Approaching end of design life. Replacement required.
11	Structure	Wood frame, plumb level & square without signs of fracture or settlement. The garage is a single story structure with a gable roof. The sheathing consists of 1x6 tongue and groove decking supported by 2x6 rafters spaced approximately 24 inches on center. The roof framing is supported by load bearing 2x6 stud walls, spaced at 24 inches on center. A portion of the roof framing was concealed by a wood framed ceiling. From the outside of the structure there appears to be a localized area, located above the framed ceiling area, where the roof and decking has been damaged and will need to be replaced. Otherwise the wood structure appears to be in good condition. Overall the structure is plumb, level and square. There are no indications of settlement.

Building 3: Photo of interior wood framing.

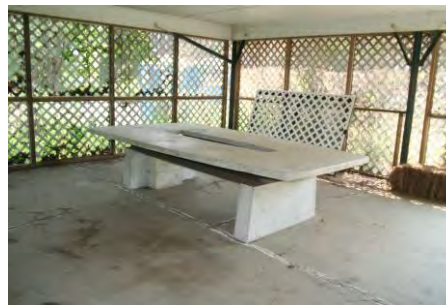
Interior View of Patio & Concrete Plant Potting Table

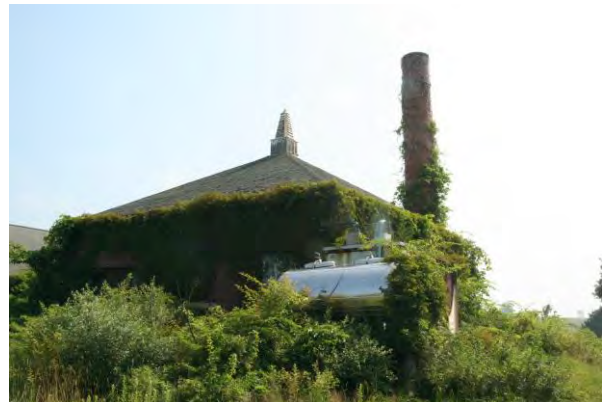
Item	Description	Comments
1	Building Name	Milk House
2	Former Use	Milk Storage and Distribution Building
3	Year Built	1940+/-
4	Gross Building Area	1,045 SF Single Level
5	Hazmat	Asbestos abatement previously by State. Interior paint lead.
6	Exterior Envelope	
7	Foundation	Concrete foundation in good condition with no signs of cracking or settlement.
8	Walls	Brick veneer on CMU in good condition with no signs of cracking or settlement. Requires repointing. Interior wall finishes are glazed block and tile.
9	Windows	Existing wood double hung and fixed have exceeded design life and require replacement.
10	Roof	Fiberglass asphalt shingle on wood sheathing and stick framing. Roof requires replacement.
11	Structure	CMU with brick walls with brick veneer and wood framed gable roof. The building is a one story structure with a hip style roof and a basement. The roof sheathing is wood decking supported by wood trusses. The roof is supported by load bearing masonry walls. The sub-surface basement walls are concrete. During the observations, the basement was flooded with several feet of water. Although the majority of the structure is concealed by wall and ceiling finishes, the structure appeared to be in good condition. The roof decking and framing that was observed through an opening in the ceiling appeared to be in good condition. There are no visible signs of sag in the roof ridge from street level. The masonry walls are also in good condition; no cracking was observed. The masonry steel lintels are deteriorated and should be replaced. The overall structure is plumb, level and square. There are no indications of settlement. Additional investigation and remediation is required to determine the source of the water infiltration in the basement.

Reference Photo: West Elevation with Milk Storage Tank

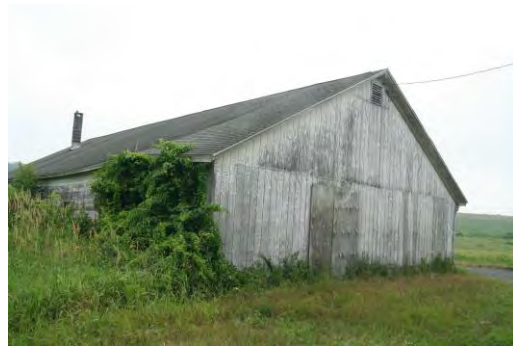
View Looking Northeast - Hydraulic Equipment Lifted Roof
