June 23, 2017
File No. 05.0045937.00

Re: Letter Condition Survey Report for the Shaw's Cove Bulkhead
Shaw's Cove, New London, CT

SHAW'S COVE BULKHEAD INSPECTION
410 BANK STREET
NEW LONDON, CONNECTICUT

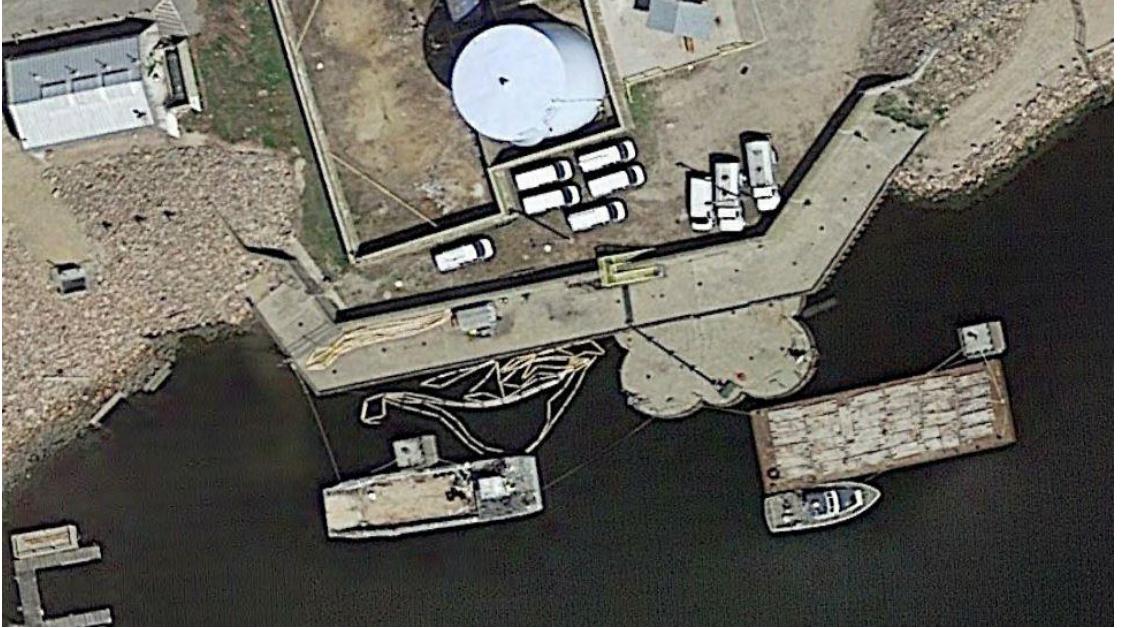
Client Name: City of New London		Site Location: Shaw's Cove, New London, CT	Project No. 05.0045937.00
Photo No. 1	Date: May 2015	Direction Photo Taken: Aerial Image (Google Earth)	
Description: Aerial image of site.

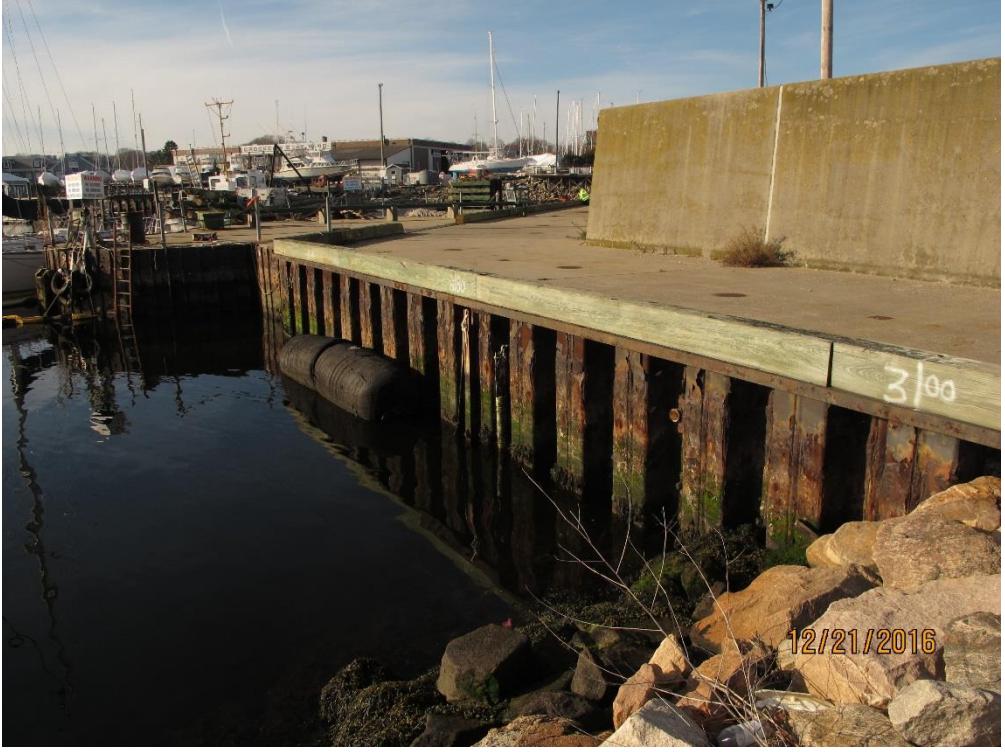
Client Name: City of New London		Site Location: Shaw's Cove, New London, CT	Project No. 05.0045937.00
Photo No. 5	Date: 12-21-16

Direction Photo Taken: Looking West
