Bridgeport

Main Street on the east and west sides of Route 8 – Road
Safety Audit

September 9, 2016

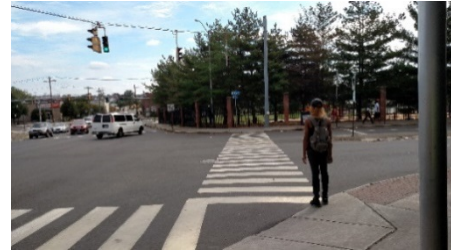
Figure 8. East Washington Avenue and Main Street

- East Washington Avenue and Main Street is a signalized four way intersection with crosswalks across two of the legs. (Figure 8)
- There are non-ADA compliant ramps on the southern and western corners of the East Washington and Main Street intersection.

- There is only one pedestrian push button at this intersection (south-east corner) and it was broken. (Figure 9)
- There are no pedestrian signal heads.

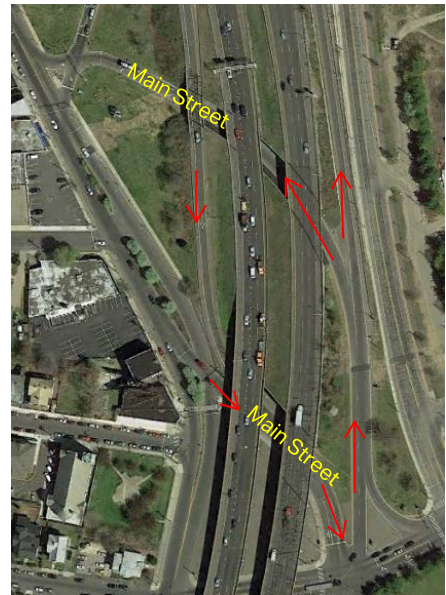
Figure 12. Main Street Traffic Circulation

- North of East Washington Avenue Main Street splits into separate roadways in each direction. The Route 8 Northbound ramp splits off to the east just north of the intersection. This can be confusing. (Figure 12)

12. Install proper signage for southbound Main Street traffic that merges with Route 8 off-ramp, directing one of the flows of traffic to yield.
13. Repair broken sidewalk.

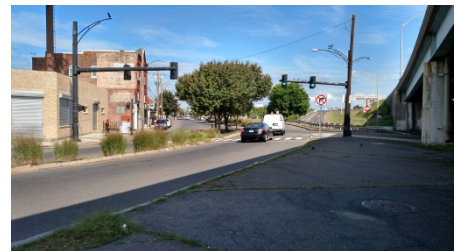
Figure 15. Main Street, Madison Avenue and Washington Avenue Intersection

- This multi-leg intersection is controlled by one coordinated signal, with planted medians to channelize and direct traffic. There is a crosswalk across Madison Avenue and Washington Avenue where Main Street splits. (Figure 15)
- Due to the crosswalk configuration many individuals jaywalk to the south of the intersection. (Figure 16)
- The signal provides an exclusive pedestrian phase with count down pedestrian heads and ADA compliant ramps.
- The planted median has trees whose branches block signs. (Figure 17)
- Madison Avenue is a one-way street eastbound, with parking allowed on both sides. Vehicles often park past the stop bar.

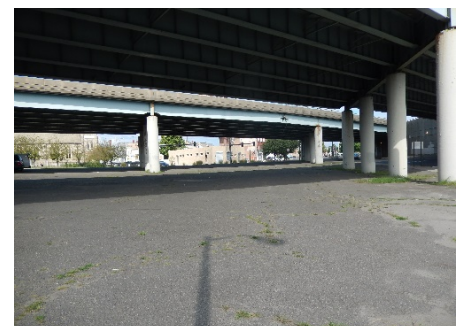
Figure 19. Route 8 Underpass

- The posted Speed limit in this area is 25 MPH.
- There are no bike lanes or shoulder lines on any of the inventoried roads.
- In the center of this area is a wide open, paved area beneath the underpass. This is an uninviting location, but is the straightest route between northern Main Street and southern Main Street, so people frequently cut through (requiring jay-walking). Occasionally police park in this area. (Figure 19)

4. Partner with community organizations and local artists to have artists submit proposals for painting the underpass area, to beautify. (Figure 26)
5. Install pedestrian signals with countdown heads, audible, and tactile pushbuttons at the intersections of Catherine Street and Washington Avenue, Main Street and East Washington Avenue and Main Street, Route 8 Ramp and Washington Avenue.
