# New Fairfield

Route 37 – Road Safety Audit

April 24, 2017

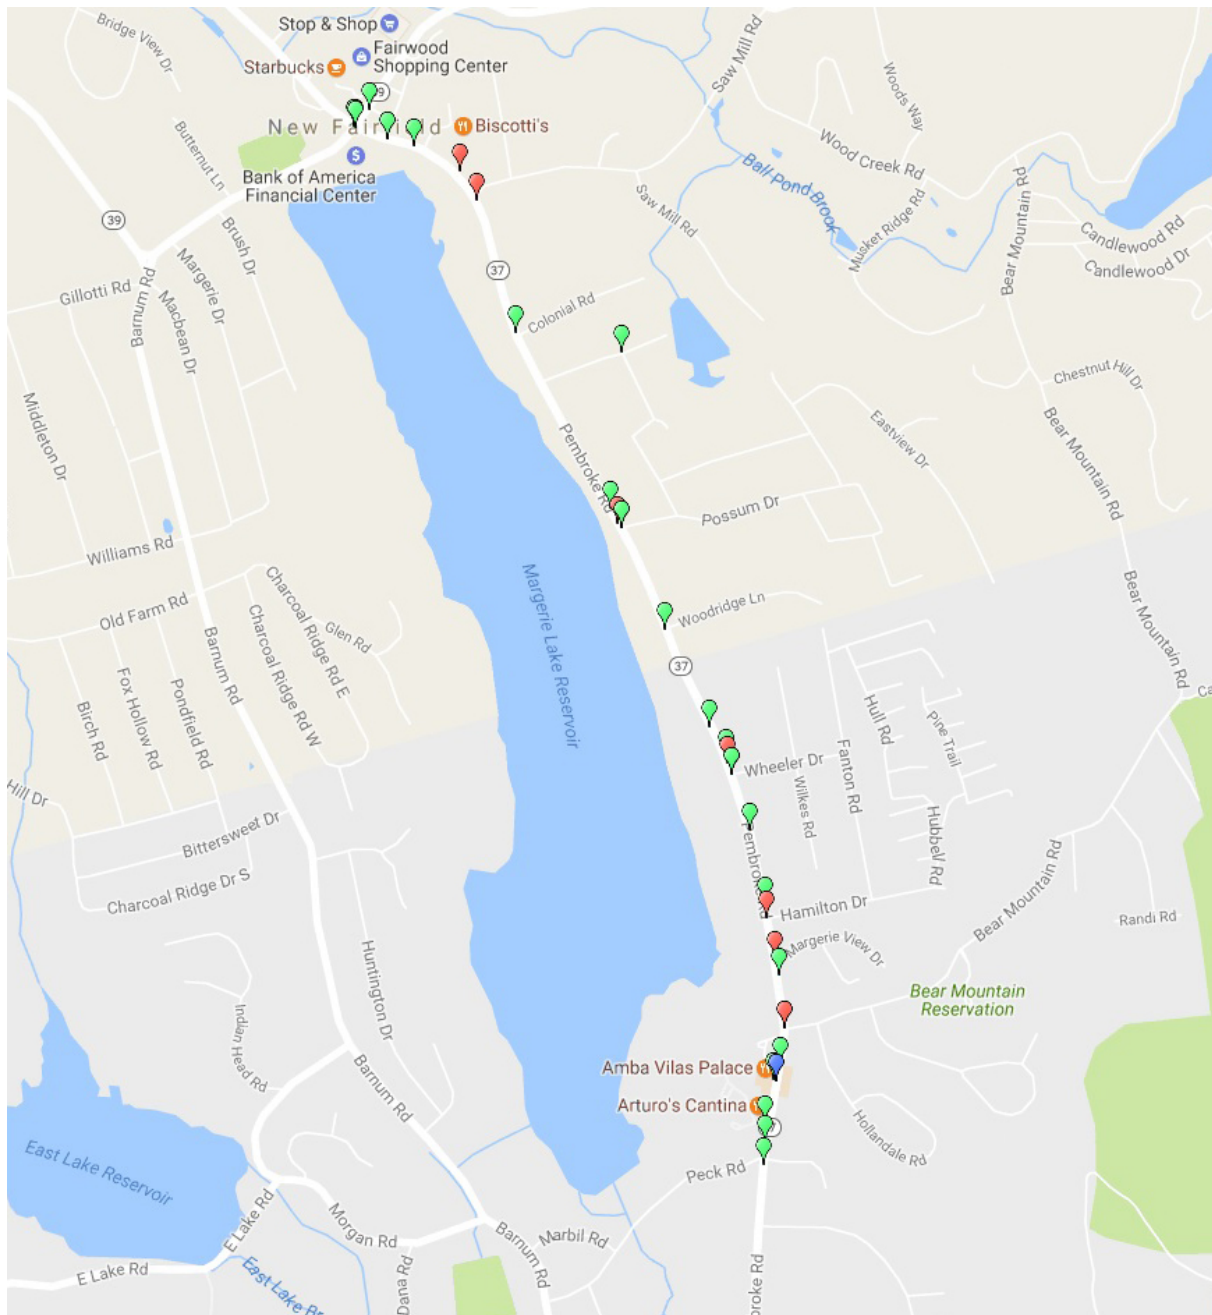
**Figure 3. Crashes that Occurred in 2015 (Connecticut Crash Data Repository)**

Between 2012 and 2014 there were 109 crashes in the RSA Area. Most crashes (77%) reported in this area resulted in property damage only; the remaining 23% of crashes resulted in an injury (Table 1). There were no fatal crashes, and none involved bicyclists or pedestrians. The crash types reported were primarily rear-end (Table 2). Figure 3 displays crashes that occurred in this area during 2015; they are dispersed throughout the corridor.

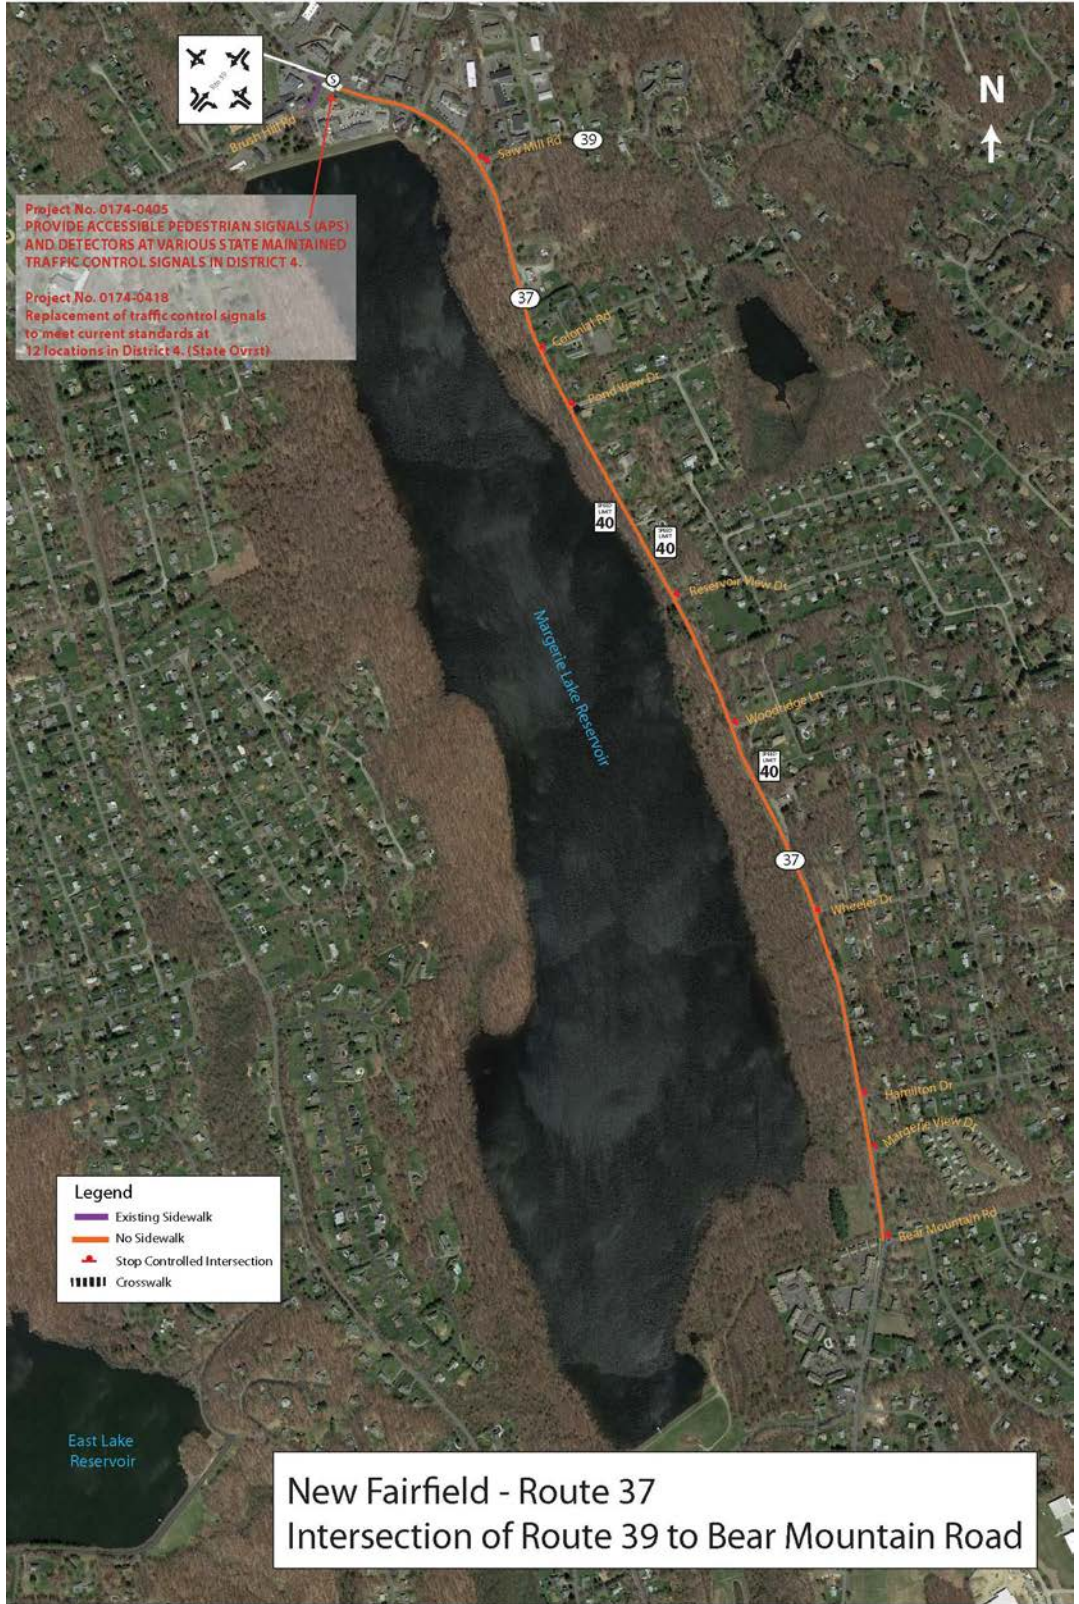
Figure 4. New Fairfield Avenue Road Geometrics

Route 37 is a two-lane road with narrow shoulders and a posted speed limit of 40 mph. The City of Danbury has sidewalks on the west side of Route 37 within a short distance of the Margerie Lake Reservoir. The Town of New Fairfield has a sidewalk system further to the north that is being extended to the Saw Mill Road intersection in 2017. There is no sidewalk adjacent to the reservoir property in between these points. The geometry of the corridor is shown in Figure 4 and described in Table 3.

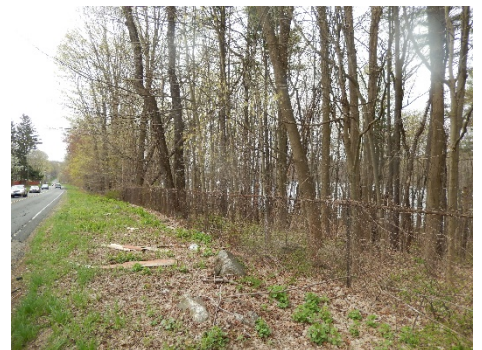
Figure 7: Margerie Lake Reservoir

- A fence surrounds the Reservoir; this is an obstacle to the trail.
- The Margerie Lake Reservoir proximity could pose some environmental concerns (Figure 7).

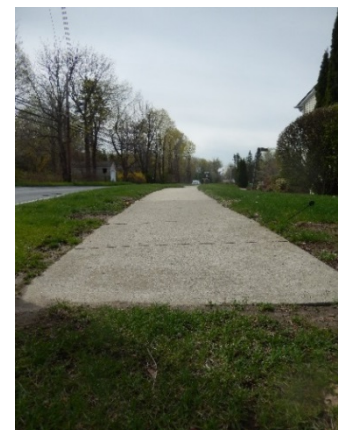
**Figure 14: Sidewalk south of Bear Mountain Road**

- Stop controlled intersection.
- Bear Mountain Road leads to Bear Mountain Park; there are no sidewalks (Figure 13).
- Shoulders measure 4' in northbound lanes, and 3' in southbound lanes.
- Empty grassy lot owned by the Town of Danbury on the western corner; possible site for a trail parking lot.
- Sidewalk begins on the southbound side of this intersection (Figure 14).

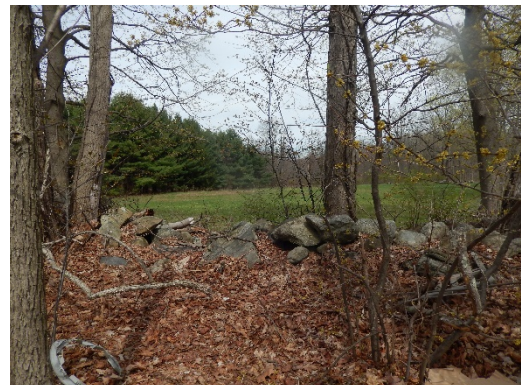
Figure 16: Open grassy area along Margerie Lake Reservoir

- Grading issues may require retaining walls.
- The roadway has very low to no curb reveal.
- If Danbury is not amenable to converting open green area on west side of Route 37 into trail parking area (Figure 16), another parking option would be the lot on the northwest corner of Routes 37/39.
