# STAMFORD ROAD SAFETY AUDIT

ROUTE 137 (WASHINGTON BOULEVARD)

NOVEMBER 2023

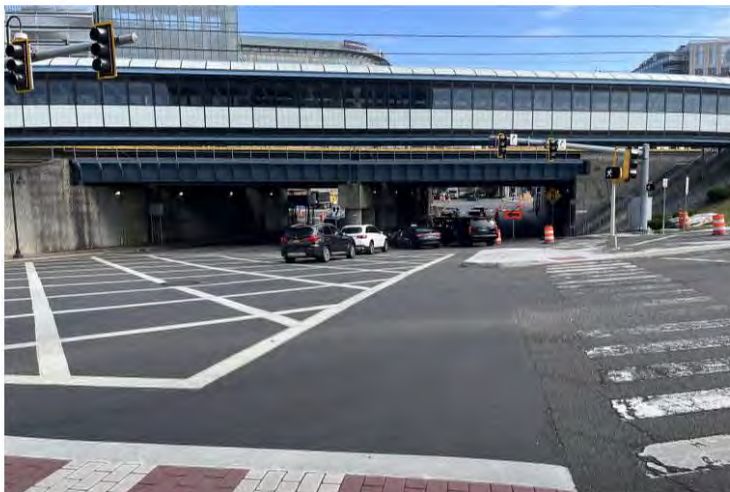
Exhibit 27: Station Place and Washington Boulevard intersection, bridge underpass in distance

- Lighting conditions on the Metro-North tracks were poor. Sidewalks are relatively narrow. Exhibit 27 shows this area under the tracks.
- RSA participants noted that the bridge walls and columns could be an opportunity for art and/or visual wraps (e.g., around bridge columns).

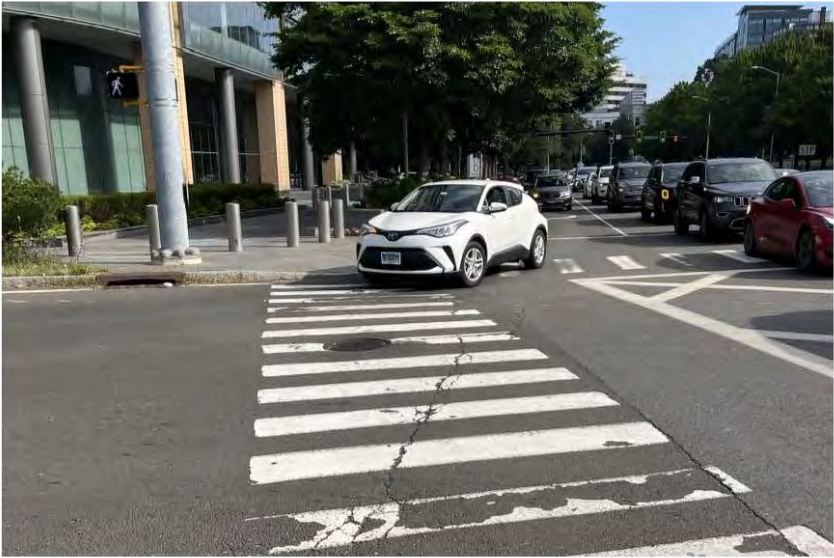
*Exhibit 28: Looking northbound across the crosswalk across the I-95 on-ramp. Note the right-turn lane in the southbound direction*

- This intersection includes the I-95 southbound on-ramp and includes heavy turning volumes from both the southbound and northbound directions to I-95. The southbound right-turn to I-95 is a dedicated right-turn lane and it is a difficult leg to cross as a pedestrian. Exhibit 28 displays this location.

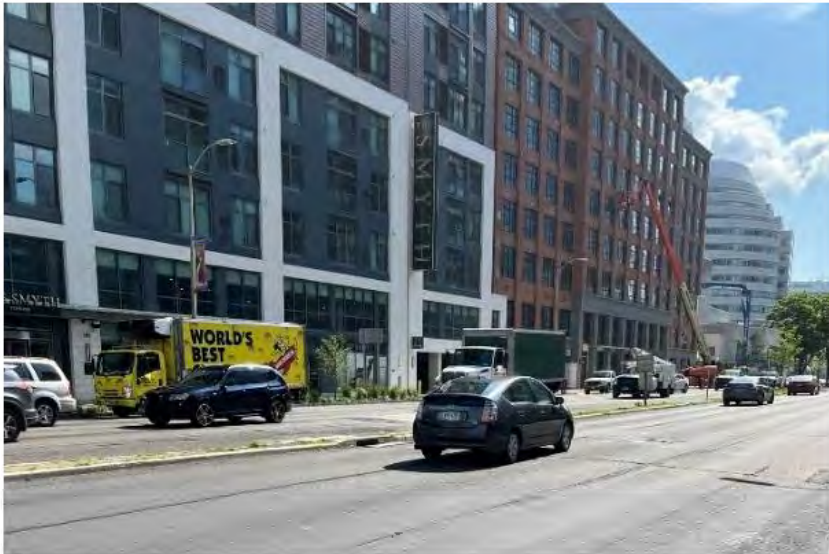
- This intersection is a hotspot on the crash heatmap.
- RSA participants noted that lighting could be improved at this intersection. RSA participants noted no visible street lighting to the north and all installed lighting was pedestrian scale only. Participants discussed light pole options that include both luminaires for both the street and sidewalk side of the pole.
- Island vegetation blocks sightlines for both drivers and pedestrians due to the height of the vegetation. It should either be lower or higher (e.g., tree canopy).
- RSA participants also noted the inconsistency of landscaped medians with none existing from Tresser Boulevard to Station Place. Exhibit 34 displays a picture of a median in the corridor.

*Exhibit 34: Median on Route 1 to the east of Washington Boulevard*

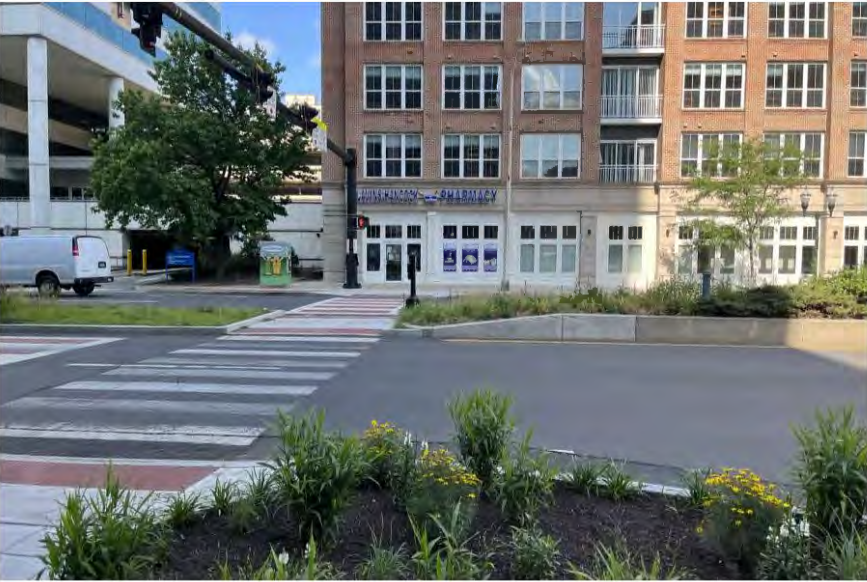
- The Pedestrian Hybrid Beacon (also known as “HAWK”) was recently reconfigured to remove the “zig-zag” which was confusing to pedestrians and caused accessibility concerns. Feedback has been positive. Exhibit 35 shows a picture of this location.

Exhibit 35: Pedestrian Hybrid Beacon (or "HAWK") south of Bell Street

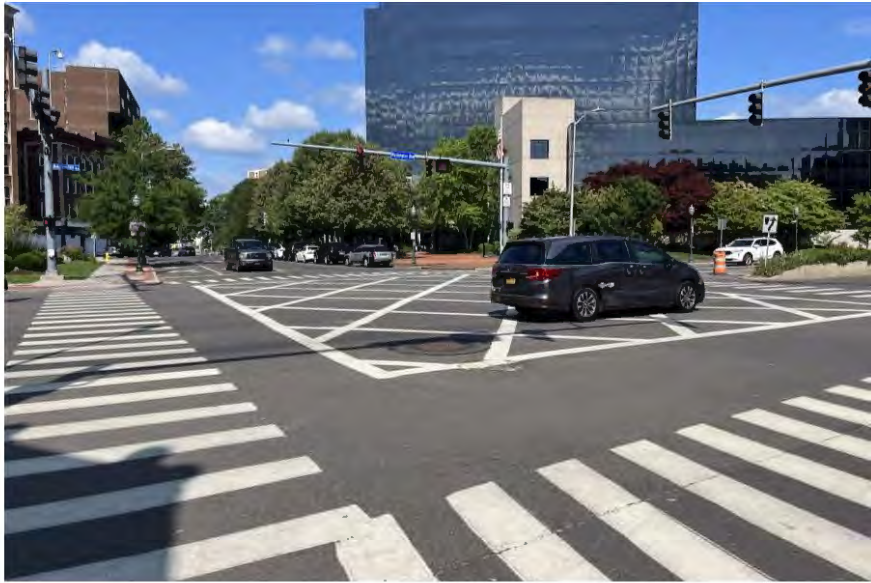
Exhibit 36: Intersection of Washington Boulevard and Main Street looking west

- The Main Street intersection is a busy location that is near to many destinations such as restaurants, government centers, Mill River Park, and more. Exhibit 36 shows this location.
- Recent pedestrian fatalities have called attention to the importance of protecting pedestrians along this section of Washington Boulevard.
- The City of Stamford has recently received approval to install temporary bumpouts at Main Street and Washington Boulevard.
- Long-term the City would like to consider a raised intersection, removal of all right-turn lanes, and a hardened centerline where feasible.

- Right turns are problematic at this intersection as well. All approaches, to this intersection except the eastbound approach, have a dedicated right-turn lane. Vehicles frequently fail to yield to pedestrians in this configuration.

- Evaluate feasibility of implementing a Leading Pedestrian Interval (LPI).
- Pursue quick-build project to remove right-turn lanes.
- Install hardened centerline with speed hump. See Exhibit 57 for an example.

- Pursue raised intersection. Raised intersections put the entire intersection at the same level as the sidewalk and introduce vertical speed control for vehicles entering the intersection similar to a speed hump or raised crosswalk. Vehicles must slow to the appropriate speed on their approach to the intersection. The vertical profile can be modified to meet the desired speed of the roadway.
- Consider extending and widening median island to serve as pedestrian refuge on all approaches.

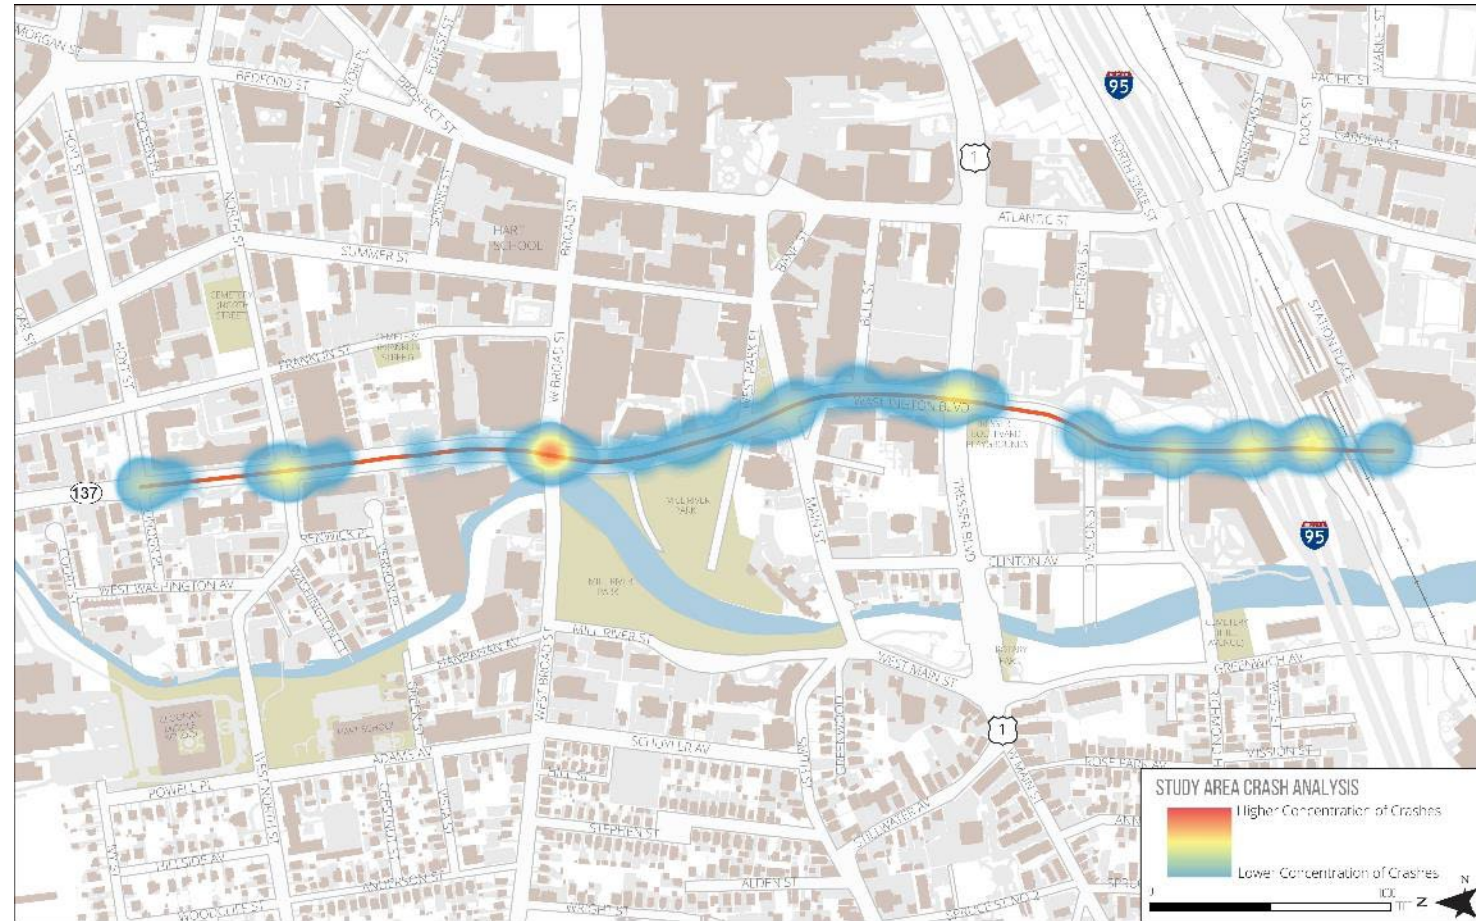
546 total crashes

- Route 137 and **W Broad St** – 100 crashes
- Route 137 and **Route 1 (Tresser Blvd)** – 69 crashes
- Route 137 and **S State St** – 58 crashes
- Route 137 and **North St** – 53 crashes
- Route 137 and **N State St** – 51 crashes
- Route 137 and **Hoyt St** – 23 crashes

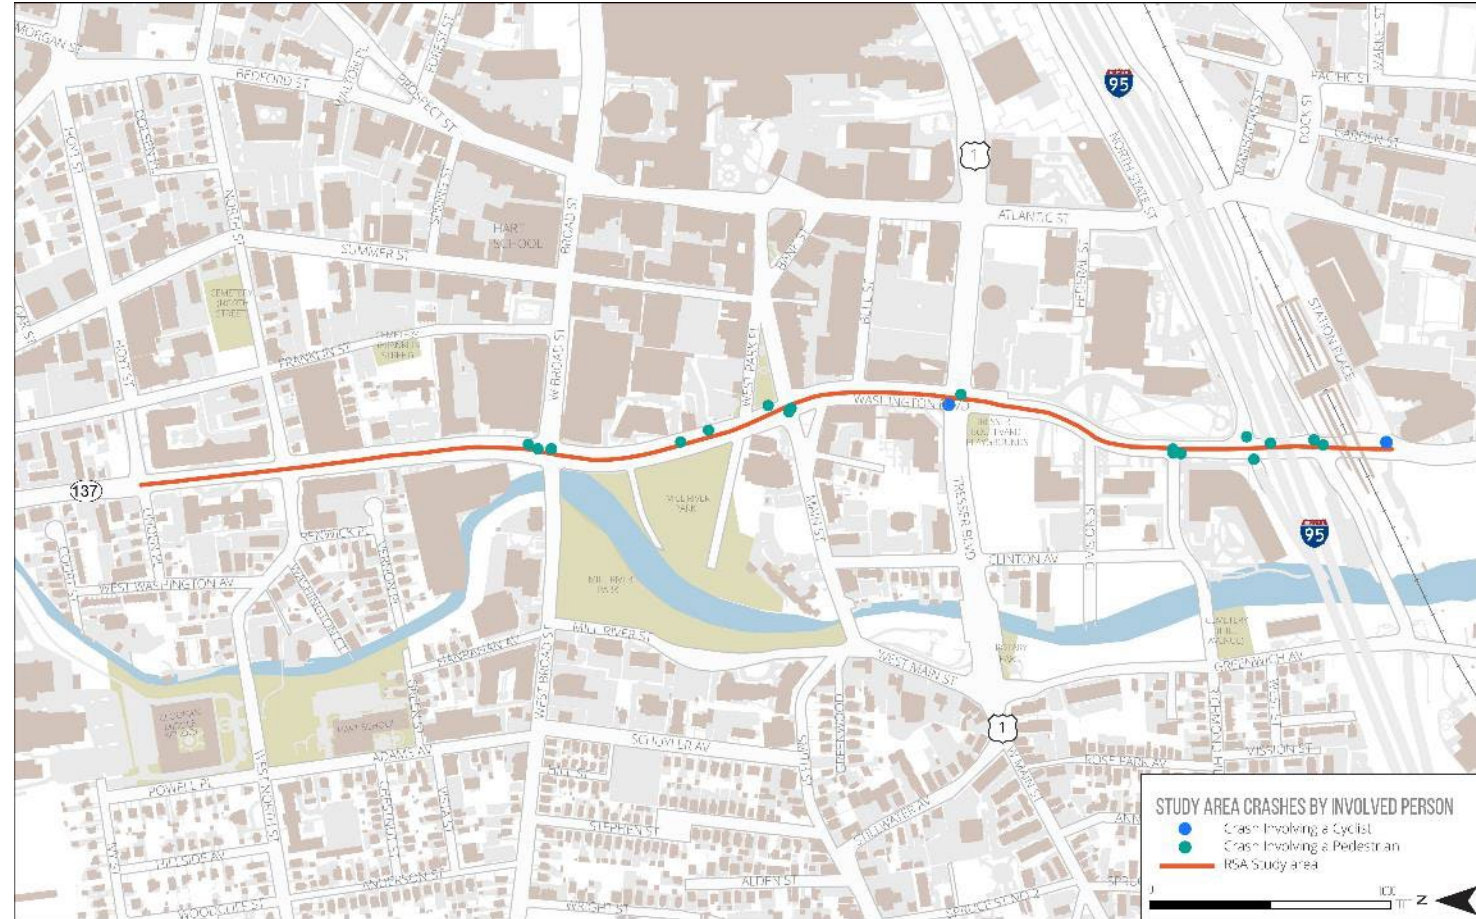
# CRASH ANALYSIS - INVOLVED PERSON

- 19 crashes involving a pedestrian in study area
- Two crashes involving a bicyclist in study area
- All but one pedestrian crash resulted in an injury of some type
- Pedestrian crashes appear centered around intersection locations

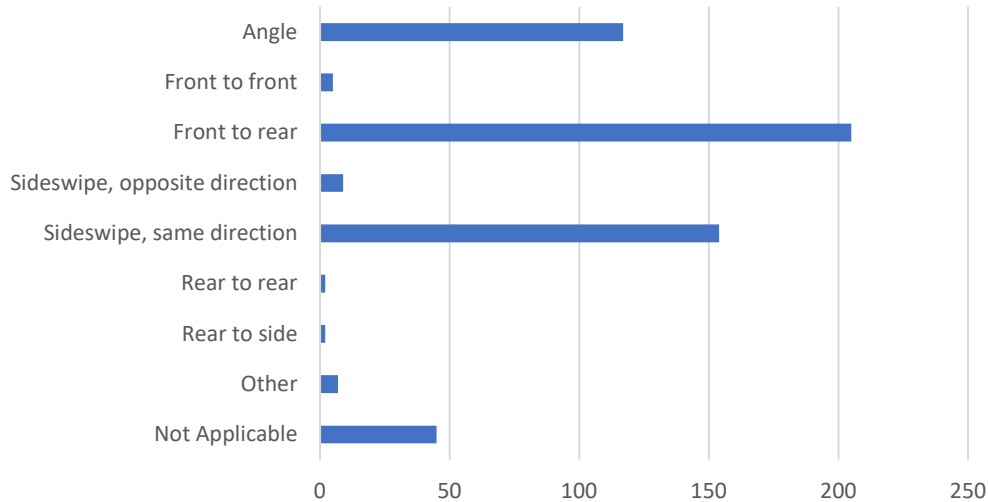
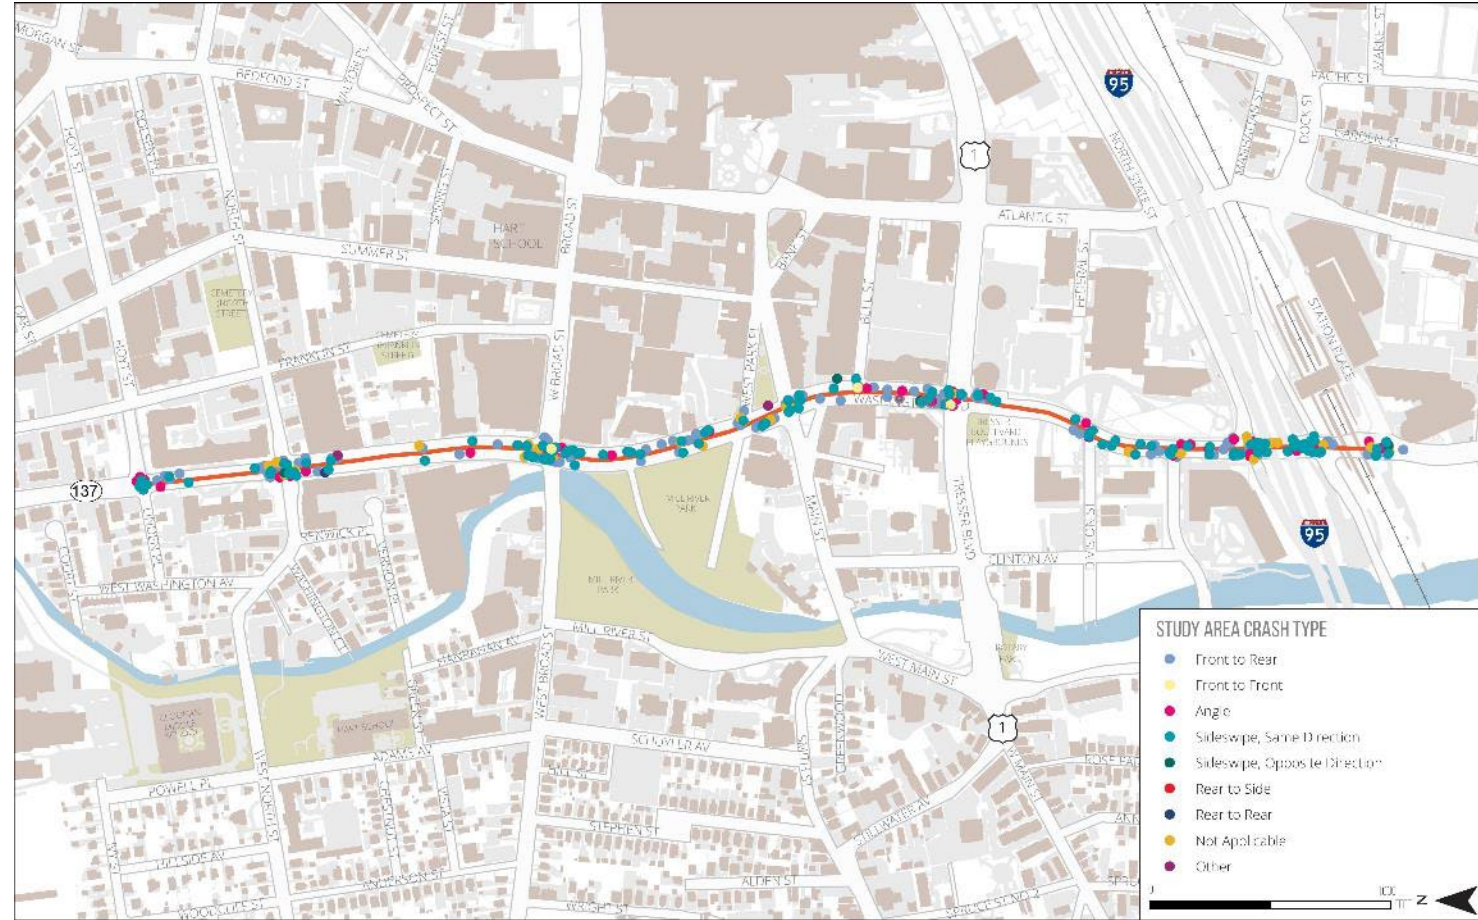
# CRASH TYPE

- Majority of crashes are **front to rear**
- Sideswipe, same direction, and angle** crashes were the second most common

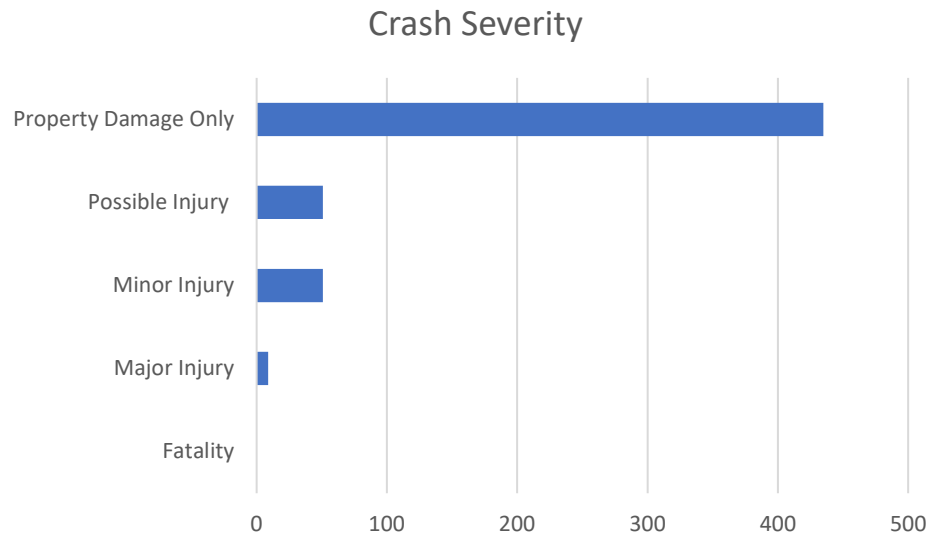
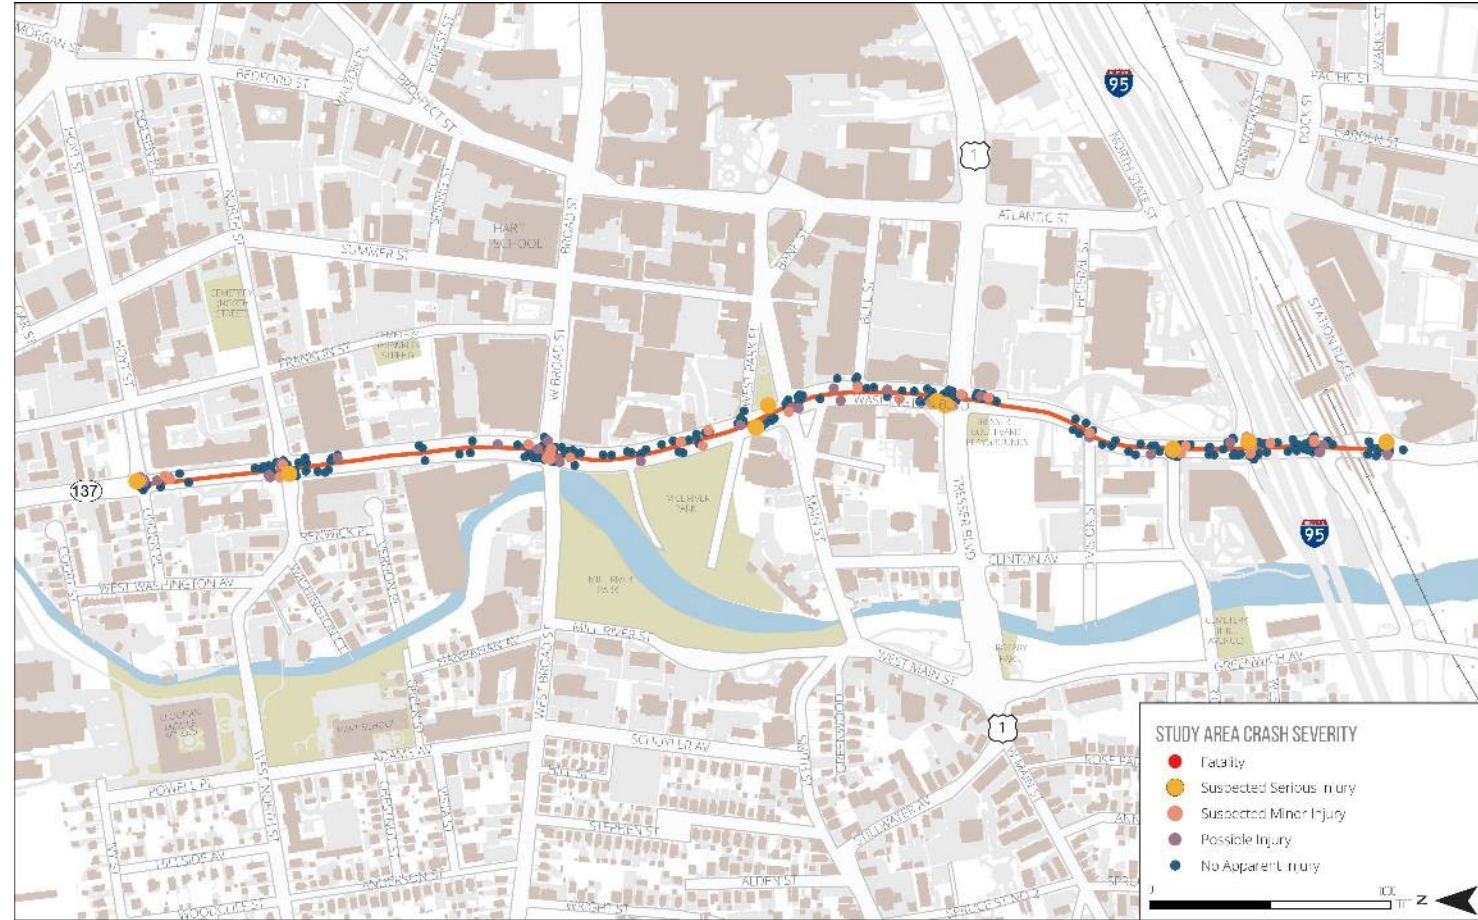
# CRASH SEVERITY

- Majority of crashes (435) are classified as No Apparent Injury-Property Damage Only
- 51 crashes resulting in possible injury and 51 minor injury crashes
- 9 crashes resulted in serious injury crash

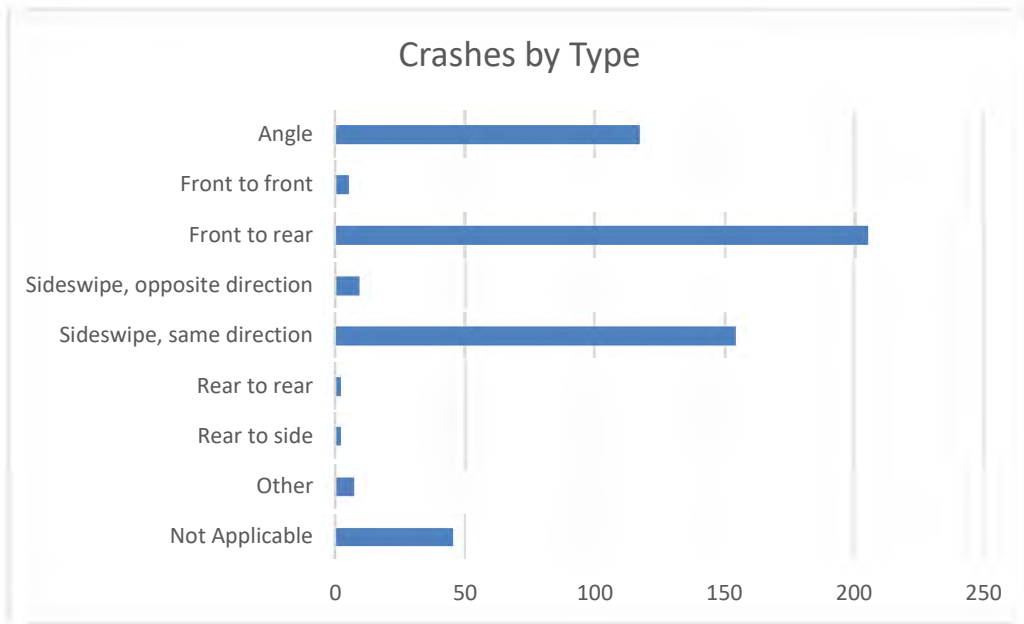
### Stamford Road Safety Audit Crash Summary - Crashes by Type

- Majority of crashes are front to rear and sideswipe, same direction

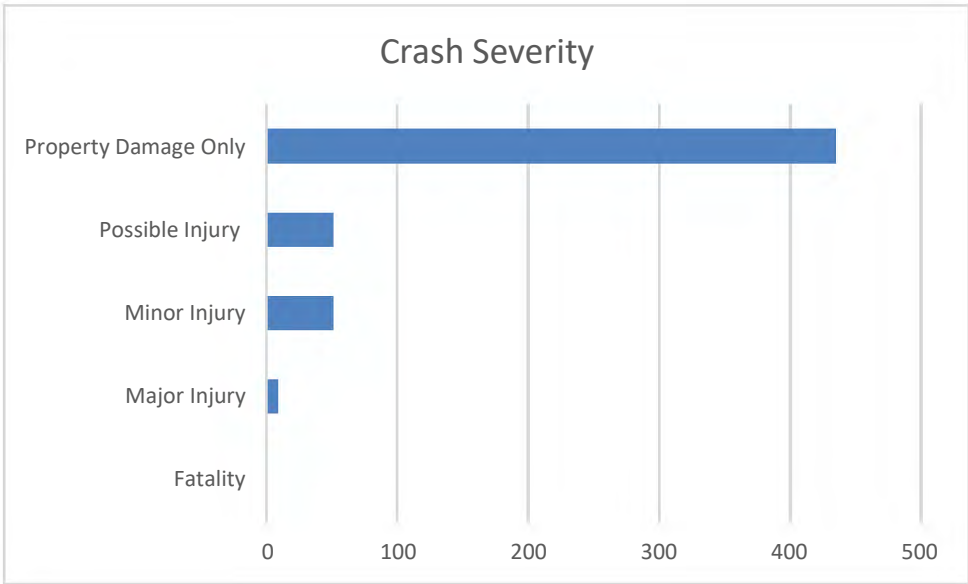
### Stamford Road Safety Audit Crash Summary - Crash Severity

- Majority of crashes (435) are classified as No Apparent Injury- Property Damage Only
- There were 51 crashes resulting in a possible injury and 51 minor injury crashes

- There were 9 serious injury crashes reported in the past 5 years.
