COMMUNITY
connectivity program

Stonington

Route 27 – Road Safety Audit

September 28, 2016

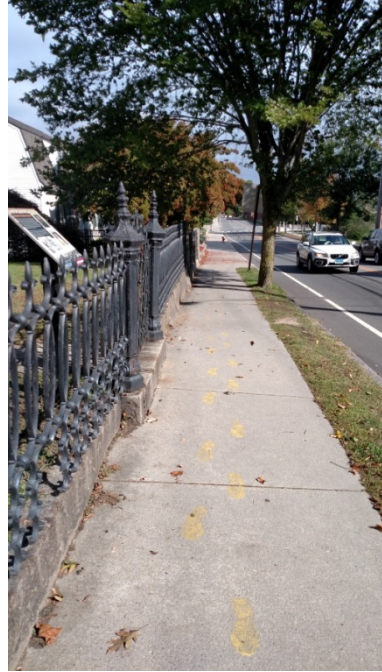
Figure 5. Sidewalk in Front of The Seaport

- Approximately 100 feet north of the Hinckley Street intersection, the sidewalk narrows to 5 feet in width with a 3.5 foot wide snow shelf. The frontage of the Seaport is planted with trees and has decorative stone posts. Along the entire length of The Seaport, the sidewalk abuts a fence. (Figure 5)

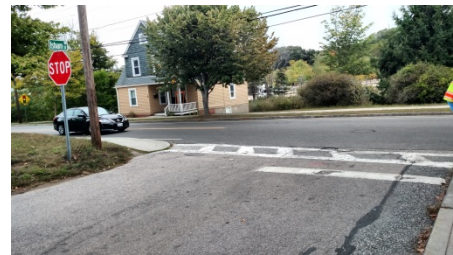
Figure 9. Stop Sign on the Left

- In the northeast corner of Isham Street and Route 27 there is an unused utility pole.
- The stop sign on Isham Street is on the left. On the back of the sign is a "no bus sign" that is restricting access to Isham Street. (Figure 9).

5. The Town to coordinate with the CTDOT to put up active speed signs. A letter from The Seaport should be submitted in support of this.
6. The Town to coordinate with the CTDOT district office to determine where Route 27 is on the list to upgrade pedestrian amenities at all signals.

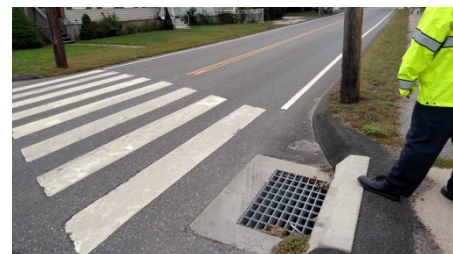
Figure 11. Crossing at School Street

- At School Street there are crosswalks on the west and south legs. On the east side ends at a utility pole and there is no sidewalk or ramp. The west side runs into a fairly new catch basin, and there is no ramp. It will be difficult to install a ramp because of the catch basin. (Figure 11).

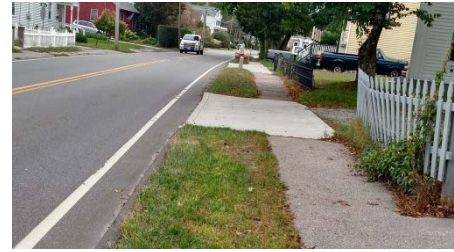
Figure 12. Newer Driveway Aprons

- Many of the driveways south of School Street have had new concrete aprons installed (Figure 12).
- Shrubs have begun to encroach on the sidewalk (Figure 13).

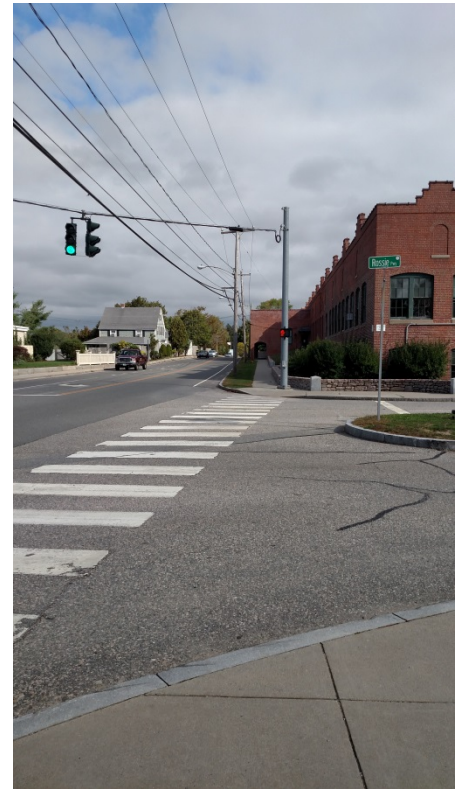
Figure 18. Long Crossing Across Rossie Pentway

- Rossie Pentway provides access to the northern parking lot for The Seaport. This is a very busy intersection.
- The pedestrian signal to cross has 7 seconds of walk time, followed by 18 seconds after the warning hand appears. This does not appear to be enough time to cross. The crosswalk across Route 27 is 44 feet and across Rossie Pentway is 84 feet. (Figure 18).

7. Retime signals to meet new standards for pedestrian crossing time.
8. Examine passive rumble strips across the road on the approaches to mid-block crossings (Figure 32).

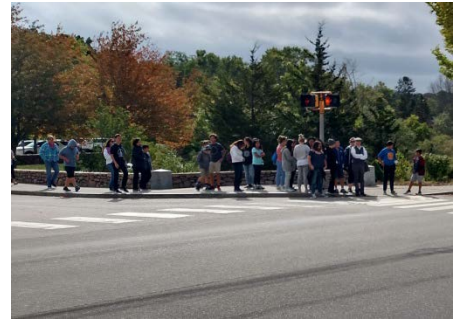
Figure 20. School Group Waiting to Cross

- The pedestrian signal heads are not count down, the pushbuttons are not tactile and the landing ramps do not have tactile warning strips.
- The waiting area on the southeast corner is small and cannot accommodate large groups (Figure 20).

12. Expand the landing/waiting area in the southeast corner at the signal for the southern parking lot.
13. Extend the sidewalk on the east side, which ends 200 feet to the north of Coogan Boulevard to the intersection.

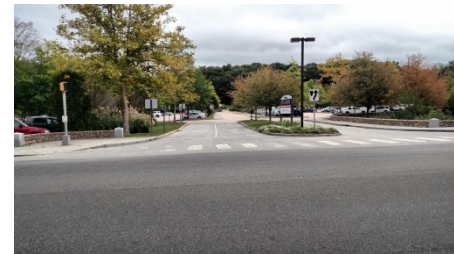
Figure 21. Long Crossing at Intersection

- The pedestrian signal to cross has 7 seconds of walk time, followed by 18 seconds after the warning hand appears. This does not appear to be enough time to cross. The crosswalk across Route 27 is 54 feet and the crosswalk across the parking lot entrance is 79 feet. (Figure 21).

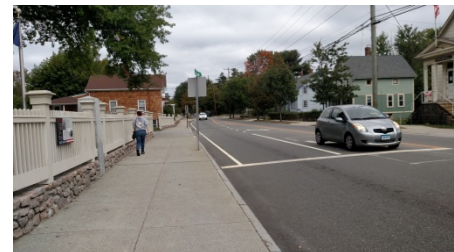
Figure 22. Wide Sidewalk on the West Side

- There is no snow shelf on the west side of Route 27 in the vicinity of this intersection. The sidewalk here is concrete and 10 feet wide. (Figure 22) The sidewalk on the east side is five foot wide concrete with a 3.5 tree planted snow shelf. Curbing is granite.
