CONNECTICUT  
DEPARTMENT  
OF  
TRANSPORTATION

CONDITION INSPECTION  
CANNONDALE STATION

**CONN. DEPT OF TRANSPORTATION  
STATION INSPECTION**

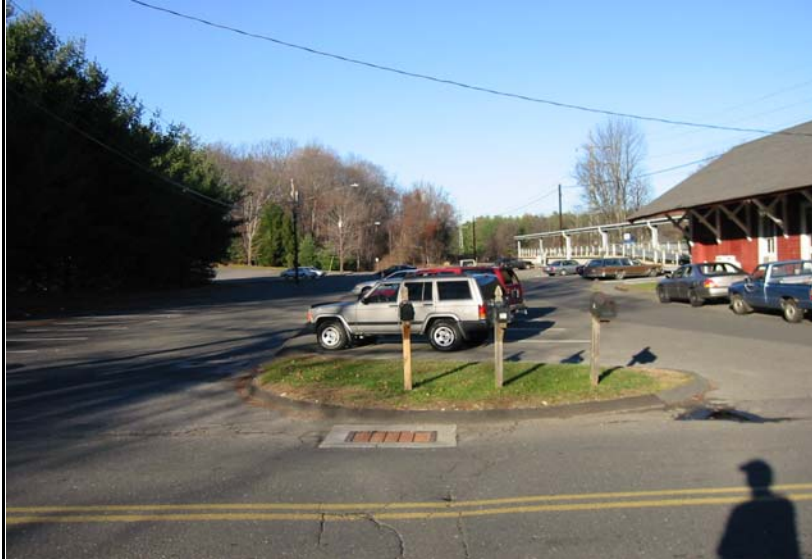
Description: \_\_\_\_\_  
General view of Quad I

Reference: \_\_\_\_\_  
Looking East

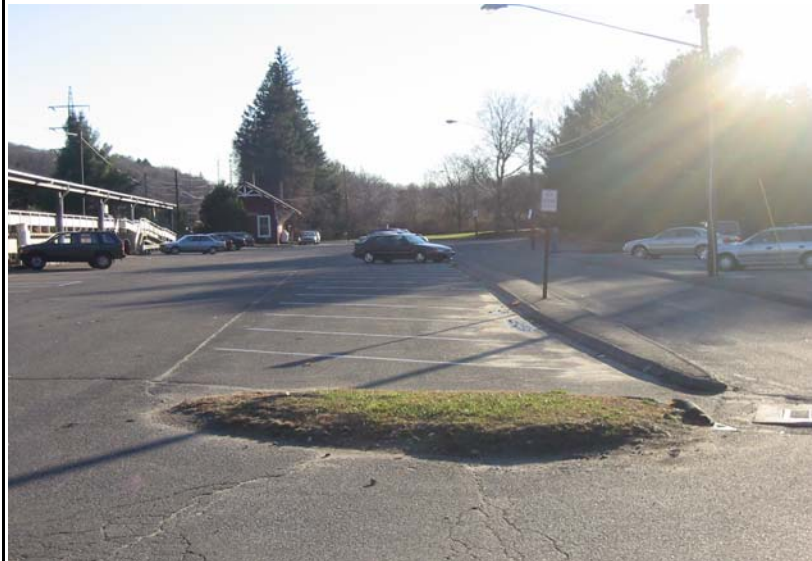
PHOTO NO. 2

Location: \_\_\_\_\_  
East end of Quad I

Description: \_\_\_\_\_  
General view of Quad I

Reference: \_\_\_\_\_  
Looking West

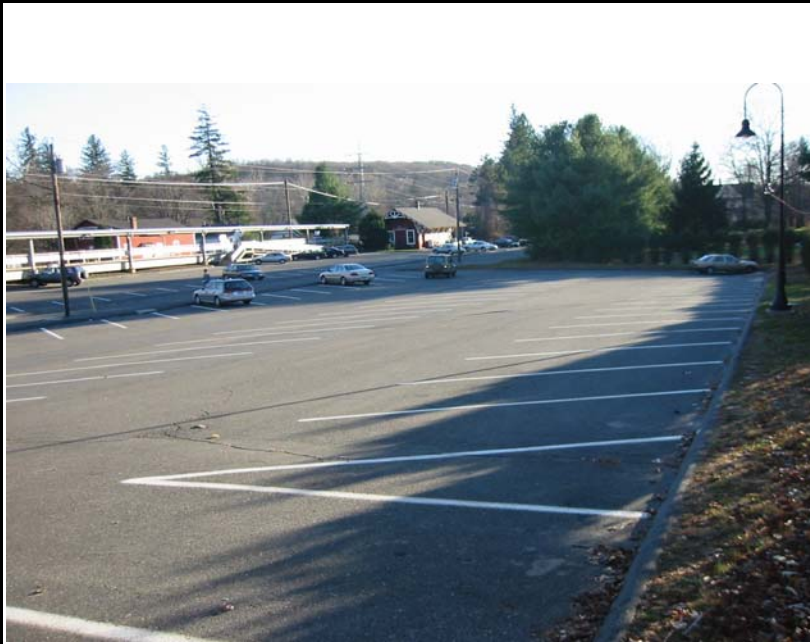
Description: \_\_\_\_\_  
General view of Quad II

Reference: \_\_\_\_\_  
Looking Southwest

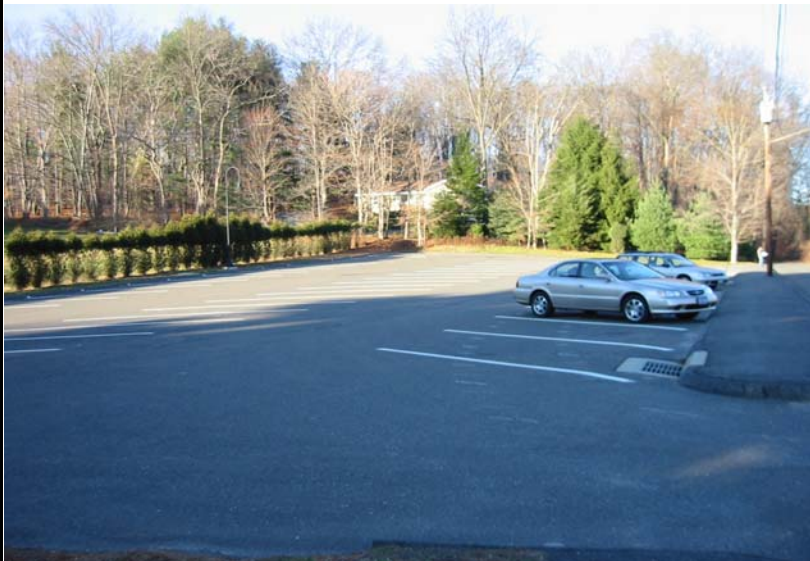
PHOTO NO. 4

Location: \_\_\_\_\_  
Southwest corner of  
Quad II

Description: \_\_\_\_\_  
General view of Quad II

Reference: \_\_\_\_\_  
Looking Northeast

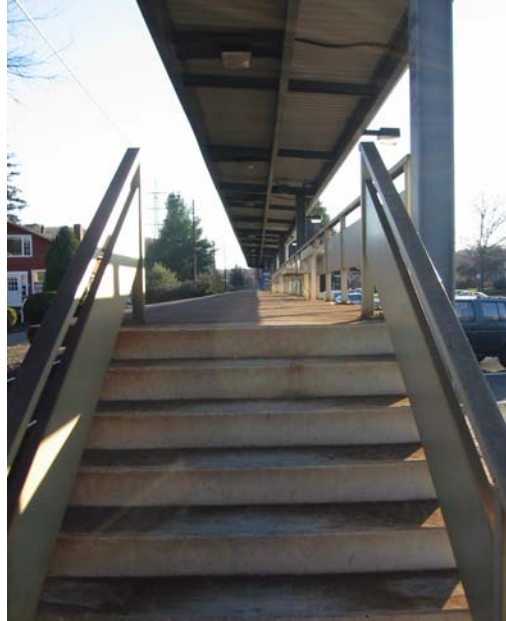
Description: \_\_\_\_\_  
General view of the platform

Reference: \_\_\_\_\_  
Looking West

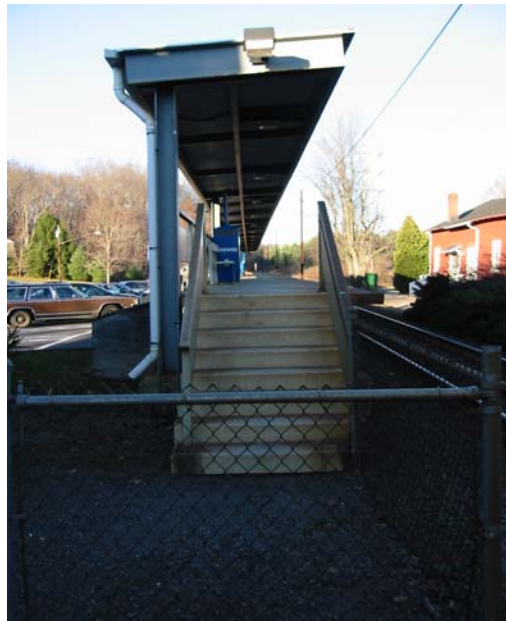
PHOTO NO. 6

Location: \_\_\_\_\_  
South of the station house

Description: \_\_\_\_\_  
General view of the platform

Reference: \_\_\_\_\_  
Looking East

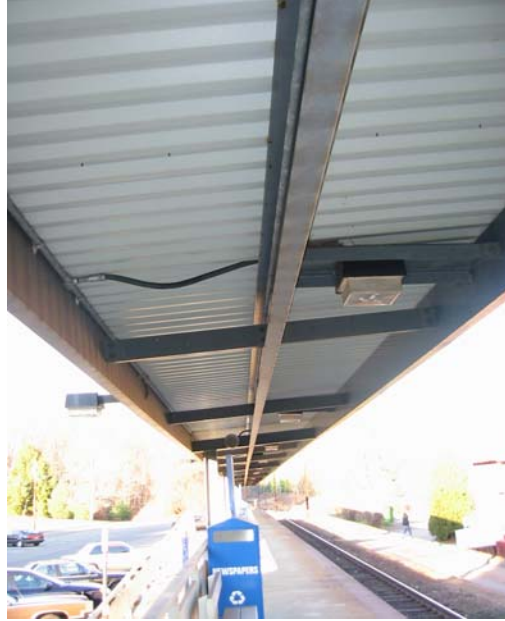
The rain canopy is in good repair, aluminum gutters in good condition. The plastic pipe downspouts are in good repair. No maintenance is required.

Description: \_\_\_\_\_  
General view of the canopy

Reference: \_\_\_\_\_  
Looking East

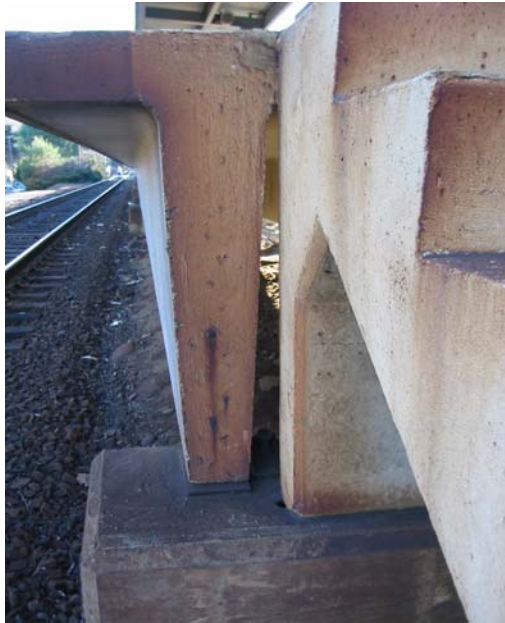
PHOTO NO. 8

Location: \_\_\_\_\_  
West end of the platform

Description: \_\_\_\_\_  
General view of the double-tee

Reference: \_\_\_\_\_  
Looking East

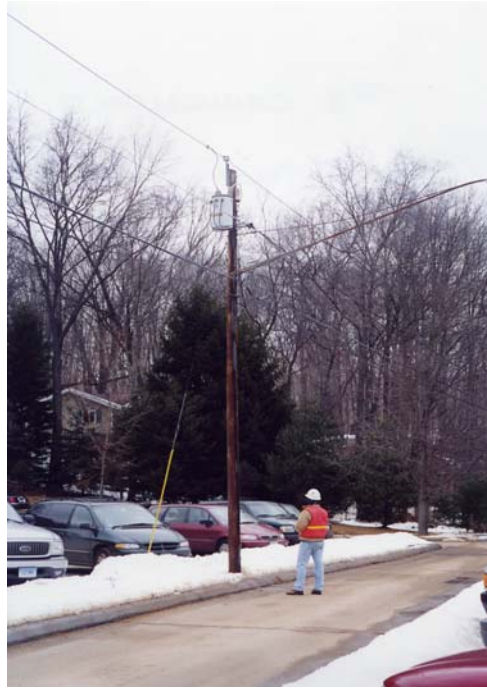
The electrical service to the platform terminates in a pedestal type enclosure. We were unable to verify the size and condition of the main panel because the enclosure was locked. However, the enclosure was well sealed and appeared to be protecting the panel inside. There were a few non-GFCI receptacles located on the platform that should be replaced with GFCI type. Also, one of the receptacle covers was missing and should be replaced.

Description:  
electrical service  
pole

Reference:  
Platform Service  
Section
