Individual Station Report

Seymour

Station Condition Inspection

CONDITION INSPECTION FOR THE SEYMOUR STATION

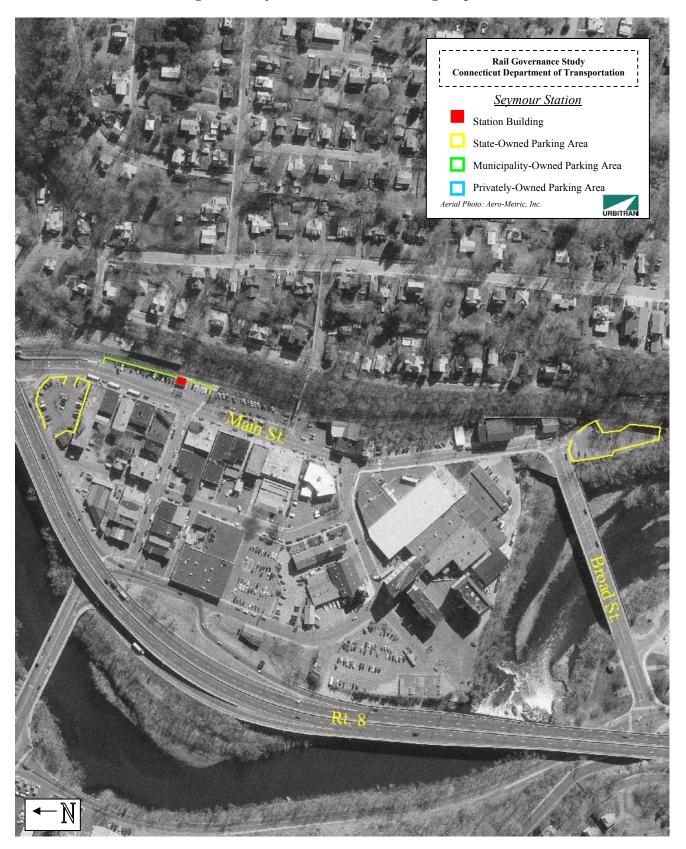
Figure 36: Seymour Rail Station Parking Map

Seymour Rail Station parking spaces close to the Station are owned by the Town of Seymour. Parking lots north and south of the station are owned by the State of Connecticut and account for approximately 80 spaces. All of the lots are used for mixed-use purposes. Because of the mixed-use nature of the lots further from the Station, it can be said that the State owns none of the rail commuter parking at the Seymour Station. Parking lot configuration and ownership status are shown in Figure 36.

Note: All parking is mixed-use 2-hour parking. The lot appears to be shared with downtown stores. A portion of the lot had parking for Fleet Bank personnel and patrons. This chart only considers the lot directly adjacent to the station owned by the Town.
