**Field Strain Monitoring to Evaluate Unexpected Cracking
in a Non-Redundant Steel Plate Girder Bridge**

July 2009

Report No. CT-2251-2-09-4

**Connecticut Department of Transportation
Bureau of Engineering and Construction
Research and Materials**

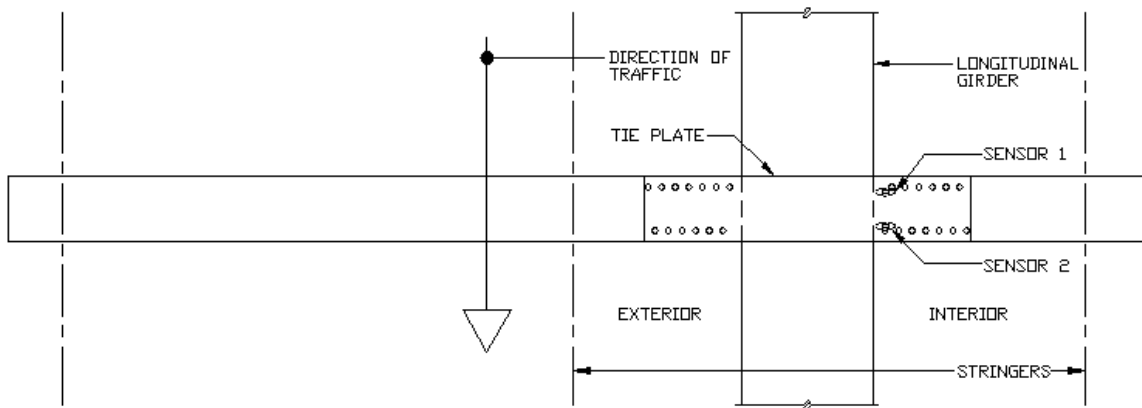
FIGURE 4 Strain gage layout for the first stage of strain monitoring, with gages located both on an uncracked tie plate and a cracked tie plate.

The initial monitoring was carried out with 2 strain gages located on an uncracked tie plate and 2 gages located on a cracked tie plate. Neither tie plate had been replaced during repairs to the bridge. The cracked tie plate was on a transverse floor beam located at the end of a simple span. The crack developed on the interior edge of the plate, located on the interior side of the longitudinal girder. The un-cracked tie plate was on the girder adjacent to the girder with the cracked tie plate. The location of the gages is shown in Fig. 4.

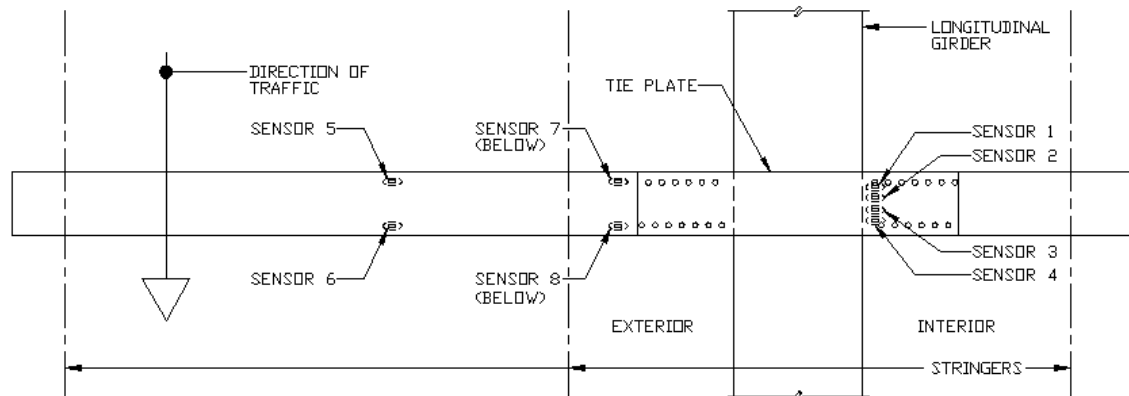
FIGURE 5 Strain gage layout for the second stage of strain monitoring, with gages located on a repaired tie plate and on the flanges of the cantilevered portion of the transverse floor beam.

As noted, the initial tests raised a number of questions, resulting in a second set of monitoring tests. This second set used 8 strain gages, 4 on a repaired tie plate, 2 on the top flange of the cantilevered portion of the transverse floor beam, and 2 on the bottom flange of the cantilevered portion of the transverse floor beam. Gages were placed on each edge of the tie plate to determine if the tie plate is acting in axial tension, as

anticipated from the design, or if there is some other type of action. In the second set of tests, half of the gages were installed on the flanges of the exterior cantilever to monitor the behavior observed in the first set of data collection. The location of the gages is shown in Fig.5.

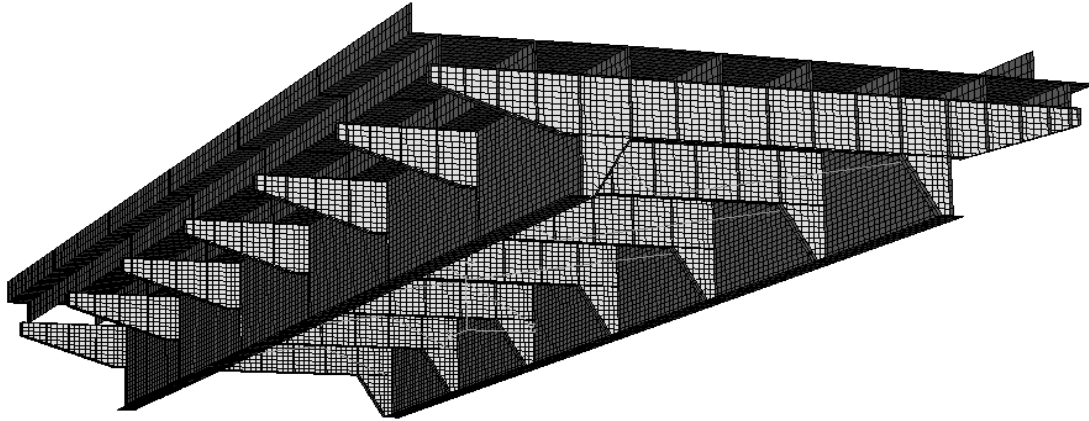
FIGURE 8 Three-dimensional finite element model.

The finite element analysis model consisted of approximately 37,000 elements, representative of all aspects of the structure, including lateral bracing members and stiffeners. The longitudinal girders, transverse floor beams, girder stiffeners, stringers, and concrete deck slab were modeled with shell elements. The lateral bracing members for the transverse floor beams were modeled with beam elements. Figure 8 shows a three-dimensional rendering of the finite element model, including mesh lines used in the analysis.
