WATERBURY TRAIN STATION VISUAL INSPECTION REPORT

January 2007

Prepared by the Bureau of Public Transportation
Connecticut Department of Transportation

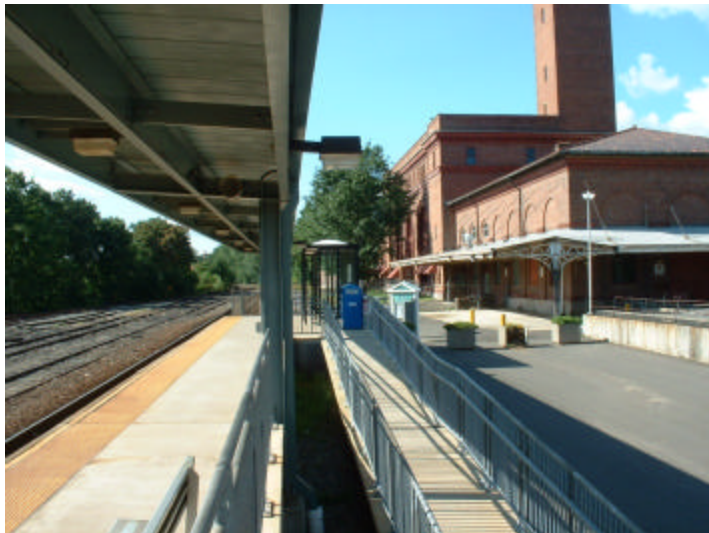
The station itself consists of a short high-level platform, a ramp, two shelters and a parking lot. The station area is clean with only an occasional tossed item. However, the area across from the platform consists of abandoned tracks and railroad debris. The shelters are clean with benches. A recycling bin is located next to the shelters.

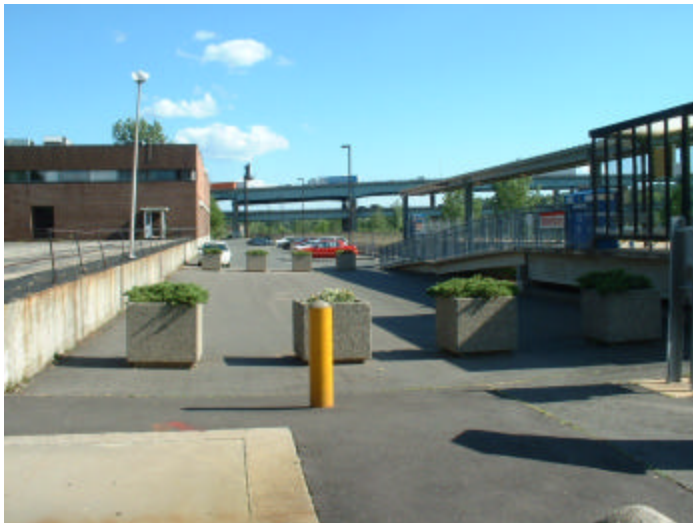
Landscaping?
