**CONDITION APPRAISAL
(FY 2021)**

CONDITION APPRAISAL UNION STATION BUILDING

The Condition Appraisal of the Union Station Building was performed by DESMAN in accordance with the executed agreement by and between the New Haven Parking Authority and DESMAN (NHPA Project No. 21-001).

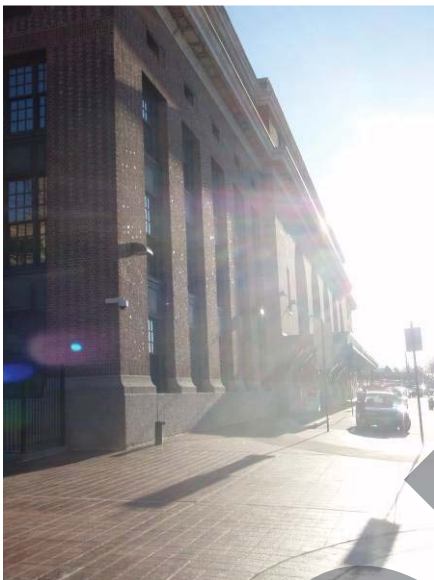
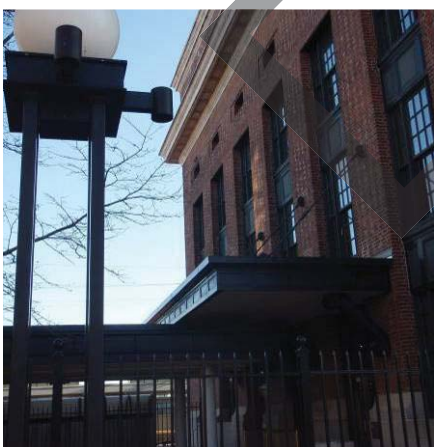
Photo #5

The main pedestrian entries are located off of Union Avenue on the north side of the Station, and pedestrian egress to an adjoining parking garage is provided to at the eastern end of the building (**Isometric #1, Photos #5 & #6**). At the western end of the facility there is a bus station/depot and car rental area. The station has an underground pedestrian tunnel, accessible by stairs, escalators and an elevator from the first level which leads to the railroad platforms located to the south of the Station.

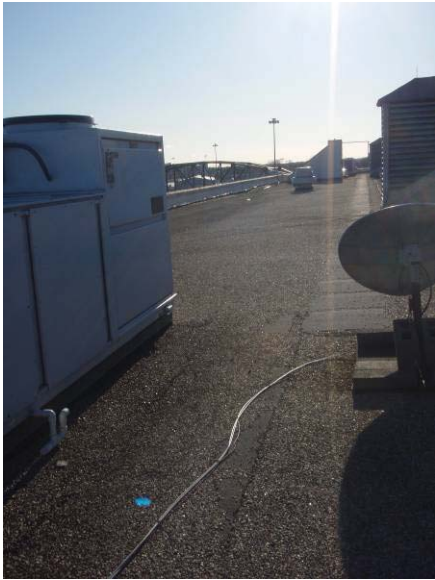
Photo #7

- 1997 The pre-existing roofing system was removed and a new four-ply built-up roof, with a 20-year warranty by Johns Manville, was installed (**Photo #7**).
- 1998 A project was implemented to upgrade the Station to comply with the Americans with Disabilities Act (ADA). The scope of work included improvements to public spaces, train platforms, restrooms and tenant entries and new signage.

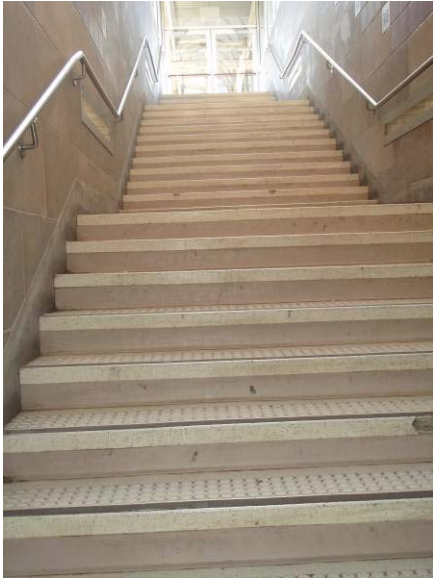
Photo #9

- Addressing various concerns to the facility's southwest stairwell, inclusive of the application of an architectural waterproof coating on the exterior surfaces of the penthouse, repair to the plaster finishes of the upper reaches of the interior of the stairwell, the replacement of the access door and its associated framing.
- Installation of rubber treads, risers, and landings on the stairs leading to the train platforms (**Photo #9**).
- Repair of the lightning arrestor system (**Photo #10**).

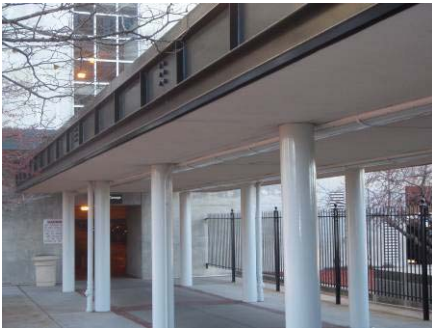
Photo #11

- The canopy between the Station and the parking garage was renovated to be more in keeping with the style and historic nature of the Station. A new plaster ceiling was installed, along with new architectural lighting (**Photo #11**).

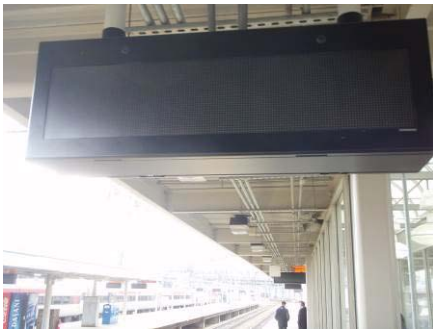
Photo #14

- Elevator Modernization and Improvements
- Installation of a new emergency generator.
- Replacement of the fire alarm system with new fire suppression components
- Installation of a New Public Address and Video Message System. **(Photo #14)**
- Installation of a New Security System **(Photo #15)**
- Installation of a New Sand/Oil Separator **(Photo #16)**
- Improvements to the Basement Level Corridors and Spaces **(Photo #17)**
- Various architectural, electrical, and mechanical Improvements to the Pedestrian Tunnel **(Photo #18)**.
- Mechanical, Electrical and Plumbing Improvements: CDOT performed various mechanical, electrical, and plumbing improvements within the Union Station Building started in 2010.

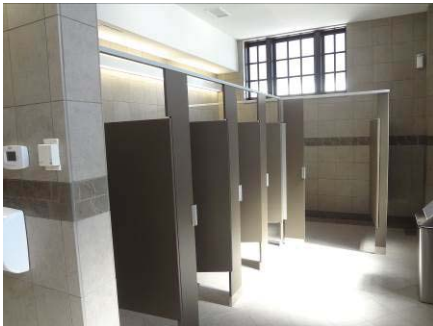
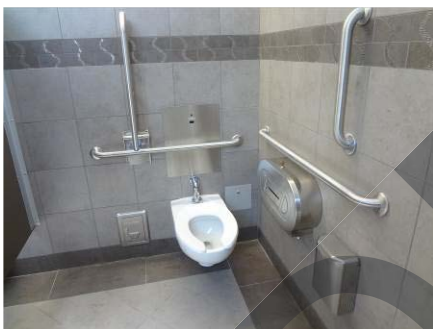
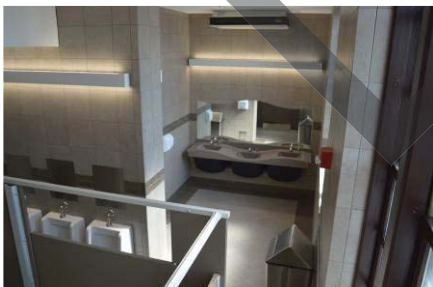
2016 Work related to the Building includes extensive renovation of the facility's public restrooms (**Photos #19, #20 & #21**). The two restrooms were gutted and entirely reworked with new floor and wall tiles. All bathroom fixtures (sinks, toilets, urinals, partitions, etc.) were replaced with new components and all existing plaster finishes were repaired and repainted. New lighting was also installed. Implementation of this work was part of Project No. 08-016 E.

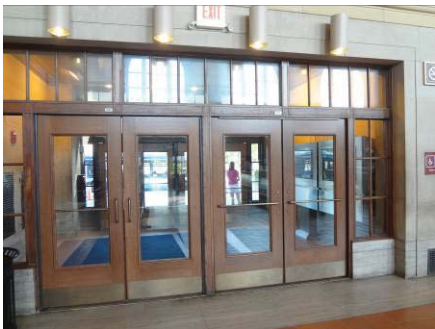
Photo #23

2017 All of the Station's entry/exit doors have been either replaced or repaired, with all hardware and automatic controls (**Photos #22 & #23**). This work was addressed as part of NHPA Project no. 10-005 A.

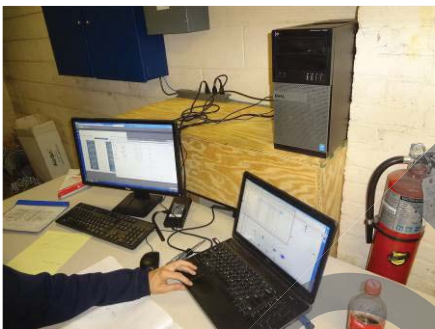
Photo #24

1. Replace Pneumatic HVAC Controls w/ Electronic Controls (**Photo #24**)
2. Replace 3 Packaged Rooftop Units (**Photo #25**)
3. Replace Eight (8) Gate Valves @ Control Valves
4. Replace two (2) Existing Recessed Wall Heaters in Main Entry

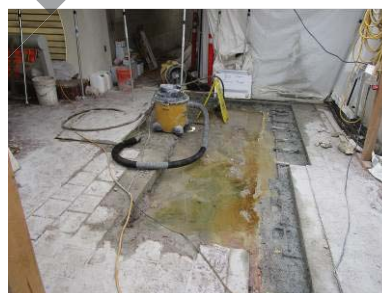
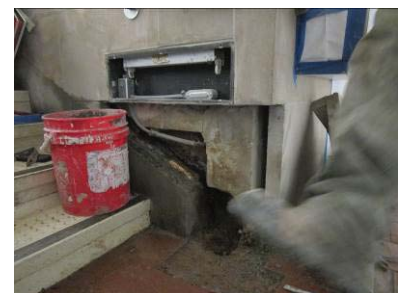
- Miscellaneous sidewalk & driveway repairs as part of NHPA Project No. 18-012.
- Replacement of the final one of the three boilers, as well as replacement of the main chiller, as part of NHPA Project No. 18-014
- Replacement of various interior light fixtures, as well as related electrical improvements throughout the Building, as part of NHPA Project No. 15-003 B.
- Underground passageway waterproofing improvements throughout the tunnel (to the train platforms) as part of NHPA Project No. 18-013 (*Photos #26 & #27*)

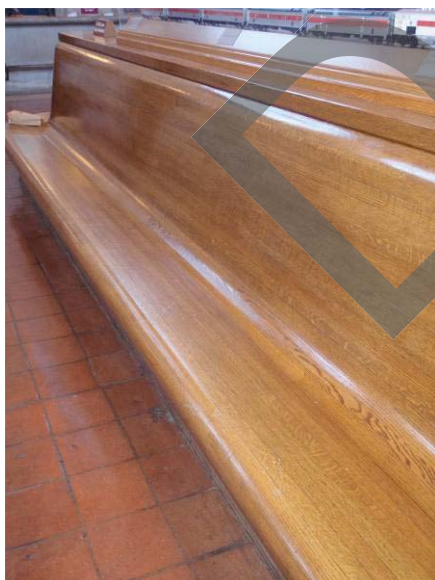
Photo #29

Items to be re-finished include, but are not limited to interior wood trim (i.e. doors and storefront, waiting room benches, stair handrails, etc.), and various brass finishes and components (**Photo #29**). Although this work is currently included as part of NHPA Project no. 15-003 A, now in design, DESMAN recommends that a nominal extent of repair continue to be programmed to address preventative maintenance needs accordingly as they arise.

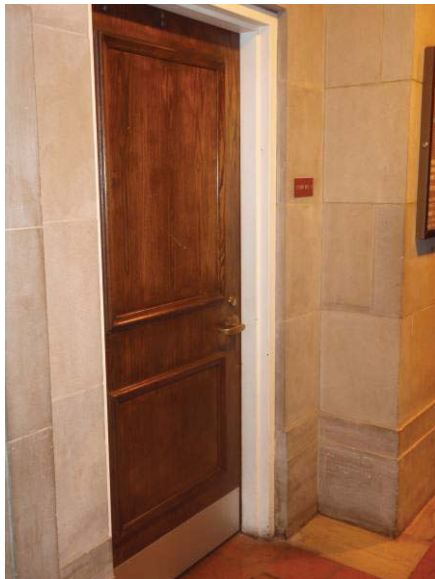
Photo #30

A review of the Station's stairwells indicates that each stair well access door on all levels would benefit from being refinished (**Photo #30**), as well as the handrails throughout the stairwells (**Photo #31**). In combination with this work, each stairwell has been identified as requiring a limited amount of plaster/sheetrock repair in combination with a fresh coat of paint (**Photo #32**).

Although this work is currently included as part of NHPA Project no. 15-003 A, now in design, DESMAN recommends that a nominal extent of repair continue to be programmed to address preventative maintenance needs accordingly as they arise.

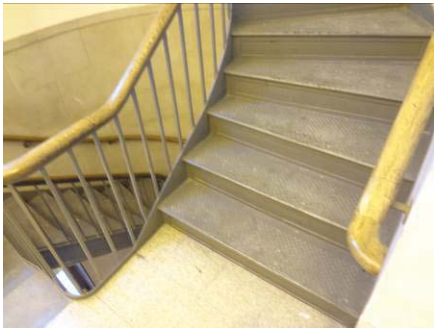
Photo #33

In addition to repainting the stairwell walls, it was noted that the stair treads and risers need to be properly prepped, primed, and repainted (**Photo #33**) along with associated balusters, railings and handrails.

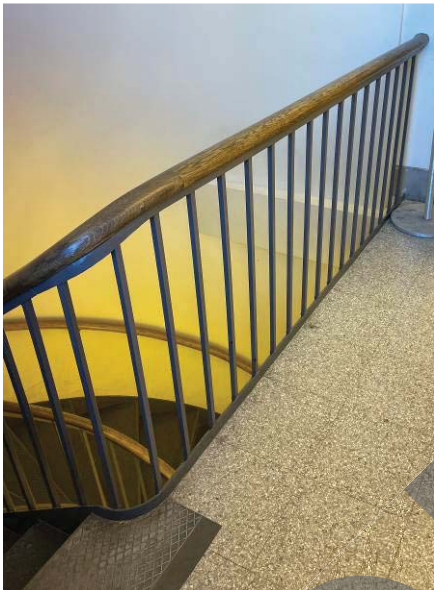
Photo #34

Recently, the Office of the State Fire Marshal informed NHPA that certain railings, associated with the upper landings of the stairs (**Photo #34**), previously understood to be acceptable are now no longer considered to be in compliance due to their lower height (the referenced code requires a minimum of 42 inches in height of applicable guards). DESMAN recommends that these sections of railing be modified so that a minimum height of 42 inches is achieved, but due to the potential historic preservation implications, that the SHPO be consulted so as to minimize the potential aesthetic impact.

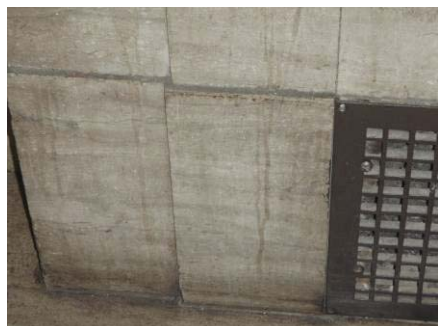
Photo #36

Various components of the building's interior, mainly concentrated to those areas occupied by the general public, need to be periodically maintained; this maintenance will entail periodic cleaning. These items include the cleaning of various limestone and travertine wall finishes within the main lobby, the lobby mezzanine area, the east and west end lobbies and the lower east end lobby at the entry to the pedestrian tunnel (**Photo #36**).

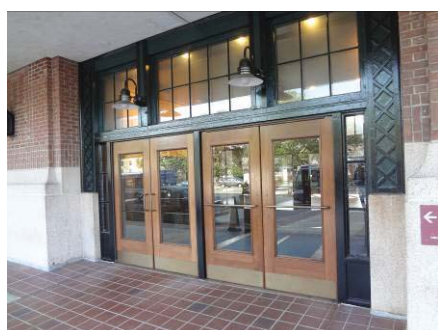
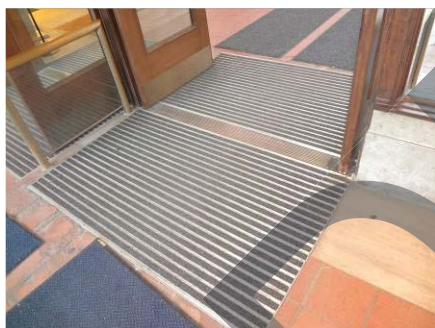
The main waiting room entry doors, west & east end entry doors (**Photos #37 & #38**), as well as the doors along the south side have all either been repaired or replaced as part of NHPA Project No. 10-005.

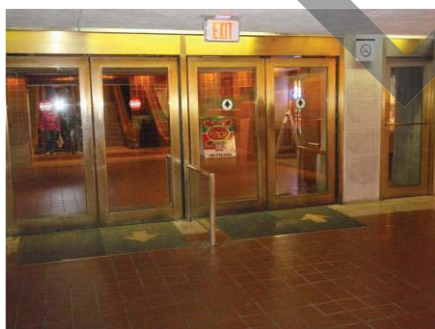
Photo #39

The brass doors located at the base of the escalators, leading to the pedestrian tunnel to the train platforms, are in need of repair (**Photo #39**). While the doors themselves are in acceptable condition to remain but be cleaned and refinished, all hardware and automatic controls should be replaced.

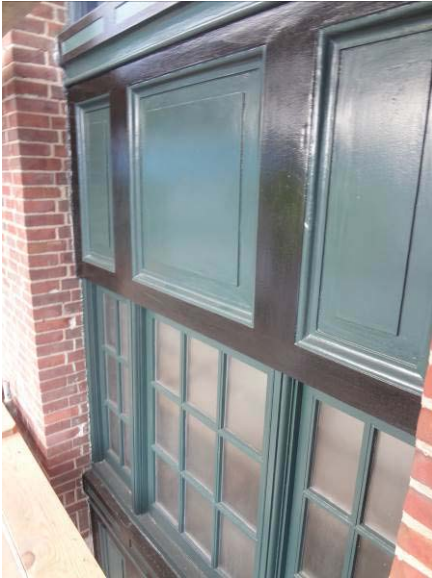
Photo #40

The exterior painted finishes on wood and metal trim located around the perimeter of the Station's windows, had been repainted as part of NHPA Project no. 08-016 B. **(Photo #40)**. However, the exterior finishes are continuously exposed to the weather and exterior environment, and therefore, DESMAN recommends that re-painting be programmed accordingly.

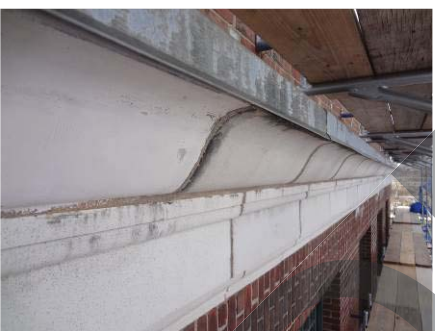
Photo #43

The terra cotta cornice is exhibiting its age (**Photos #43 & #44**). Although NHPA and DESMAN have been hesitant to program extensive repairs to this cornice due to the historic nature of the building, the time is approaching that repairs should be considered more inevitably due to concerns of waterproofing and maintain the building envelop. Acknowledging that respecting the historic nature of the building is critical, there are various options for coatings that may be applied and faux terra cotta that may be installed that would be minimally visible. DESMAN recommends that NHPA continue to monitor the condition of the cornice and program repairs accordingly. That said, an assessment and initial investigation is currently in progress as part of Project No. 19-013.

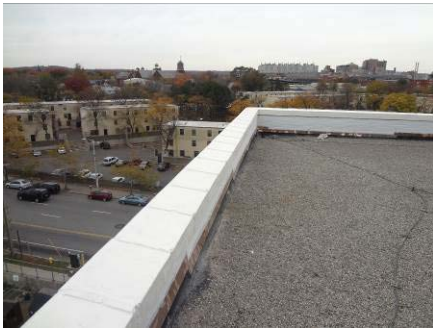
Photo #46

- a. Existing caulking was nearing the end of its useful life. The caulking has all been replaced as part of NHPA Project no. 08-016 B.
- b. Cracking in the coping stones, as a result of miscellaneous distress and the mounting of the lightning arrestor system air terminals was also contributing to water penetration. The coping stones have been coated with an elastomeric coating to waterproof and span the cracking as part of NHPA Project no. 08-016 B (**Photo #46**).

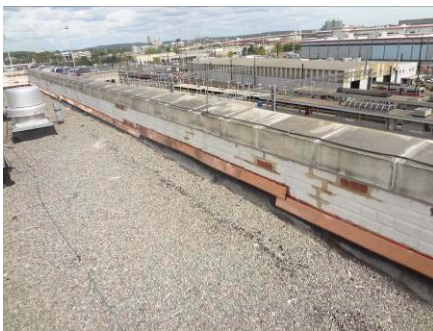
Photo #47

- c. Miscellaneous brick removal and re-pointing, on the interior face of the parapet, has been addressed as required, to maintain the waterproofing integrity and prevent leaking (**Photo #47**). Following the masonry repairs, the architectural waterproofing coating has been repaired and re-coated as part of NHPA Project no. 08-016 B.

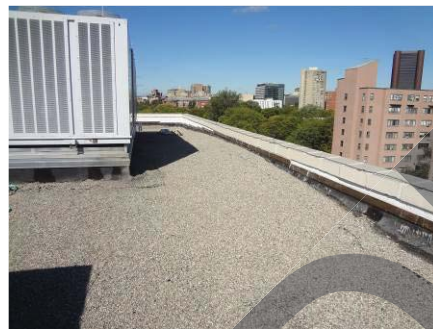
Photo #48

- d. Miscellaneous flashing has been repaired or replaced as required as part of NHPA Project no. 08-016 B (**Photo #48**).

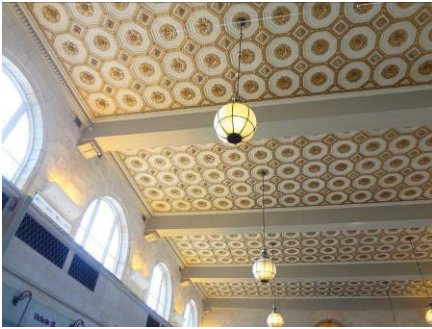
Photo #50

Cleaning of the globe lights in the main waiting area should enhance the aesthetics of the lobby area (**Photo #50**). The wall sconces above the galleries in the main waiting room require a fresh coat of paint. This work is currently included as part of NHPA Project no. 15-003 A, now entering design.

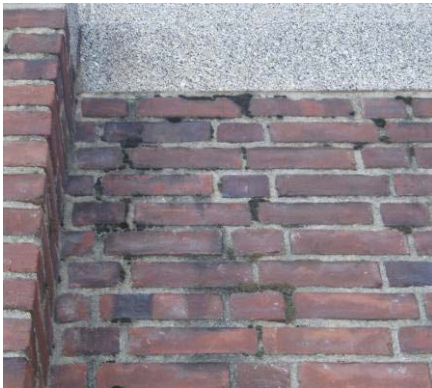
Photo #51

Miscellaneous re-pointing of the brick enclosure was recommended to remove organic growth (**Photo #51**), and repair of miscellaneous units was recommended throughout.

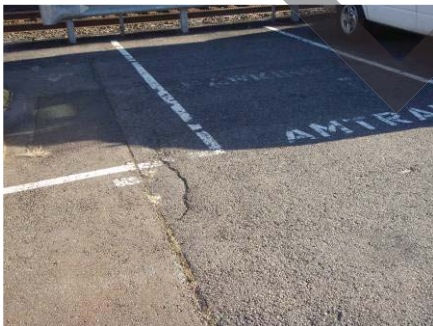
Photo #52

- Cracking has been observed in the bituminous concrete pavement throughout the west lot. These cracks should be properly cleaned and sealed to prevent further deterioration of the pavement.
- Miscellaneous pavement repair is required within the west surface parking lot (**Photo #52**) to address differential settlement issues. This is especially important for those defects that are several inches deep and present a potential trip hazard.

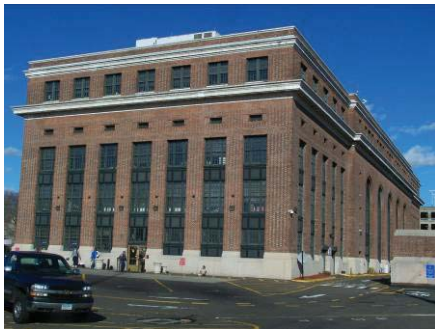
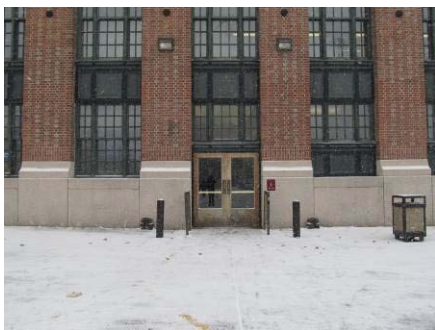
Originally, a canopy structure was intended to be installed at the West Entrance (**Photos #53 & #54**) as part of the comprehensive renovation project of the early 1980s; however, it was never installed. Since then, this entrance has become a challenge since it serves patrons waiting for buses as well as other related needs.

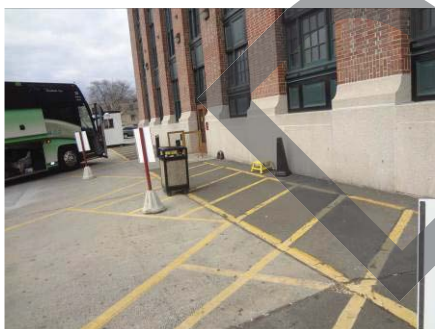
Photo #55

There may be opportunities which could make this area more inviting (**Photo #55**). Various enhancements could include installing the canopy as originally intended, perhaps similar to the East Entrance and the Main Entrance or some such variation, but also updating the signage and lighting to better identify the entrance, provide bench seating, or replacing the bollards with illuminated bollards, all of which could assist in transforming the area (various concepts as follows)

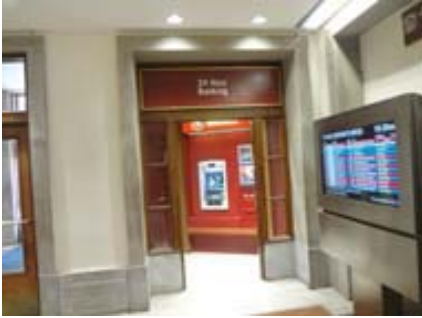
Photo #58

Pursuant to recent discussions, **DESMAN** understands that **PNH** desires to review and study various issues that may be involved in the construction of a potential family restroom (**Photo #58**), in addition to the existing restrooms currently located at the Union Station Building. This study has been in progress as part of NHPA Project No. 18-022; plans however for a single toilet family restroom have been deferred and instead will be considered as part of a comprehensive plan to increase public restrooms.

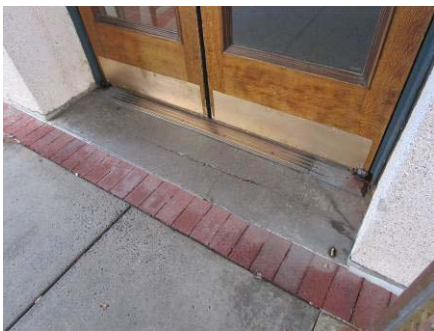
Photo #59

Cracking in the stone thresholds has apparently allowed moisture through, and so nominal leaking has been observed into the tunnel below (**Photo #59**). **DESMAN** recommends that these thresholds be properly sealed and any cracking be repaired.

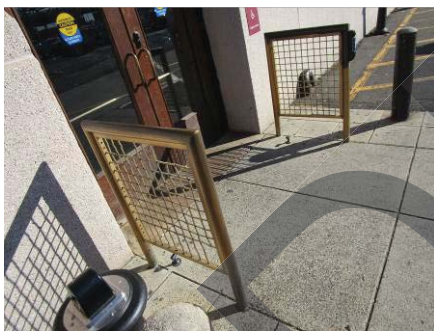
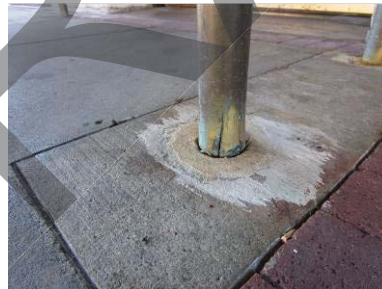
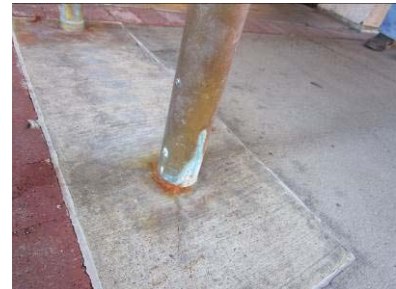
The brass railings by the exterior doors have been susceptible to moisture and thus have corroded, becoming loose (**Photos #60, #61 & #62**). **DESMAN** recommends that these railing systems be replaced, perhaps mounted onto a raised curb of some form so as to provide further protection.

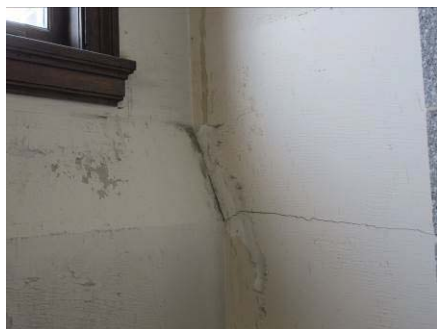
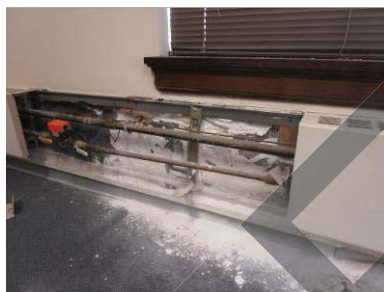
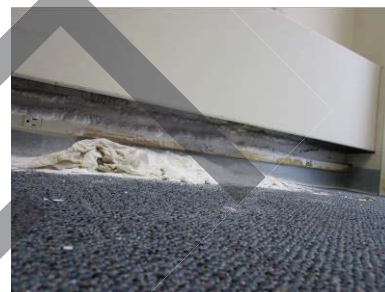
Apparently due to moisture penetrating through the windows or roofing system above, various extents of damage have been observed throughout the now-vacant tenant spaces (**Photos #63, #64 & #65**). Since the source of moisture is not exactly confirmed, DESMAN recommends that the envelop be monitored along with other planned improvements, and this wall damage be repaired as required.

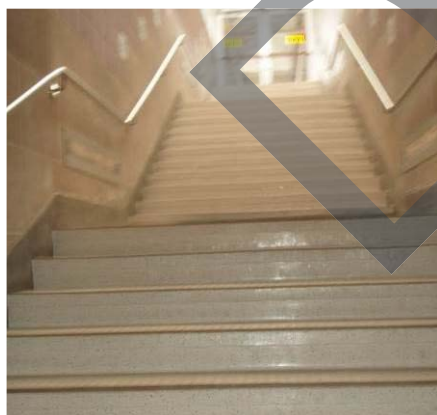
Photo #68

The stair treads and stair landings within the tunnel which access the station's railroad platforms had exhibited some limited wear due to heavy usage and were addressed and replaced in the CDOT project's scope of work (**Photo #68**). NHPA, however, has requested that DESMAN consider a future replacement program in which DESMAN considers other options besides rubber flooring that may be more durable for the long-term, such as supplemental metal treads that may be installed as a retrofit.

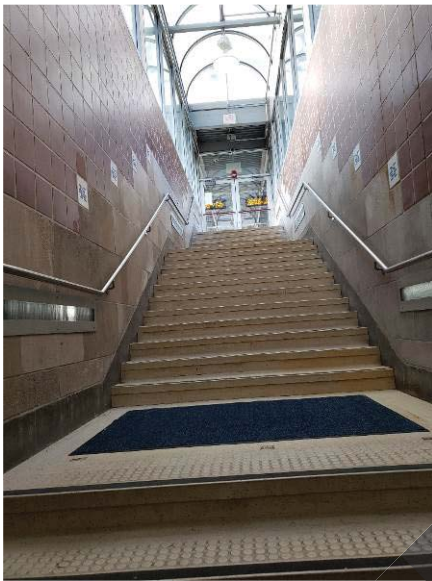
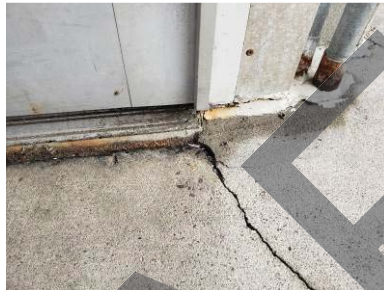
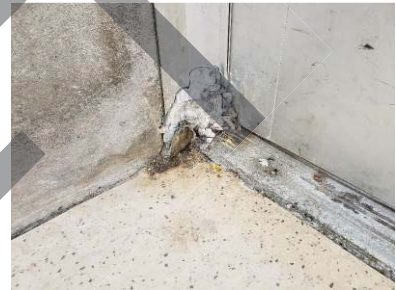
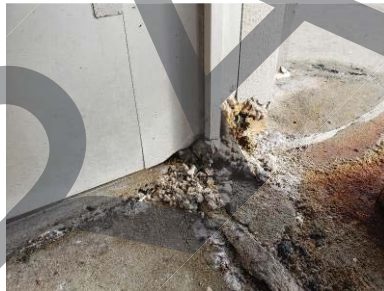
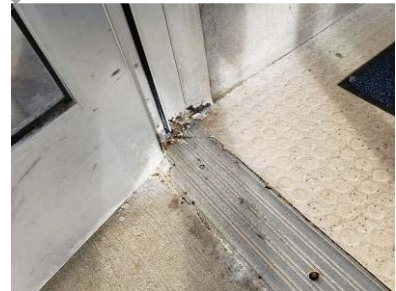
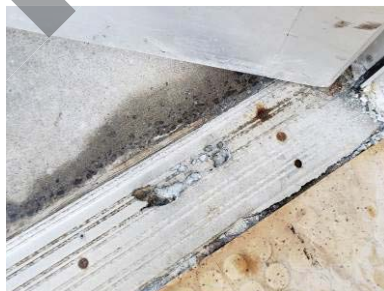
Door and Frame Replacement: Over time, excessive use of ice-melt materials on the train platforms has corroded the various doors and frames to the stairs, to the degree that certain doors cannot easily be repaired but now must be fully replaced (**Photos #69, #70, #71, #72, #73, #74 & #75**). DESMAN therefore recommends that replacement of the door systems be programmed accordingly. At the time of work, parties will need to coordinate with the trains accordingly for appropriate Force Account requirements.

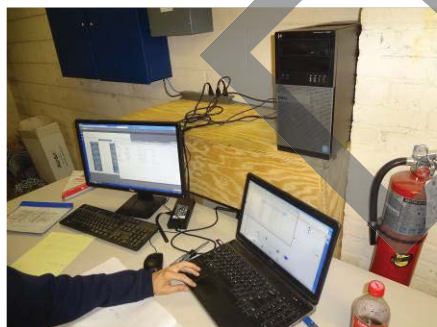
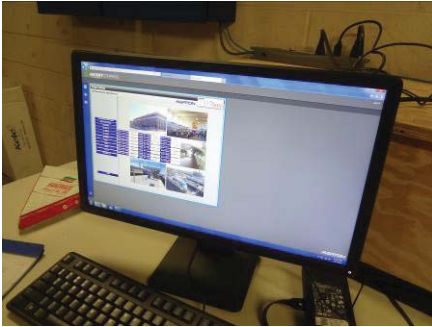
This work has been addressed as part of NHPA Project No. 10-005 B. The upgrades included installation of a new web based Head End Controller for the Building Management System (**Photos #78 & #79**) and replacement of all remaining

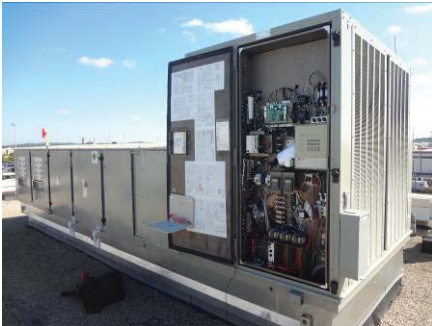
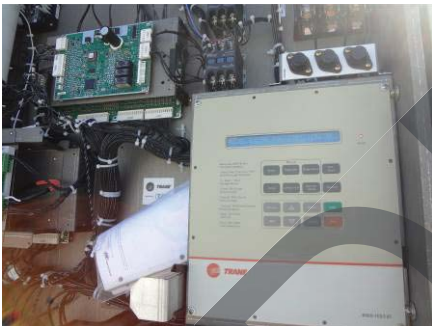
Three of the six packaged rooftop air conditioning units were replaced in 2003, and the second set of three were replaced (**Photos #80 & #81**) as part of NHPA Project No. 10-005 B. However, due to recent mechanical failures that have been difficult to maintain, we are now recommending that replacement be accelerated and therefore consider replacement of the initial three. DESMAN recommends that they be monitored and planned for accordingly.

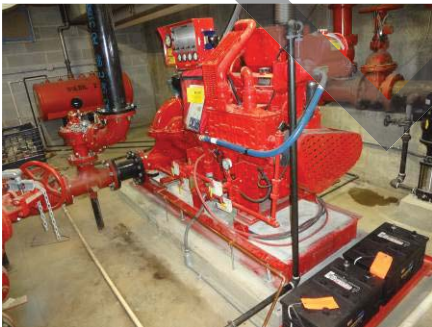
Photo #82

The 30-year old fire pump was replaced (**Photo #82**) as part of NHPA Project No. 10-005 B.

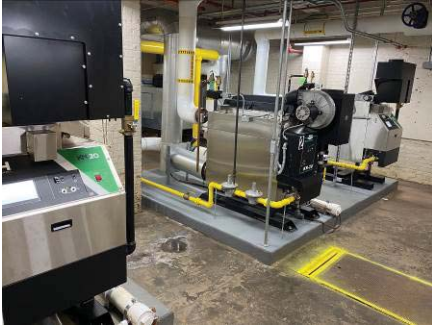
Photo #83

There are three (3) boilers serving the Station (**Photo #83**). Two boilers were replaced circa 2010 and the third boiler was replaced in 2019 as part of NHPA Project No. 18-014.

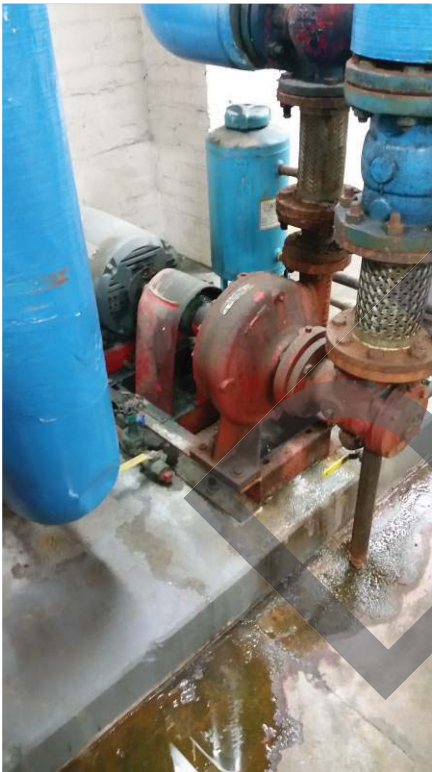
Photo #84

The previous chilled water pump, installed during the 1980's, has now been replaced (**Photo #84**) as part of NHPA Project No. 18-014 now complete.

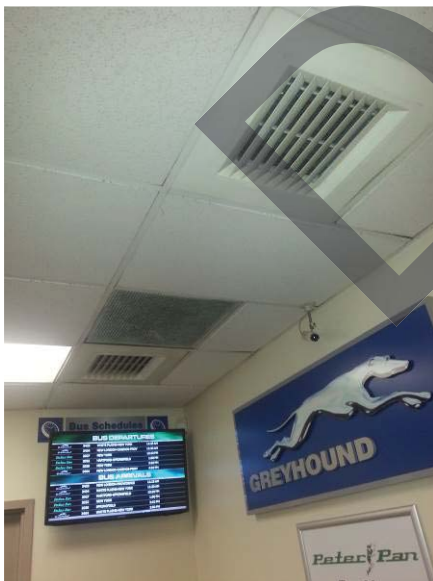
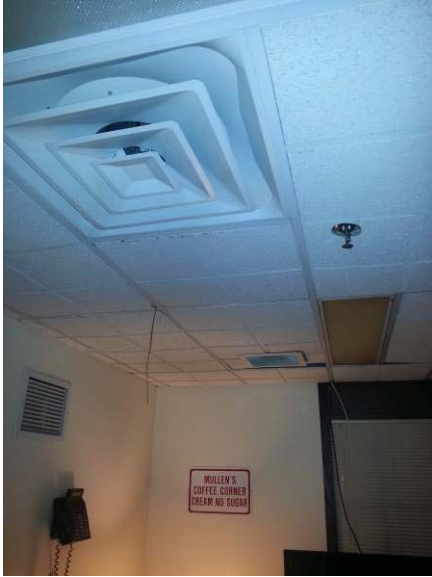
- The Amtrak, Avis & Greyhound spaces (**Photos #85 & #86**), currently served by AHU-6, had been experiencing overheating issues; after review, we found that the unit was originally set up for free economizer cooling but that there was excess restriction in the outside air duct so economizer was ineffective. We addressed the overheating by adding a booster fan in the basement to supply the correct amount of outside air for economizer. Further improvements to AHU-6 controls were included in NHPA Project #10-005B, so additional improvement should be noted. We would subsequently recommend continued monitoring of these spaces to confirm.

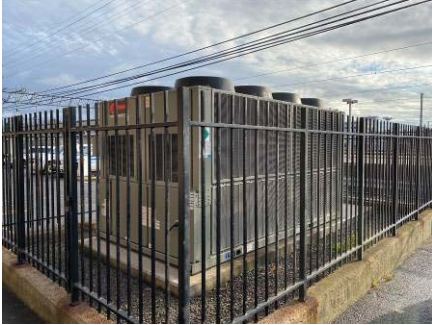
Photo #88

15. The prior 90 ton chilled water plant has been replaced with a new 100 ton chiller in 2019 as part of NHPA Project No. 18-014 (**Photos #88**). DESMAN recommends that regular preventative maintenance be scheduled and provided for every 3 years approximately.

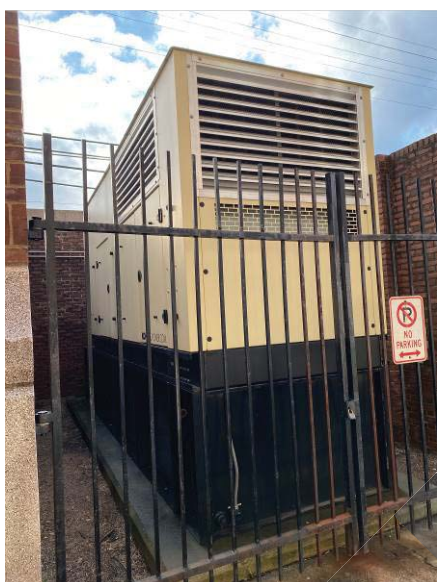
Photo #91

The emergency generator was replaced as part of the CDOT's code and upgrade project currently completed circa 2014 (**Photo #91**). DESMAN notes that additional loads have been added to the generator system. Maintenance is an operating expense and therefore is not included within the projected repair and preventative maintenance costs.

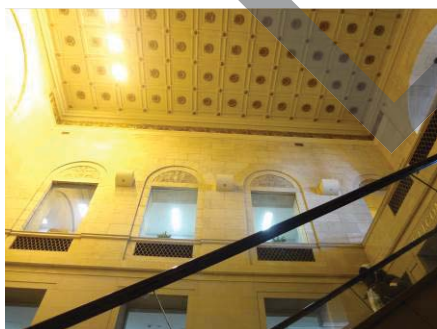
Photo #92

Also, as recommended by DESMAN, modifications were made to the light fixtures over the escalators (**Photos #92**). Due to their height and positioning over the escalators, access for maintenance was challenging and scaffolding was necessary. This work was accomplished as part of NHPA Project No. 15-003 B in 2019, now substantially complete.

Due to the challenging access experienced with this work, we recommend that maintenance and future replacement be considered accordingly via the services of a specialized contractor.

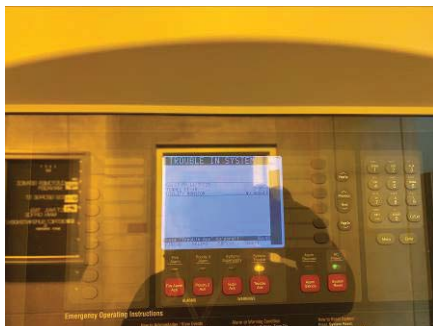
Photo #93

As noted at the time of our visit, the fire alarm control panel was indicating a trouble signal from Tunnel Exhaust Fan #10 (**Photo #93**). We understand that Maintenance is aware of this, so we therefore recommend that PNH monitor this issue accordingly.

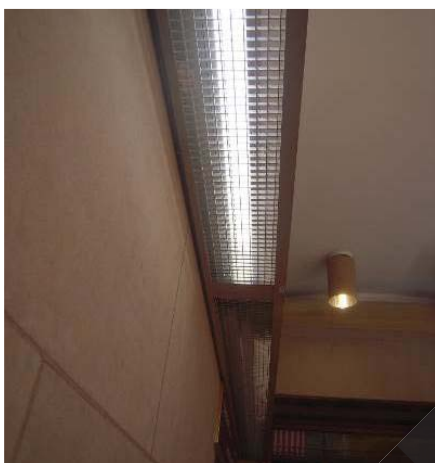
Photo #94

Production of many replacement ballasts for T12 fluorescent systems has already been discontinued. As a result, replacement T12 lamps and ballasts will become increasingly expensive and difficult to obtain. Replacement of any remaining T12 fluorescent systems in the facility should be considered in the near future. There were existing T12 fixtures serving the back stairwells, first floor wall-wash fixtures (**Photo #94**), and first and second floor restrooms.

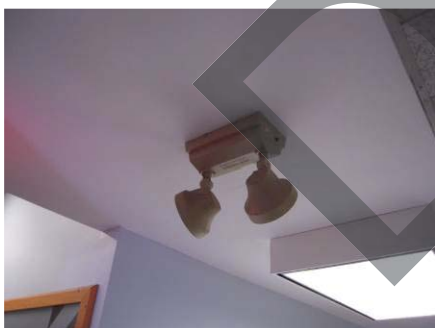
Photo #95

Existing battery-powered twin-head emergency lighting units are installed throughout the second, third and fourth floor corridors (**Photo #95**). DESMAN recommends that PNH Maintenance monitor them and repair/replace them as may be required.

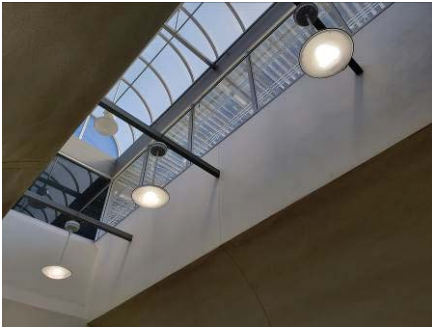
Photo #96

16 foot pendant mounted fixtures in each of two high ceiling areas of the tunnel were replaced in 2019 as part of NHPA Project No. 15-003 B (**Photo #96**).

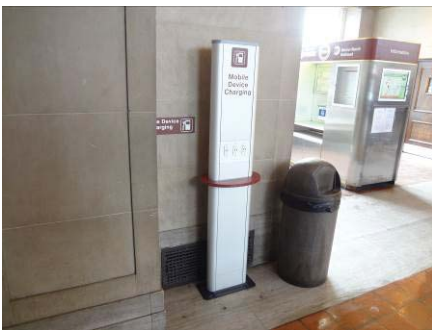
Photo #97

8. Mobile Device Charging Stations have been installed at various locations throughout the Union Station Building (**Photo #97**). DESMAN recommends that PNH monitor the stations for volume of usage and prepare a preventative maintenance program accordingly.

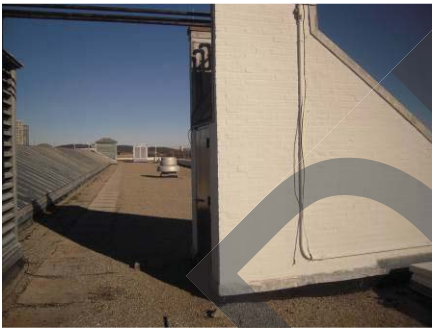
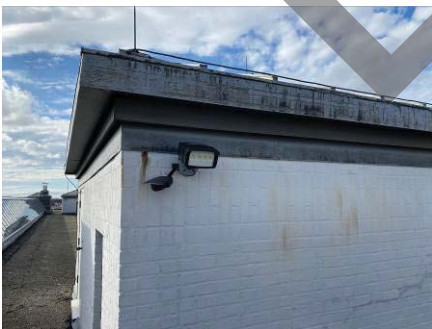
9. PNH had requested that service lights be installed on the roof in designated locations (**Photos #98 & #99**) to provide enhanced lighting when performing maintenance on the various roof level mechanical units and equipment. This work was completed in 2019 as part of NHPA Project No. 15-003 B.

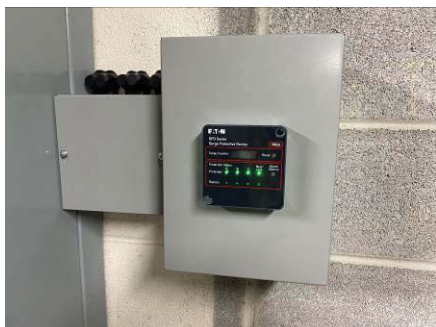
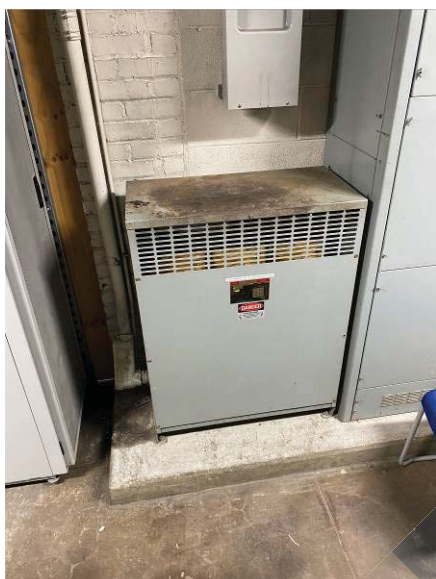
We understand that the existing 112.5 kVA transformer, in the main electrical room serving the Concession Distribution Panel, has been reported to get very hot during times of high loading and is showing visual signs of overheating (**Photos #103 & #104**). We recommend that replacement of the transformer be considered in order to eliminate the overheating condition and lessen the risk of an unanticipated failure. We note however that a modern transformer of this rating may have a considerably larger footprint which may require relocation within the main electrical room.

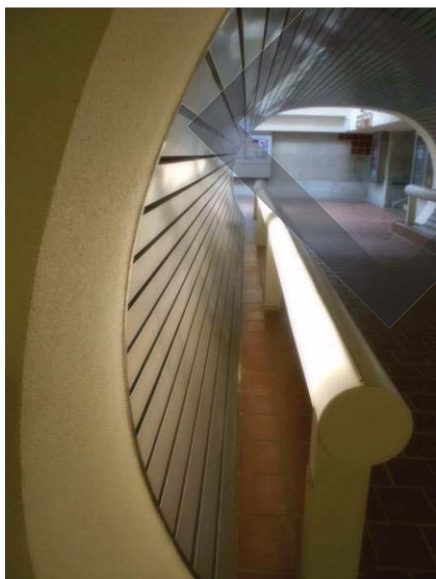
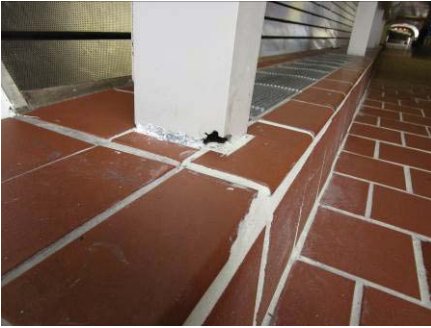
13. Replacement of the Tunnel Light Rail: In order to enhance the tunnel leading to the train platforms, consideration has been made to enhance the rail light on either side of the tunnel (**Photos #105 & #106**). A simple but decorative enhancement may be to retrofit or replace the rail with a color-changing lighting system that may be programmed for additional aesthetics. At that time, DESMAN recommends that the mounting system be modified, as well, so as to avoid the rail system being exposed to moisture and subsequent corrosion.

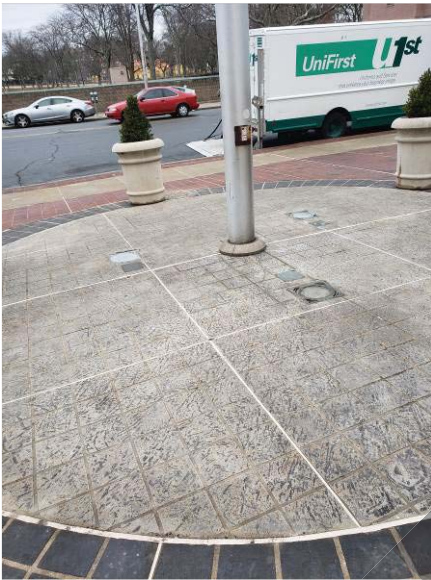
Photo #107

14. Lights around Flagpole: the embedded light fixtures surrounding the flagpole in the front of the Station are aged and damaged due to water (**Photos #107, #108 & #109**). DESMAN recommends that these fixtures be replaced.

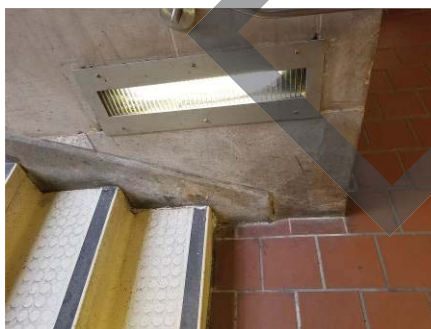
Photo #110

15. The lights within the walls of the stairs leading to the train platforms are aged and difficult to maintain due to their exposure to moisture (**Photo #110**). Currently, one set of lights at a stair are not working; DESMAN is reviewing this issue further for recommended course of action.
16. There have been multiple issues related to the building's heating hot water pumps recently, which have included failure of one pump, failure of at least one motor and tripping of an upstream breaker in the pump power feed. While we are not aware of a certain correlation between these failures, the situation warrants monitoring. While we understand that replacement of the motor and pump have been resolved as part of maintenance, we suspect that the 40 year-old breaker may be need of replacement, and so we therefore recommend that replacement be programmed accordingly.

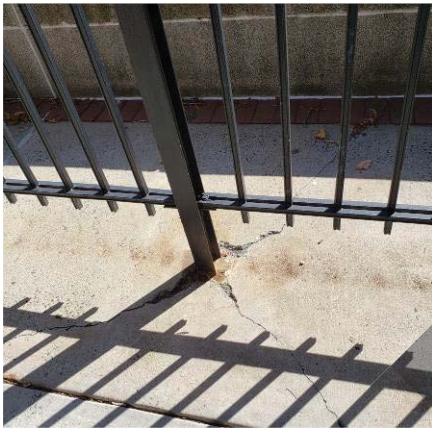
Photo #115

Various site elements have been damaged, such as moisture damage and corrosion to fencing. All elements and materials should be repaired as may be required. **(Photos #114 & #115).**

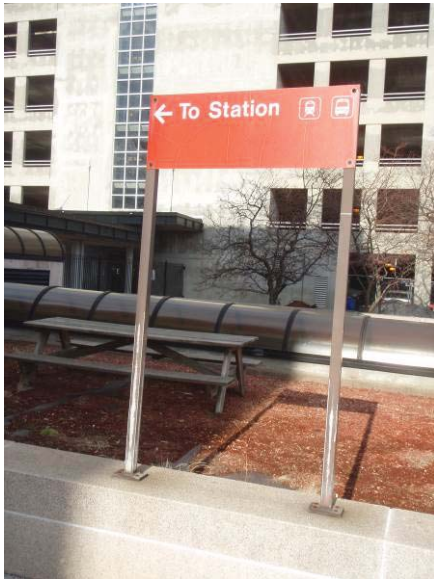
Photo #116

In the meantime, any existing signage which have been damaged should be replaced. DESMAN also recommends that the signage program be reviewed for any potential updating as may be appropriate for patron requirements. **(Photo #116)**

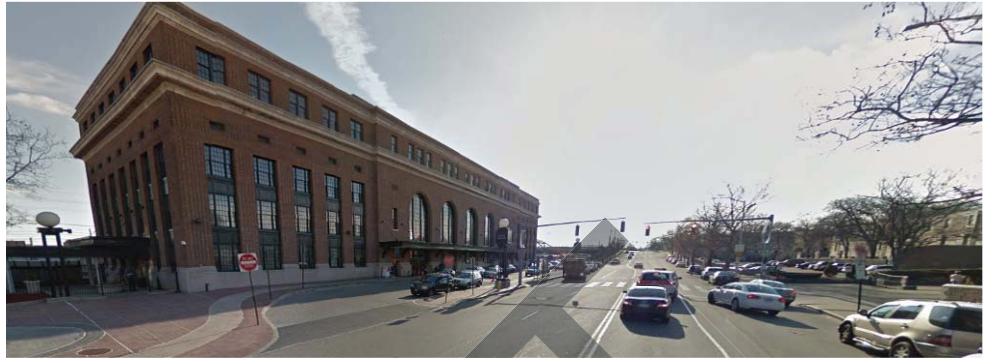
Photo #117

PNH has determined the need to modify the existing traffic and transit operations along Union Avenue and in front of New Haven Union Station **(Photo #117)** to better organize and delineate the various functions for all types of travel including shuttle bus, city bus, taxi, Uber, limo, pickup/drop off by car, bicycling and walking. Improvements include, but are not limited to, installing new vehicular signage and pedestrian wayfinding signage, installing new bus shelters, installing a new bicycle parking area, and other streetscape and site improvements at New Haven Union Station (the "Project"). Although this work is currently being considered as part of Project no. 15-023, progress is on hold per discussion with the City of New Haven and State of Connecticut.

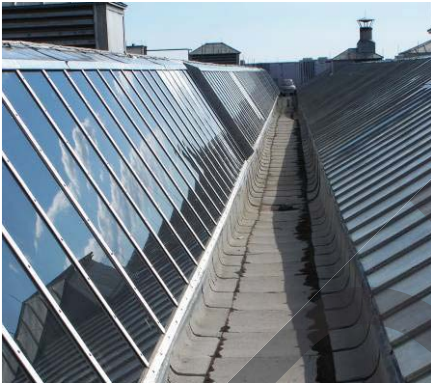
Photo #118

1. Some of the coated skylights on the fourth floor offices are peeling. Should privacy or heat/light protection still be required, a new coating should be applied, or the glass replaced with opaque glass or insulated panels. DESMAN recommends that these be monitored as required. **(Photo #118)**
2. Periodic inspection of the perimeter fencing is recommended to assure this fence remains secure and properly maintained.

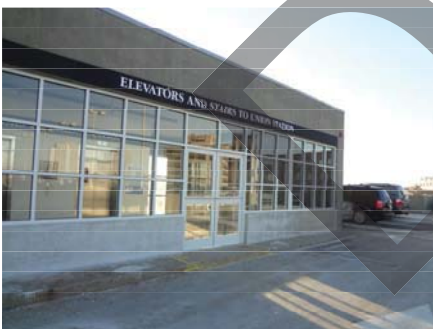
Photo #1

The storefront associated with this facility’s roof level has been replaced (**Photo #1**), while the lower level storefront construction remained essentially unchanged.

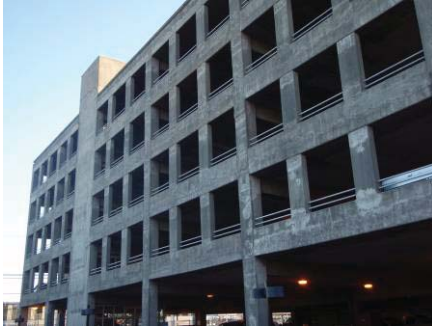
Photo #2

The six level, free standing parking facility (**Photo #2**) is located on Union Avenue adjacent to the Union Station Transportation Center Building (Railroad Station) in New Haven, Connecticut. This facility remains in relatively good structural condition, but conditions exist which should be addressed to preserve and protect it.

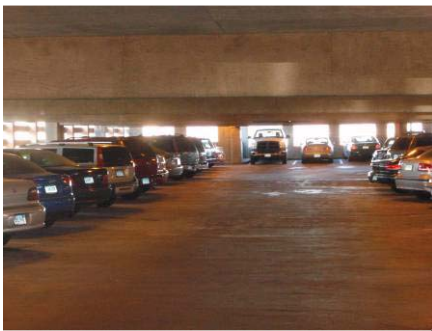
Photo #3

The facility is rectangular in shape with a longitudinal dimension of 277 feet and a transverse dimension of 174 feet with five supported levels (i.e., structural slabs) and one slab-on-grade. The facility's structural configuration consists of two non-sloping exterior parking bays (**Photo #3**) and one sloping interior parking bay providing vehicle access between parking levels. Traffic flow within the facility is clockwise with one-way traffic on the exterior parking bays and two-way traffic flow on the interior bay.

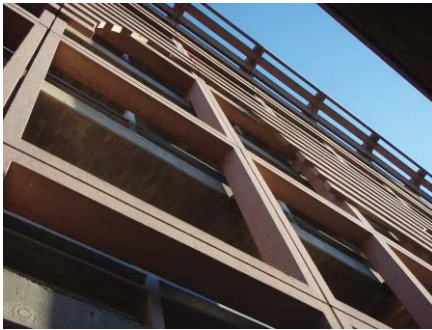
Photo #4

The parking facility's façade, along Union Avenue, features architectural pre-cast concrete elements supported by the facility's structural frame (**Photo #4**).

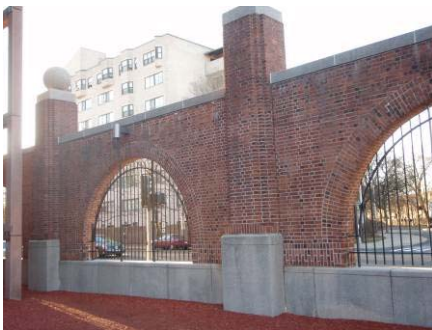
Photo #6

- 2015 A comprehensive repair and improvement project was started in Spring 2014 and was completed Fall 2015. Work consisted of concrete repair, waterproofing repairs, masonry repairs (**Photo #6**), plumbing repairs, storefront repairs and replacement, painting and re-stripping.

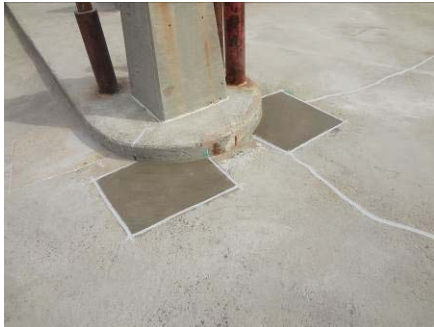
Photo #10

Partial Depth Concrete Repair: Miscellaneous concrete spalling had been located throughout the garage (**Photo #10**). Repair of concrete deck deterioration and vertical and overhead concrete deterioration, throughout the interior of the garage, has been addressed as part of Project no. 08-016 B, and additional miscellaneous repair will be addressed as part of Project No. 18-016 currently in design. However, DESMAN has observed additional shallow deterioration occurring throughout the garage and so recommends that continued repair be programmed accordingly, consisting of a combination of shallow-depth and partial-depth repair approaches.

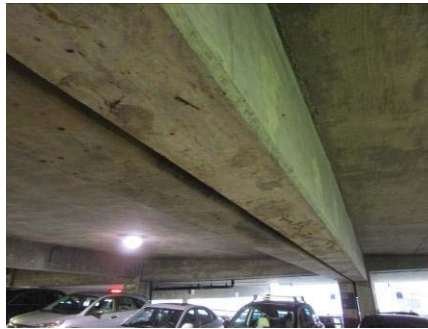
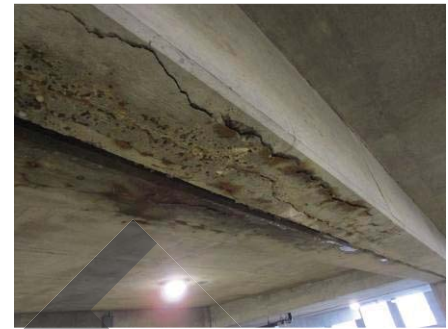
Overhead Concrete Repair: Significant deterioration has now been observed, specifically along the underside of the beams on either side of the expansion joints (**Photos #11 & #12**); the deterioration appears to be shallow and related to the chairs that support the bottom layer of reinforcing steel. DESMAN recommends that continued repair be programmed accordingly.

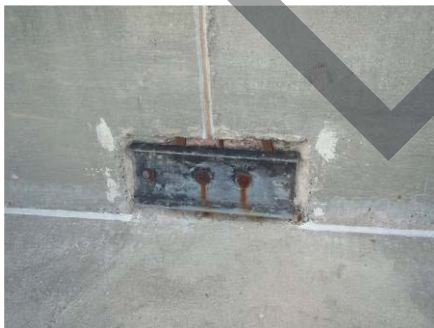
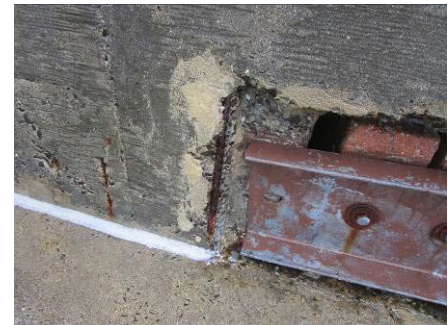
Pre-cast Concrete Facade: The original design of the architectural facade panels, while aesthetically pleasing, has hard attachments to the garage structure on either side of the facility's expansion joints, and so stranded cable supports have been installed to provide an additional level of safety. Thermal movement of the structure tends to rack the face; fortunately, the facade seems to be flexible enough to withstand this movement successfully. The condition should continue to be monitored periodically (**Photos #13 & #14**). All connections and hardware should be cleaned and cold-galvanized to maintain their structural integrity (**Photo #15**); cold-galvanization of the connections and hardware is planned to be addressed as part of NHPA Project No. 16-006, and at that time, DESMAN recommends that the surrounding concrete be repaired as well (**Photos #15 & #17**).

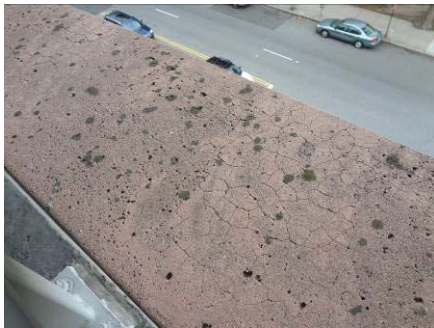
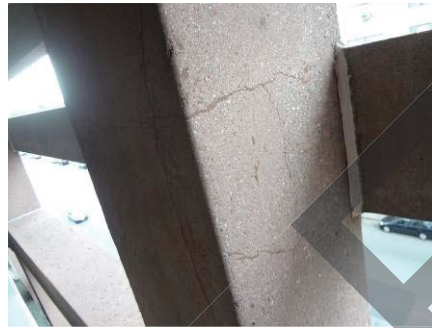
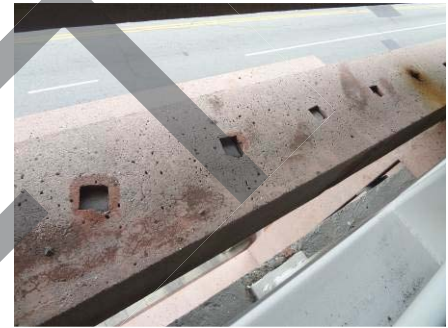
The surface of the precast concrete façade, however, is now demonstrating its age; significant cracking has become visible recently, along with other miscellaneous concrete repair (**Photos #18, #19 & #20**). While some cracking appears narrow enough that it could simply be coated over with a waterproofing coating, other

cracking appears wider, thus prompting epoxy injection. Since maintaining the aesthetics of the façade is critical, limited replacement with a new precast piece may be desired if the crack repair is too unsightly. Ultimately, a repair program may consist of a combination of epoxy injection with a subsequent coating, as well as replacement of selected pieces of precast. This work is part of Project #19-016, currently in design.

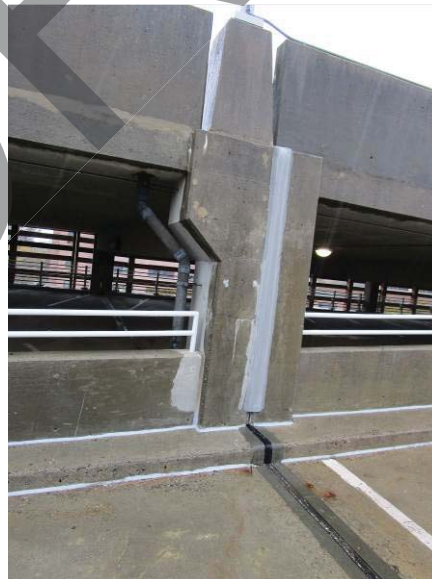
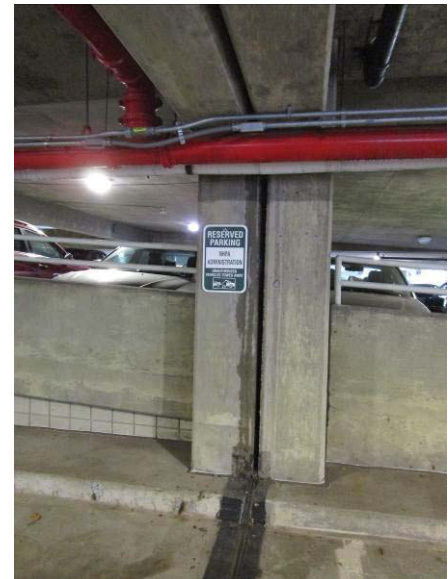
Expansion Joint Repairs: The expansion joints throughout the garage have all been replaced (**Photo #21**) as part of Project no. 08-016 B. At that time, however, the associated vertical glands were not replaced (**Photos #22 & #23**); DESMAN recommends that the vertical glands now be replaced as well, prioritizing the roof level accordingly.
