**CONDITION APPRAISAL
(FY 2021)**

CONDITION APPRAISAL UNION STATION BUILDING

The Condition Appraisal of the Union Station Building was performed by DESMAN in accordance with the executed agreement by and between the New Haven Parking Authority and DESMAN (NHPA Project No. 21-001).

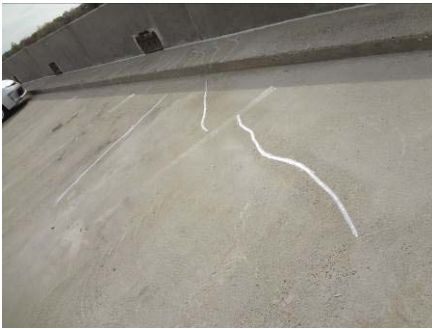
Photo #24

Crack Repair/Control/Construction Joint/Cove Joint Repair: A significant amount of polyurethane sealant material has been installed historically throughout the garage to seal leaking cracks, and control/construction joints. Some of this sealant material had been showing signs of deterioration consistent with exposure to higher volumes of vehicular traffic, or in certain instances, was worn or damaged due to exposure to direct sunlight (UV degradation) or because of damage caused during snow removal operations (**Photo #24**).

Although miscellaneous replacement of sealant material had been addressed as part of Project no. 08-016 B, further sealant repair work should be anticipated as being required over the next five years as well (including additional cove joint repair), and additional miscellaneous repair will be addressed as part of Project No. 18-016 now in construction.

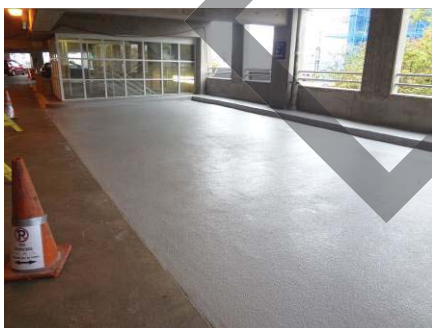
Photo #25

A waterproofing membrane system had been in place over the garage office and over the mechanical room on the ground level, and the system should remain in these locations. The membrane systems had reached the end of their useful lives and have now been repaired and re-coated (**Photo #25**). This work was addressed as part of Project no. 08-016 B.

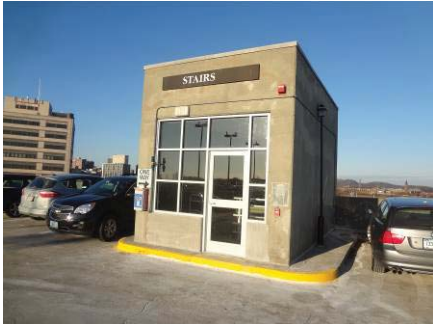
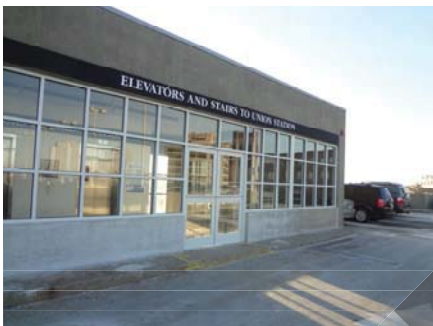
Miscellaneous Storefront Repair: This facility's storefront located at the stairwell and elevator lobbies had been in relatively poor condition, particularly those installed on the facility's roof level. The roof level store front systems were replaced as part of Project no. 08-016 B (**Photos #26 & #27**).

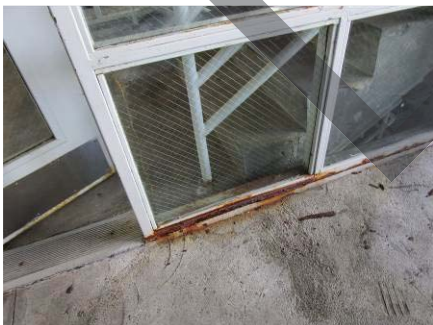
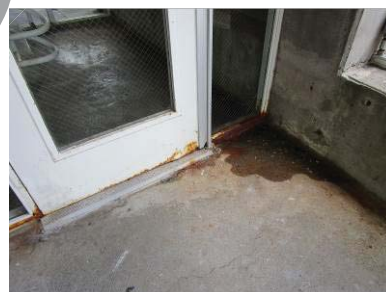
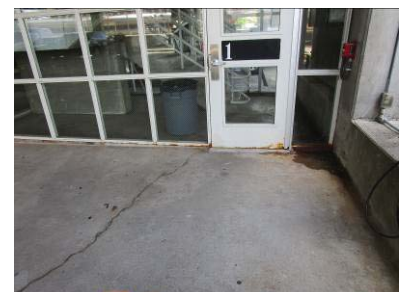
Although miscellaneous repair was addressed as part of Project no. 08-016 B, continued moisture has further deteriorated the storefront systems (**Photos #28, #29 & #30**). DESMAN therefore now recommends that full replacement be considered, incorporating a raised concrete curbing similar to the storefront systems installed at the roof level, or perhaps the existing storefronts be removed and replaced with a typical guardrail system mounted on a raised curb (since the stairs are no longer required to be enclosed), all to avoid exposure to moisture and continued deterioration.

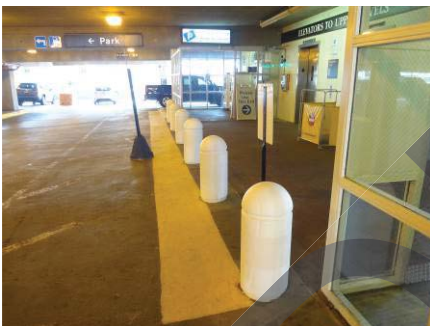
Photo #35

Desman recommends that certain aesthetic improvements be considered at the main lobby area, specifically the first level lobby which is the most visible public area of the garage (**Photo #35**). Various options include:

1. Removal of the existing pavers and placement of a decorative stamped/textured concrete,
2. Painting of the walls and ceiling with a reflective coating,
3. Enhancement with new and/or supplemental decorative lighting, illuminated bollards could provide additional lighting as well as an architectural enhancement
4. Installation of additional informational signage and graphics.
5. Replacement of the glazing and storefront system for the office that is more consistent with the historic character of the Station. (**Photo #36**)
6. Various concepts as follows.

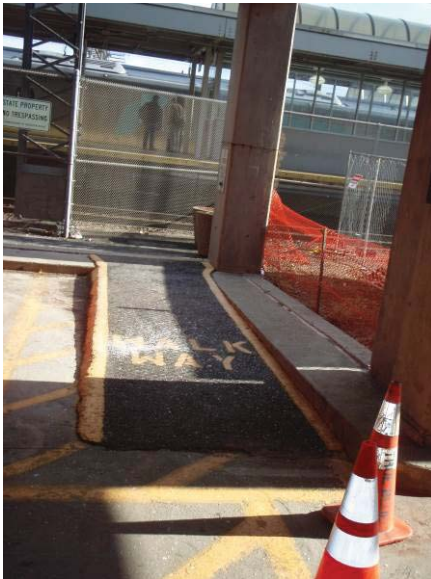
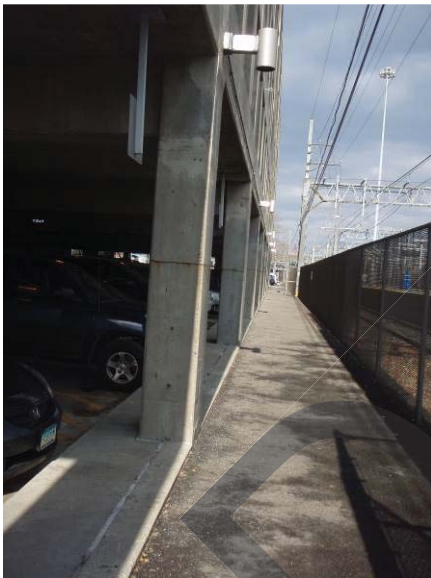
Pedestrian Route Enhancements (southern walkway): The pedestrian pathway provided from the East Lot to the main lobby may be improved as well (**Photos #37 & #38**). In conjunction with the installation of decorative lighting already programmed, the existing asphalt may be removed and a decorative stamped/stenciled concrete may be placed, providing an aesthetically enhanced pathway highlighting the route to the Station.

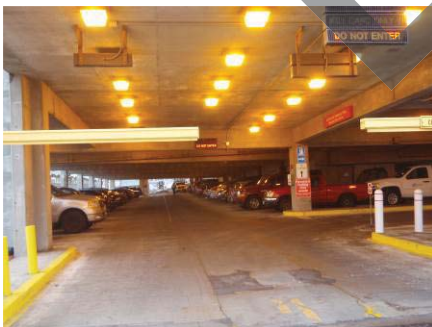
Photo #39

Vehicular Entrance Enhancements: As an effort to enhance the visitor's experience upon entering the garage, cost-effective improvements may be considered as well (**Photo #39**). Application of a high-reflective coating across the ceiling and surrounding vertical surfaces, in conjunction with improved lighting (already programmed) and supplemental signage and graphics, may be programmed accordingly.

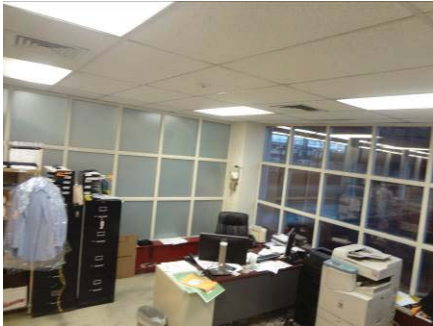
Photo #40

Manager's Office: The existing space being used as a Manager's Office would benefit from certain aesthetic improvements (**Photo #40**). Enhancements, such as new flooring, ceiling with new lighting, and painting, as well as renovations of the bathroom, could be programmed accordingly.

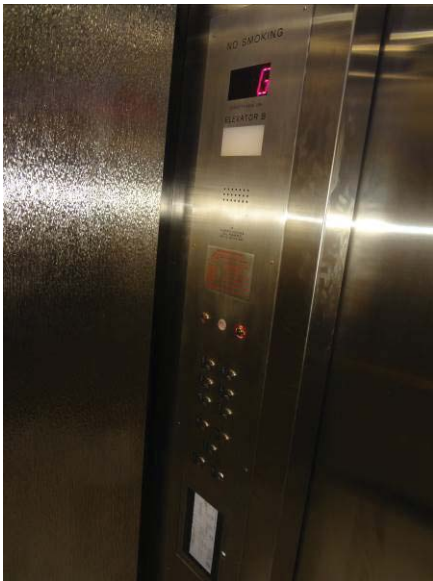
Photo #42

Elevator Modernization: The elevators have been renovated and modernized as part of Project no. 13-012 B (**Photo #42**). New controllers, power units, and door upgrades were among the improvements as well as improvements to the elevator machine room HVAC, inclusive of the installation of an air conditioning system and supplemental heating. Illuminated level annunciators, call buttons, and other miscellaneous design features were installed to enhance the visual appearance of the elevators (**Photo #43**) and to meet changing building and ADA code requirements.

In order to assist PNH in the ongoing execution of its Maintenance Agreement with Schindler Elevator Corp., DESMAN recommends that PNH program the services of DESMAN and its elevator sub-consultant, Sterling Elevator Consultants, to oversee an elevator maintenance audit on a regular basis.

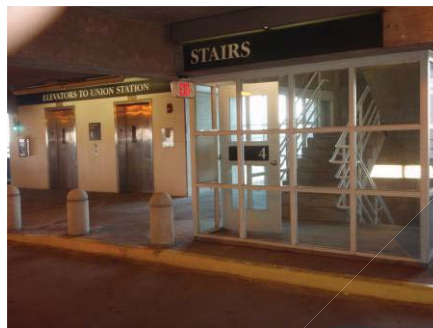
Photo #44

Painting Storefront & Stairwell Handrails (Stairwell & Elevator Lobbies): This work relates to the need to periodically re-paint the stairwell and elevator lobby storefronts (**Photo #44**) and stairwell handrails as an enhancement to general aesthetics and to protect otherwise exposed metal surfaces prone to the effects of corrosion. Previously painted surfaces can degrade over time depending on environmental exposure, vandalism and abuse, and normal wear and tear. This work was last comprehensively addressed as part of Project no. 08-016 B.

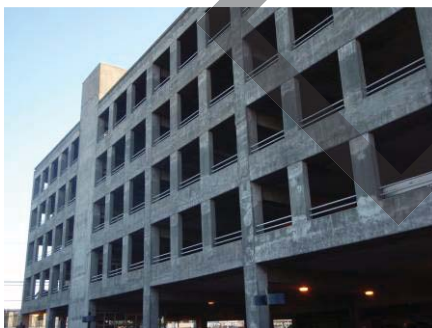
Photo #45

general aesthetics and to protect otherwise exposed metal surfaces prone to the effects of corrosion (**Photos #45 & #46**). Previously painted surfaces can degrade over time depending on environmental exposure, vandalism and abuse, and normal wear and tear. This work was last comprehensively addressed as part of Project no. 08-016 B.

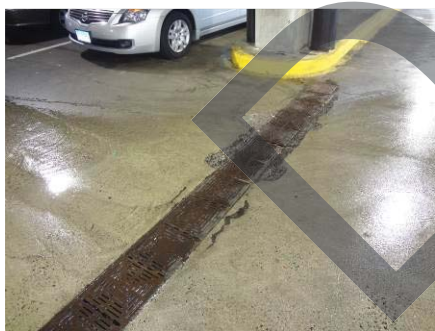
Photo #47

The trench drain at the base of the ramp (grade level) has deteriorated beyond the ability to clean and repair and thus is now in need of full replacement (**Photo #47**). DESMAN recommends that the existing cast iron frame body be removed in its entirety and a new hot-dipped galvanized body and frame be installed with all new grates. At this time, consideration can also be made for the removal of the trench drain at the northwest entry/exit portal; since the concrete slab has a positive slope regardless, the trench drain system has proven to be an unnecessary maintenance expense and can be removed, repairing the concrete slab afterwards (DESMAN notes that the trench drain system at the southeast entry/exit portal has already been removed). This work will be addressed as part of Project No. 18-016 now in construction.

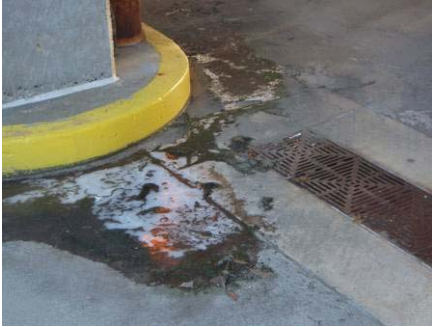
Photo #48

Cleaning & Flush Floor Drains: Accumulation of sand and debris continues to be noted in and around drains, or deposited in unused corners of various parking decks, particularly the roof where sand has been used during the winter months to address icing conditions. It is important that accumulated sand be removed from the garage decks each spring as they hold concentration of chloride (road salt) and moisture in direct contact with the concrete deck; causing an increase in the amount of deterioration which could take place.

Sand carried into the storm drains can clog drains and associated drain lines. In combination with periodic garage wash down, it is imperative that the facility's drainage system be kept clean and operational. The costs associated with the flushing of the facility's drainage system has been included within our estimated repair and preventative maintenance costs scheduled to be performed in the future as associated with related construction, but the drains should also be cleaned periodically as an operating expense. The costs associated with cleaning and flushing down the deck surfaces as an operational cost is not included within projected repair and preventative maintenance costs.

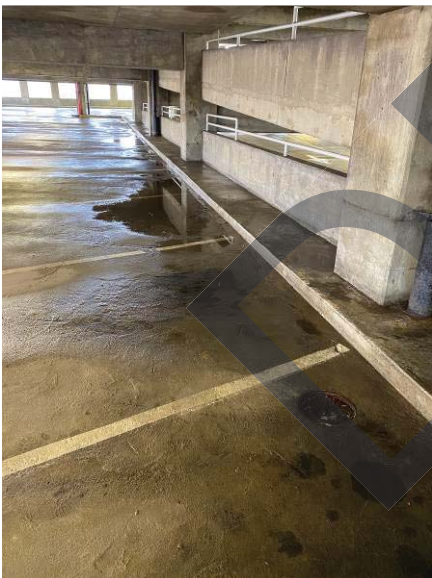
Photo #49

Drainage System Repairs: The floor drains and piping are exhibiting more significant deterioration, the drains more so than the piping but the piping is still showing miscellaneous repair **(Photos #49, #50 & #51)**. DESMAN recommends that a comprehensive replacement program, including various supplemental drains, be planned accordingly.

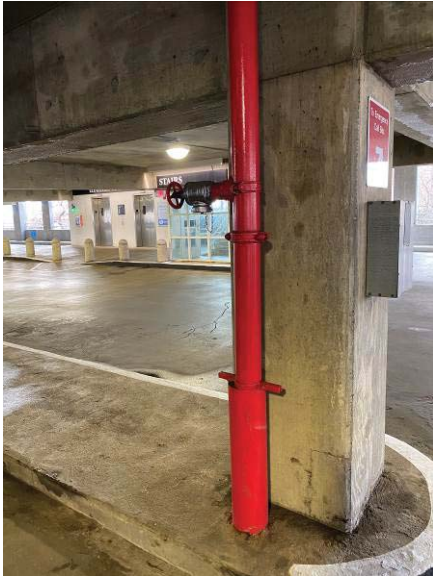
Photo #52

The standpipe system was replaced as part of Project no. 08-016 B (Photo #52).

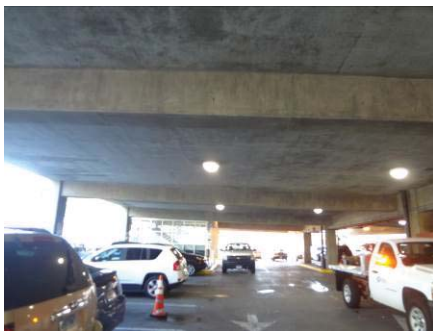
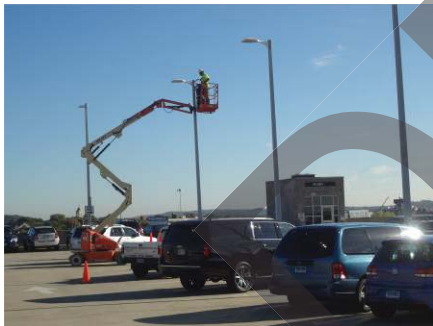
Lighting Fixture Replacement: The garage light fixtures were replaced as part of NHPA Project No. 08-016 C (**Photos #53 & #54**). Many of the facility's existing light fixture lenses became yellowed, and high voltage ballasts were starting to malfunction, indicative of a need to replace all of the facility's lighting fixtures.

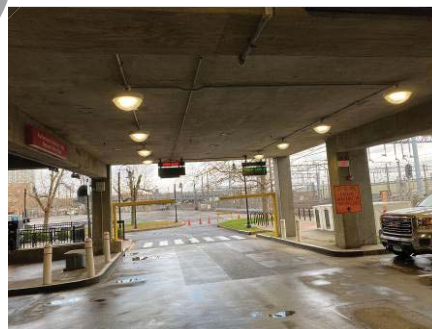
Photo #55

As noted, replacement of the existing light fixtures with new LED fixtures was performed as part of Project no. 08-016 C now complete (**Photos #55 & #56**).

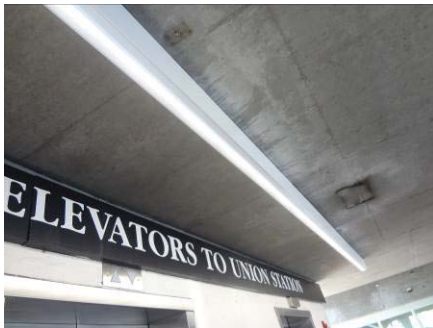
Photo #57

New Elevator Lobby Lighting: The pre-existing fluorescent fixtures serving the elevator landings have now been replaced as part of the lighting replacement project (**Photo #57**).

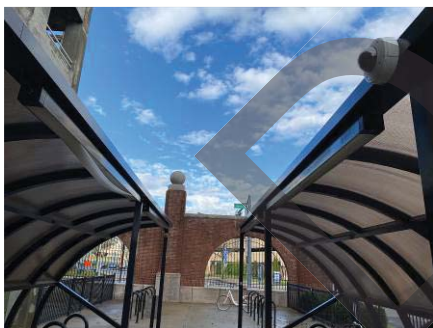
Photo #58

Miscellaneous Electrical Repairs: Several of the light fixture lenses, on the Bike Parking shelters, were observed to be aging and failing (**Photo #58**); DESMAN recommends that the fixtures be replaced, as well as damaged and/or missing exit signage, all as required (**Photos #59 & #60**).

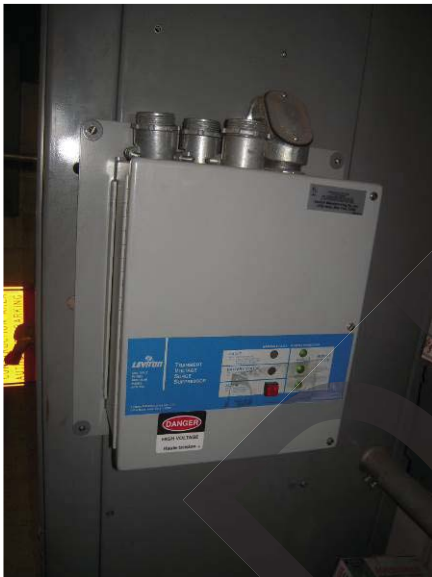
Photo #52

Surge protection: Concern about surge protection for the electrical distribution system had been raised. Such protection can help prevent damage to equipment connected to the system and limit power outages. Protection can be provided at any point in the distribution system and is typically designed based on the level of protection desired at any point. Multiple levels of protection are often implemented with devices installed at the incoming service, at select subpanels and at the sensitive equipment. Additional surge protection was provided as part of NHPA Project No. 15-003B (**Photo #52**).

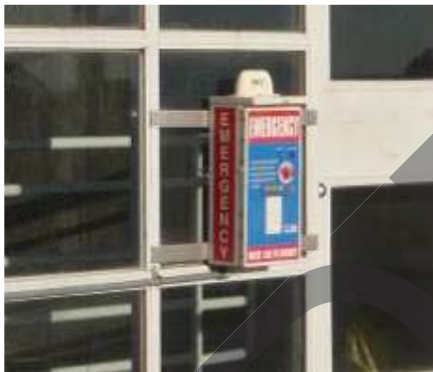
Photo #57

NHPA has requested that DESMAN review the opportunities for enhancing security at the Union Station Garage, including opportunities for video surveillance, access control and audio communication systems (**Photos #57 & #58**); improvements may include a control room and may be coordinated with other facilities.

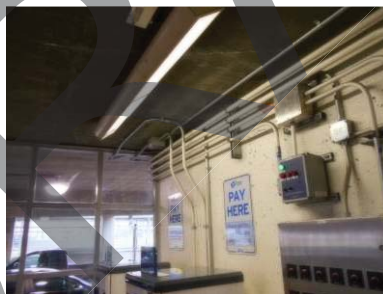
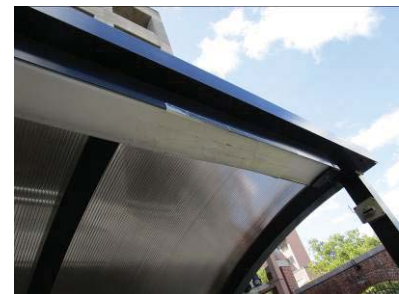
Although the light fixtures throughout the parking garage were recently replaced with new LED fixtures, certain miscellaneous fixtures were not replaced; these include the lights in the bike shelter to the east of the garage, as well as the lights in the paystation kiosk (**Photos #55 & #56**). DESMAN recommends that these fixtures be monitored and replaced when appropriate.

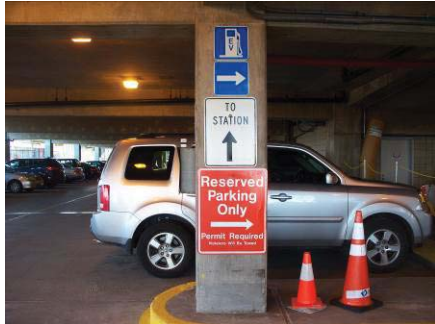
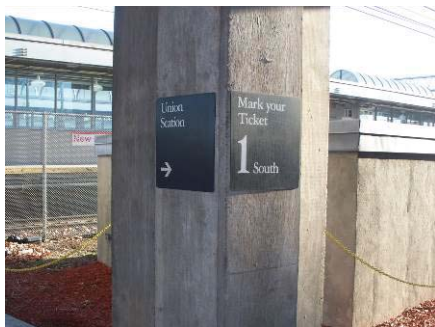
A comprehensive signage replacement program (**Photos #59 & #60**) is part of NHPA Project no. 15-003 D. In conjunction with NHPA’s current branding program, the signage will be updated with new graphic faces to be more in keeping with NHPA's logo and graphic standards. This project was designed but then canceled due to the imminent construction of an adjacent second garage which will impact the signage needs.

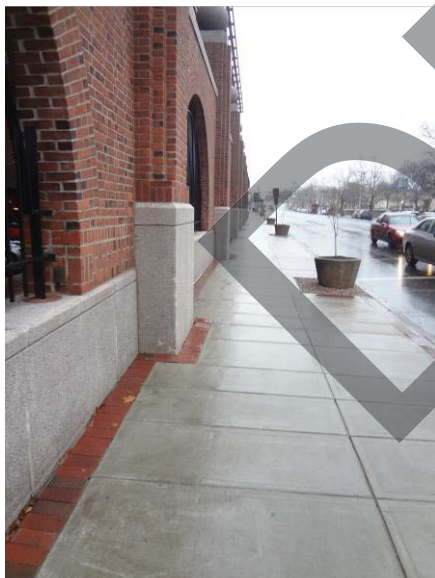
Photo #61

Sidewalk Replacement: NHPA had addressed some miscellaneous sidewalk repair, in front of the decorative masonry wall along Union Avenue, as part of Project No. 08-016B (**Photo #61**). However, the decorative pavers continued to heave and deteriorate, due to freeze-thaw and related contaminants, contributing to failure of the cove joint along the wall, and miscellaneous deterioration of the sidewalk continued. Certain miscellaneous sidewalk repair has now been addressed, as part of Project No. 18-011 B. DESMAN recommends that the sidewalk continue to be monitored for further repairs as may be needed.

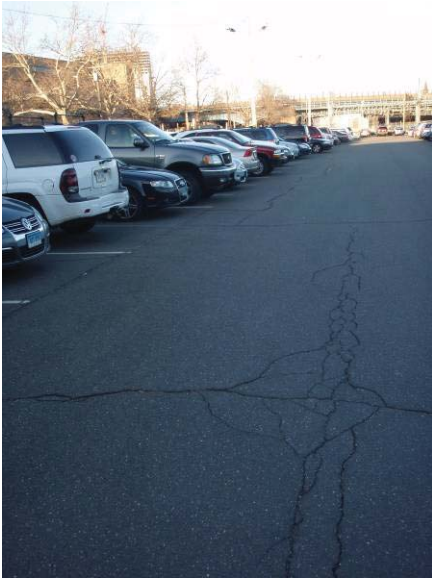
Photo #62

- The condition of the east end parking lot is such that it is recommended that the entire lot be milled down and overlain with 1-1/2" to 2" wearing course (**Photo #62**). Significant settlement exists in certain locations which catches and holds water creating a nuisance to pedestrians and is also detrimental to the ongoing condition of the pavement remaining.

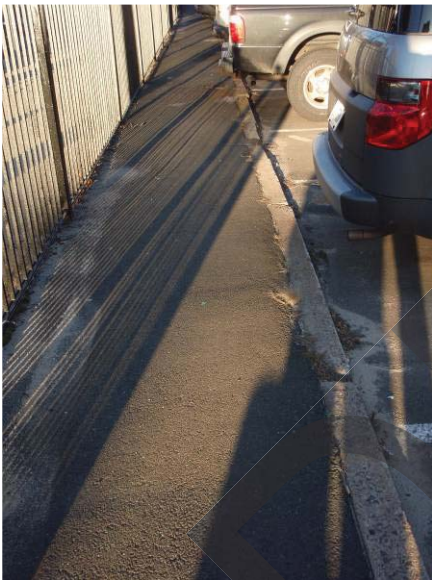
Photo #63

- Several sections of curbing are damaged (**Photo #63**). In the interim, before repairs can be implemented it is suggested that all loose pieces be removed from the site along with all other accumulated debris.

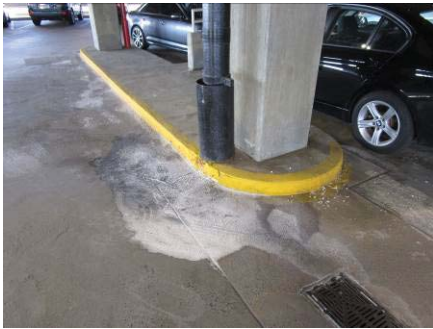
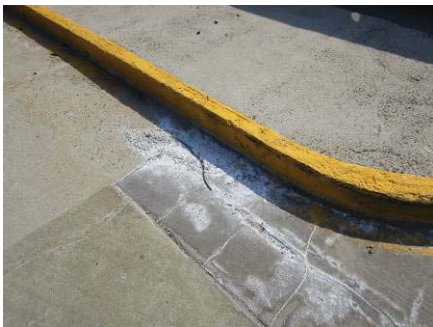
Ice-Melt and Snow Removal: **DESMAN** has regularly observed excessive amounts of ice-melt materials being used (**Photos #64 & #65**). **DESMAN** does understand that winters in New England can be challenging, however we caution any operator to take care when using ice-melt materials in excess. The large size of the aggregate (being driven over and walked upon) in combination with the chemical-makeup of the particles, can be harmful to the concrete structure and metal components of the garage.

DESMAN notes that chloride-based ice-melt products can be detrimental to the long-term durability of the concrete matrix, and **Desman** therefore recommends that an alternative product be used. While **Desman** does not specifically endorse a specific product or manufacturer, **Desman** does suggest that in lieu of a calcium chloride product, an alternative product such as Cryotech NAAC[®], as manufactured by Cryotech Deicing Technology, of Fort Madison, IA (tel: 800-346-7237, www.cryotech.com) be used.

Regardless, **DESMAN** strongly recommends that the facility be cleaned and washed at least twice a year, using the washdown system installed for that purpose, typically coinciding with the spring season and fall season, to remove contaminants and specifically remove the excess ice-melt materials (used over the

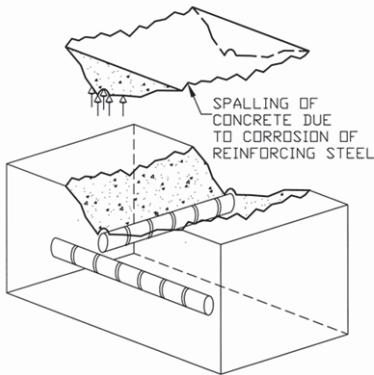
Fig. A

Concrete is a porous material, susceptible to water penetration which can result in increased potential for deterioration. Corrosion of reinforcing steel is an electrochemical process accelerated by the presence of water acting as an electrolyte. In addition, water penetrating into concrete (*Fig. A*) can carry water-soluble chlorides (de-icing salts) to the reinforcing. The combination of chlorides and water further accelerates this corrosion process.

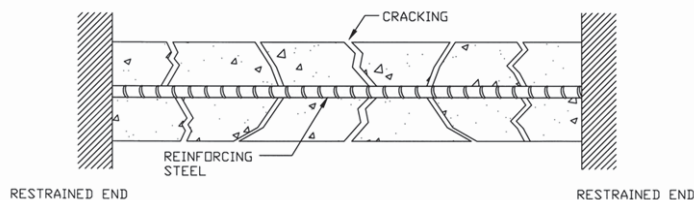
Fig. D

Volume changes due to thermal movement, shrinkage, creep, and loading can also contribute to the deterioration of reinforced concrete. These volume changes will produce stress in restrained members, often resulting in cracking of the member (Fig. D). These cracks also provide access to water and other deterioration mechanisms to attack the member.
