Docket No. 272 – Development and Management Plan Inspection

Underground Line Watercourse and Railroad Crossings

Date: November 28, 2007

Location: Crossings of Watercourses and Railroads in Segments 3, 4a and 4b

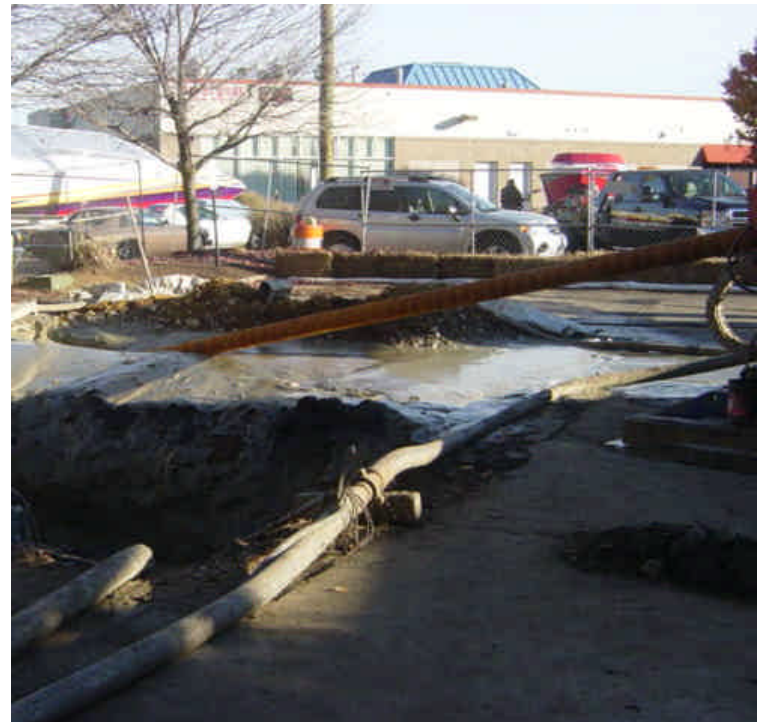
HDD is underway on the west side of the Housatonic River. The drilling pit appears to be adequately sized, but has been located several feet from where the drill string is actually entering the ground. Slurry material is not being aimed directly into the drilling pit and is flowing over the paved area. Perimeter controls are in place around the staging area, but slurry material should be better contained to minimize unnecessary impacts.
