Docket No. 272 – Development and Management Plan Inspection

Underground Line Watercourse and Railroad Crossings

Date: February 7, 2008

Location: Crossings of Watercourses and Railroads in Segments 3, 4a and 4b

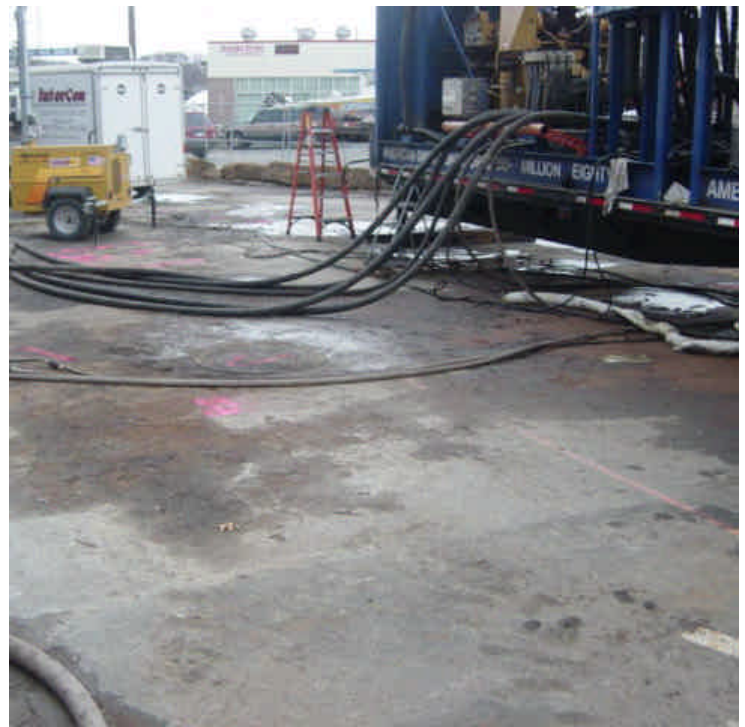
A spill/leak was observed near the generator trailer. Absorbent material appeared to be spread over most portions of the spill and absorbent booms were also utilized. Isolate the source of the spill/leak and provide containment and repair.
