Docket No. 272 – Development and Management Plan Inspection

Underground Line Watercourse and Railroad Crossings

Date: February 14, 2008

Location: Crossings of Watercourses and Railroads in Segments 3, 4a and 4b

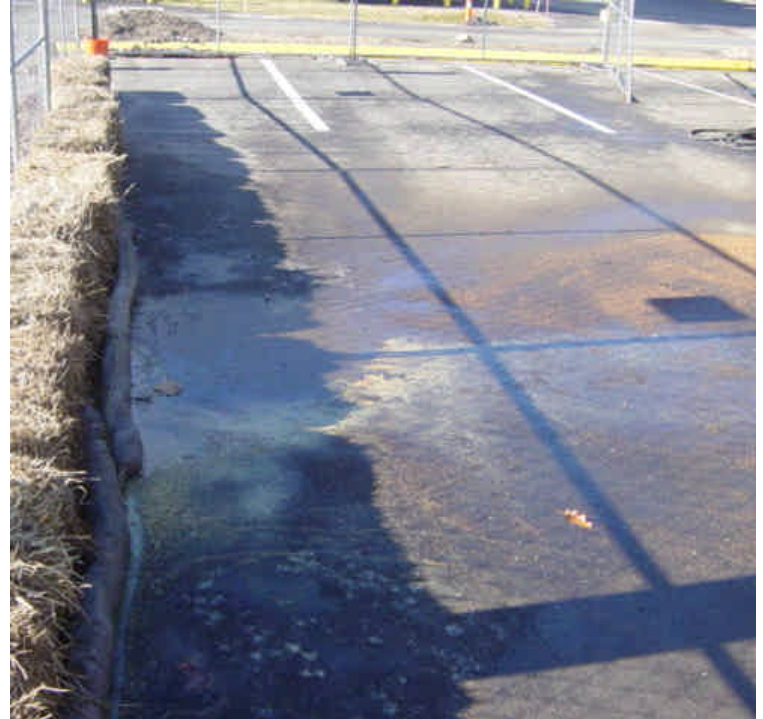
The spill/leak that has been observed for the last two weeks near the generator trailer is worsening. Absorbent material remains spread over some portions of the spill and absorbent booms were in use. However, material continues to leak and a small pool of yellow liquid was observed adjacent to the hay bale barrier. Repair the leaking machinery ASAP and provide additional containment and clean-up.
