Docket No. 272 – Development and Management Plan Inspection

Underground Line Watercourse and Railroad Crossings

Date: March 6, 2008

Location: Crossings of Watercourses and Railroads in Segments 3, 4a and 4b

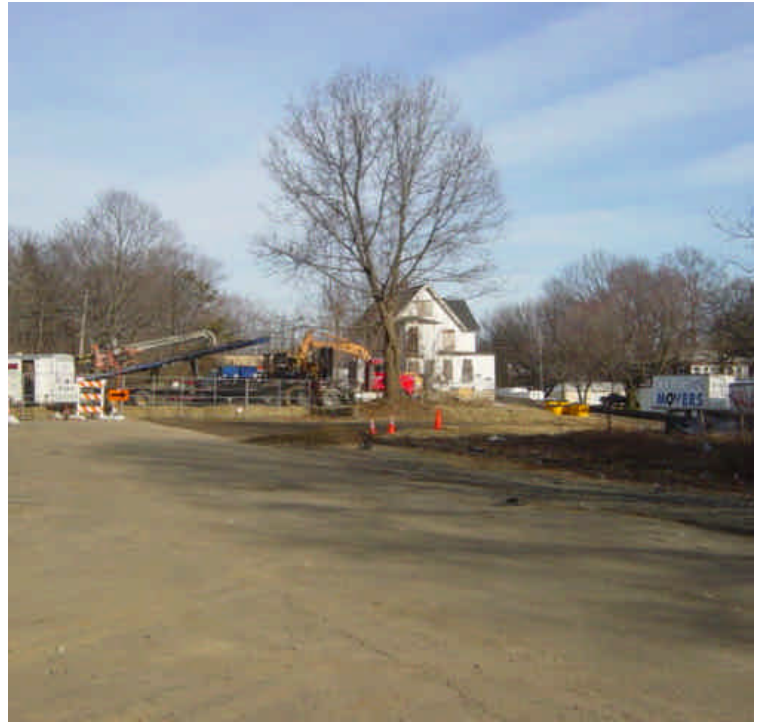
A staging area has been set-up on the south side of the Metro North R.R. in Milford. The staging area has been surrounded by haybales and a filter boom. A temporary access drive has been cut to provide access to the boat launch area. Drilling equipment is being set-up including a bentonite reclamation machine under the I-95 overpass.
