Docket No. 272 – Development and Management Plan Inspection

Underground Line Watercourse and Railroad Crossings

Date: April 10, 2008

Location: Crossings of Watercourses and Railroads in Segments 3, 4a and 4b

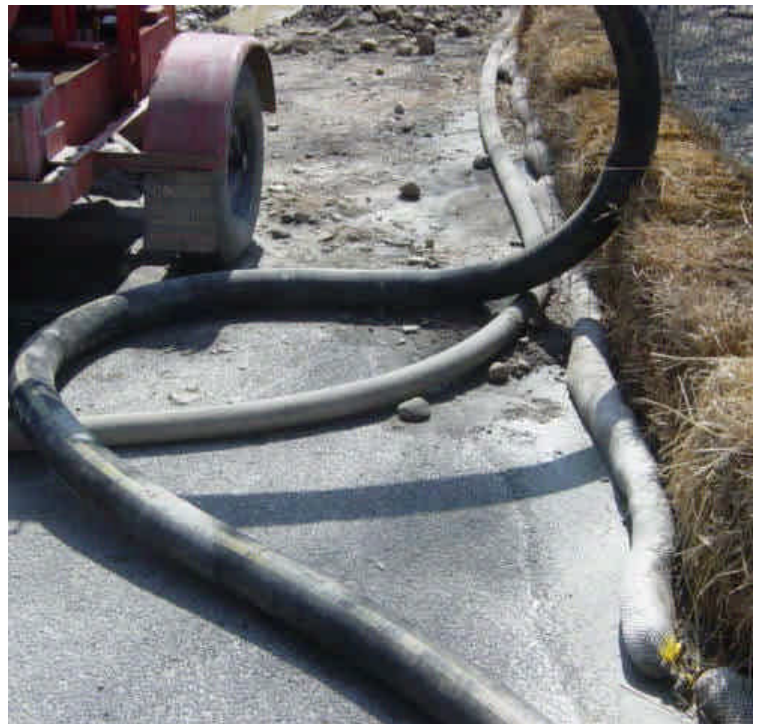
Conduit has been pulled through the first of two borings at the Metro North Railroad Crossing in Milford. A minor amount of slurry material was observed near the perimeter of the staging area, but it was being adequately contained by a haybale barrier.
