**Written and Photographic Documentation
of the
Hopmeadow Street Tobacco Sheds
1503 Hopmeadow Street
Simsbury, Connecticut**

**GLN Construction Management, Inc.
March 2011**

**Bruce Clouette, Ph.D.
Archaeological and Historical Services, Inc.
Storrs, Connecticut**

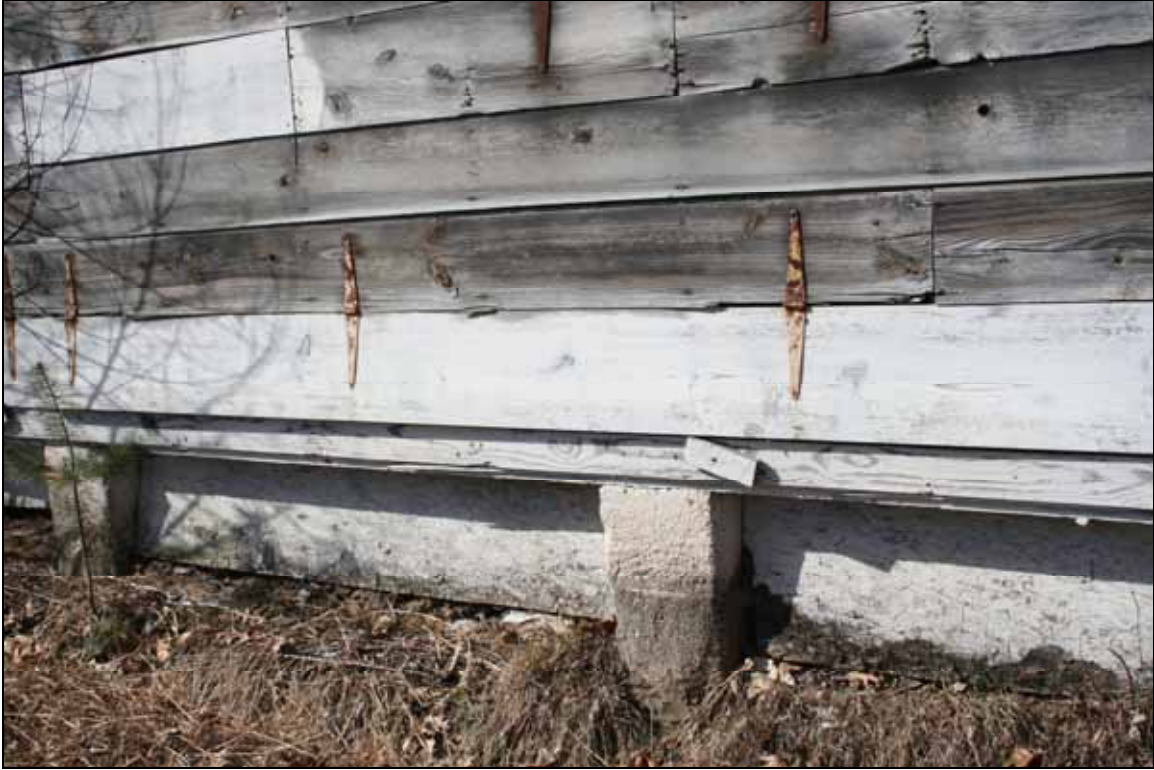
Photograph 34: Detail of eroded concrete foundation pier, showing lower portion, formerly embedded in the ground, exposed (No. 91, southwest corner, east elevation, camera facing northeast).
