THE NUCLEAR ENERGY ADVISORY COUNCIL REPORT

2009

Established Pursuant to Public Act 96-245

December 10, 2009

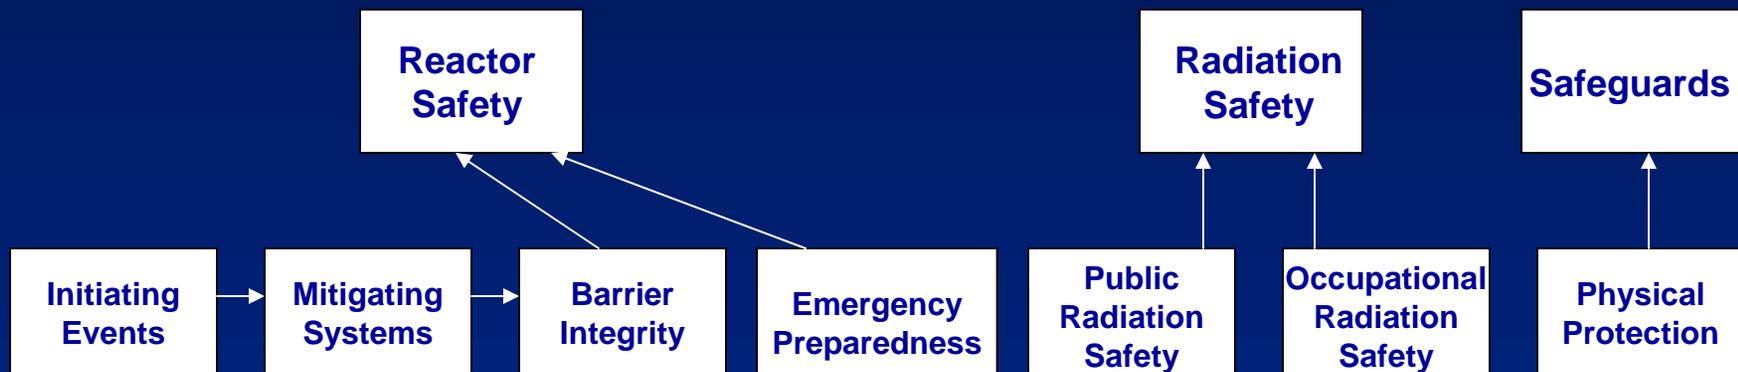
Reactor Oversight Process

3 Strategic Areas & 7 Cornerstones

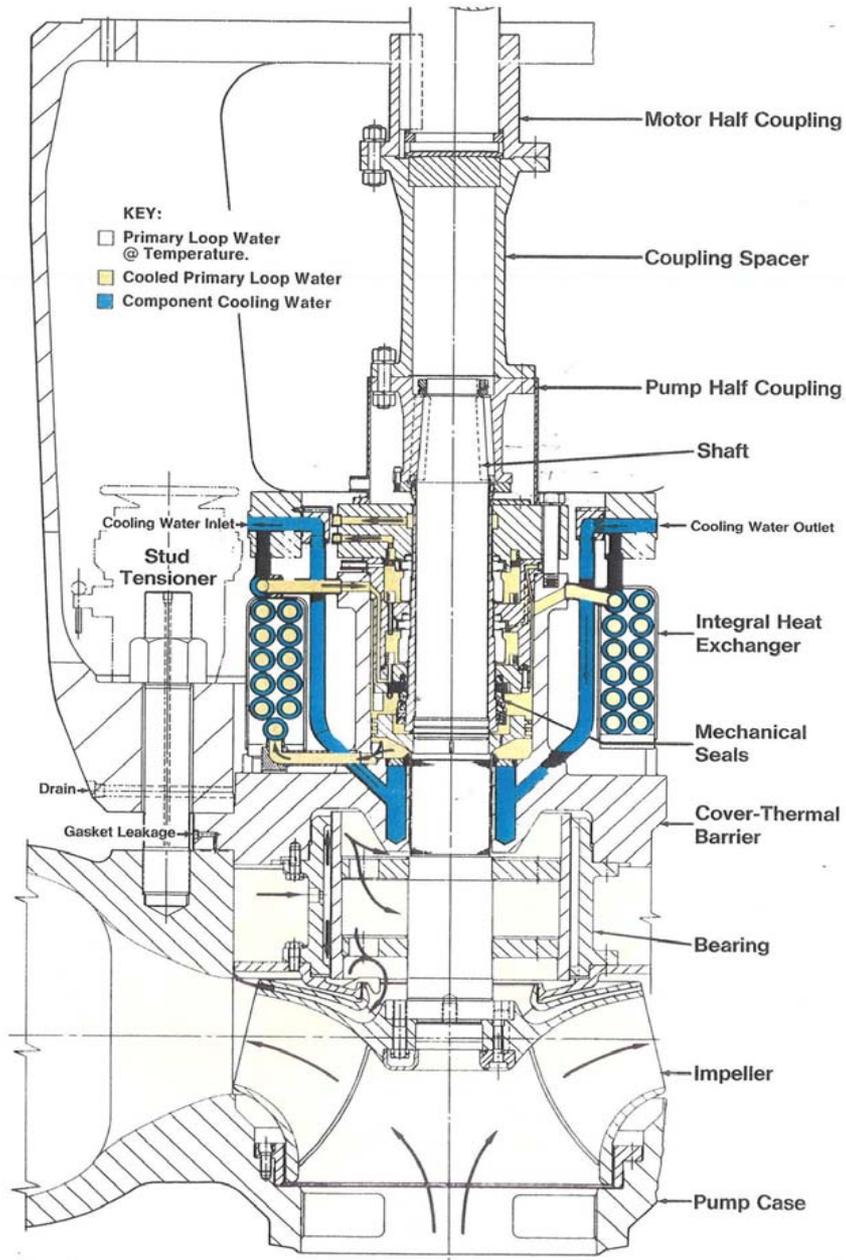
M2 - Challenges to Restart

- RCP Seal Package
 - Repair completed 7/10/09
- RCP Seal Cooler Leak
 - Detected on restart during visual walkdown
 - .01 ± gal/min (very small leak)
 - OEM weld defect
 - Difficulty in performing code repair/inspection
- Enclosure Building Filtration System
 - Demonstrate removal capability prior to release to atmosphere
 - 99% particulates
 - 95% radioactive gases

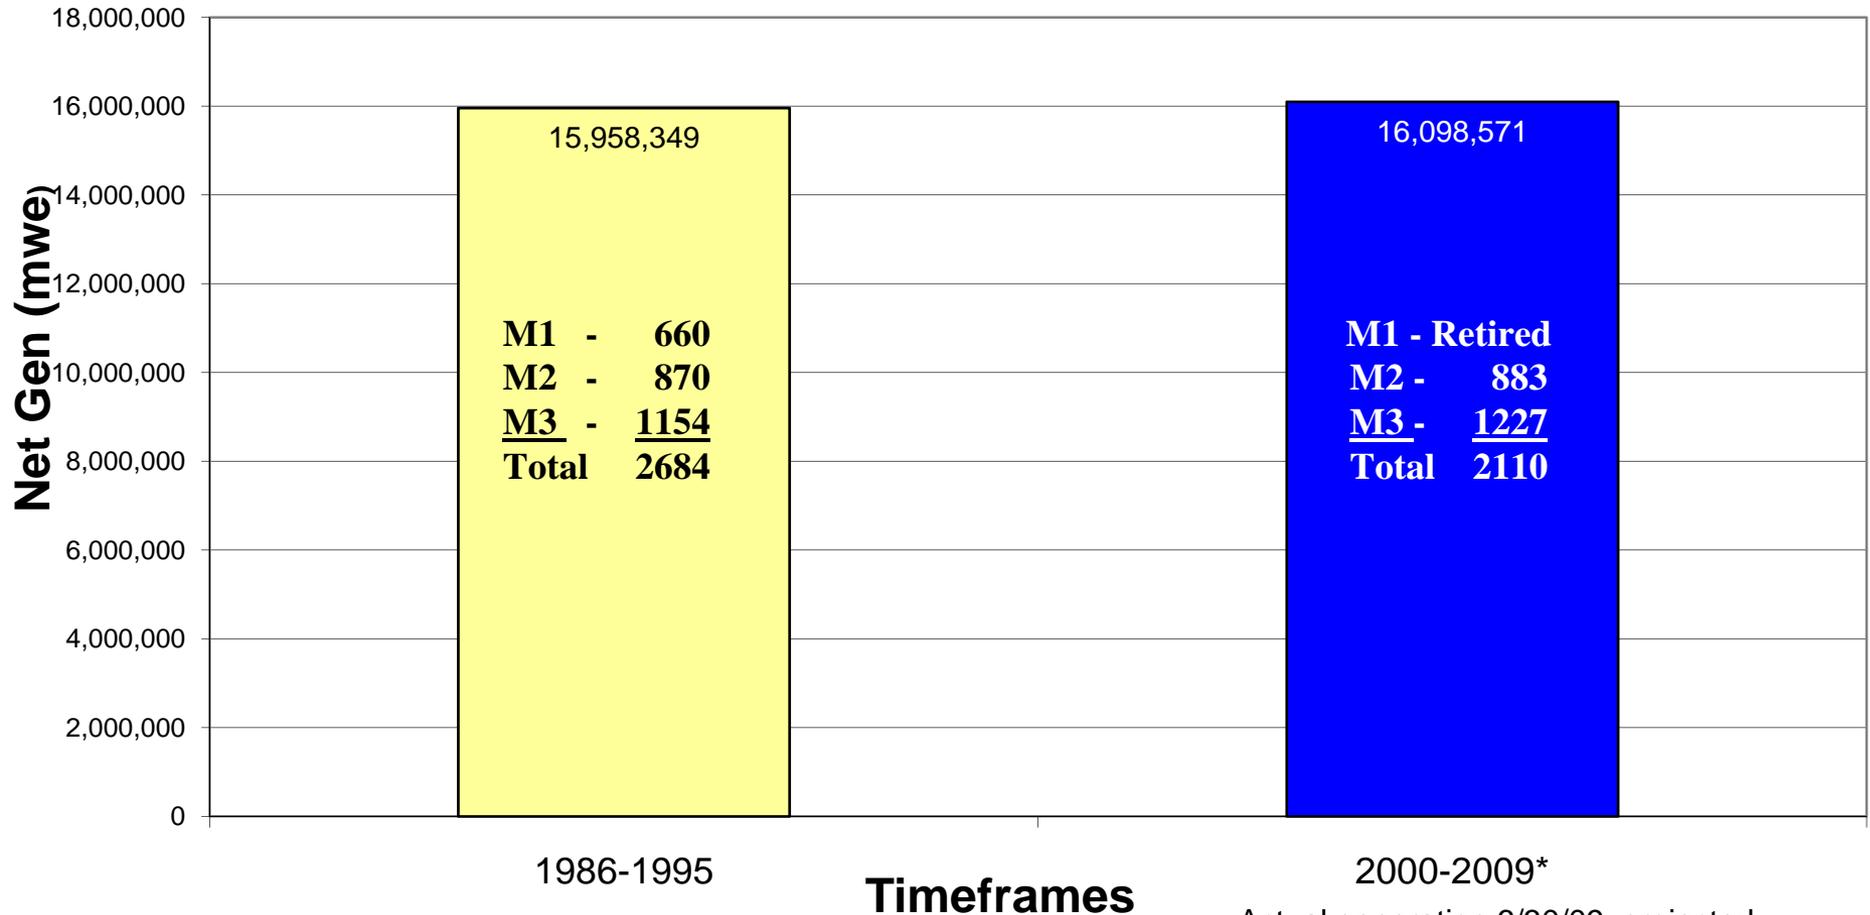
Millstone Station Net Generation Comparison - Average Per Year

Millstone Average Net Generation

Reliability Investments are Working

*Actual generation 6/30/09, projected through 12/31/2009
