# REHABILITATION STUDY REPORT

## BRIDGE NO. 01349

*Route 136 over Saugatuck River*

*Town of Westport*

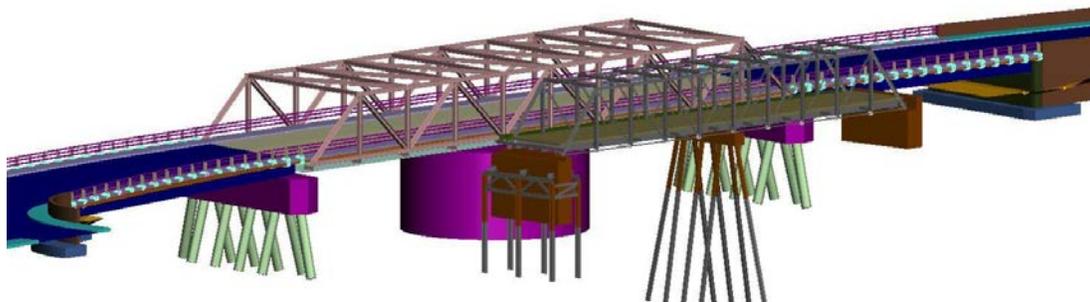
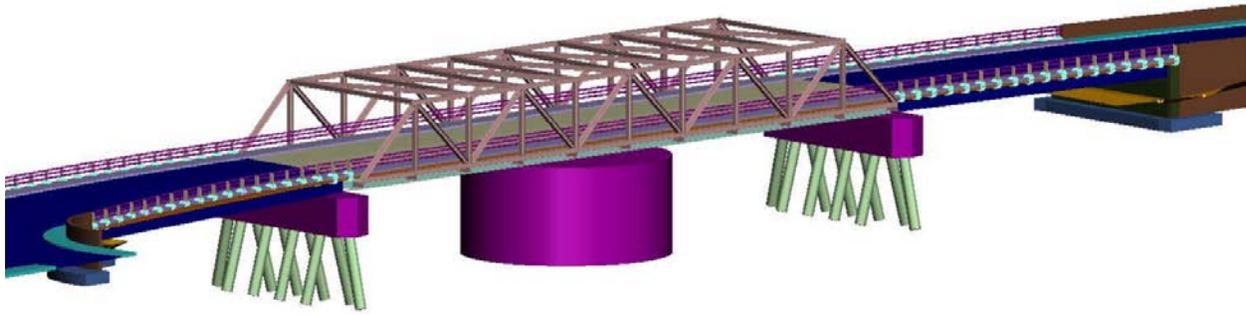
The structure proposed is for comparative purposes only. Should a bridge replacement option be selected, a structure-type study would determine the actual bridge type to be selected and the geometry and lane capacity. For relative location comparison, the structure modeled for this report is depicted below, first with the existing fixed spans shown, followed by a depiction of just the replacement bridge.

Construction of the proposed off-alignment replacement bridge is anticipated to take approximately 2.5 to 3 years, including two winter shutdown periods, and vehicular and pedestrian traffic would be maintained throughout construction on the existing bridge.
