Docket No. 86-12-03

The Reliability and Performance of
The United Illuminating Company's
Transmission and Distribution System for 2008

Annual Report 2009

The United Illuminating Company

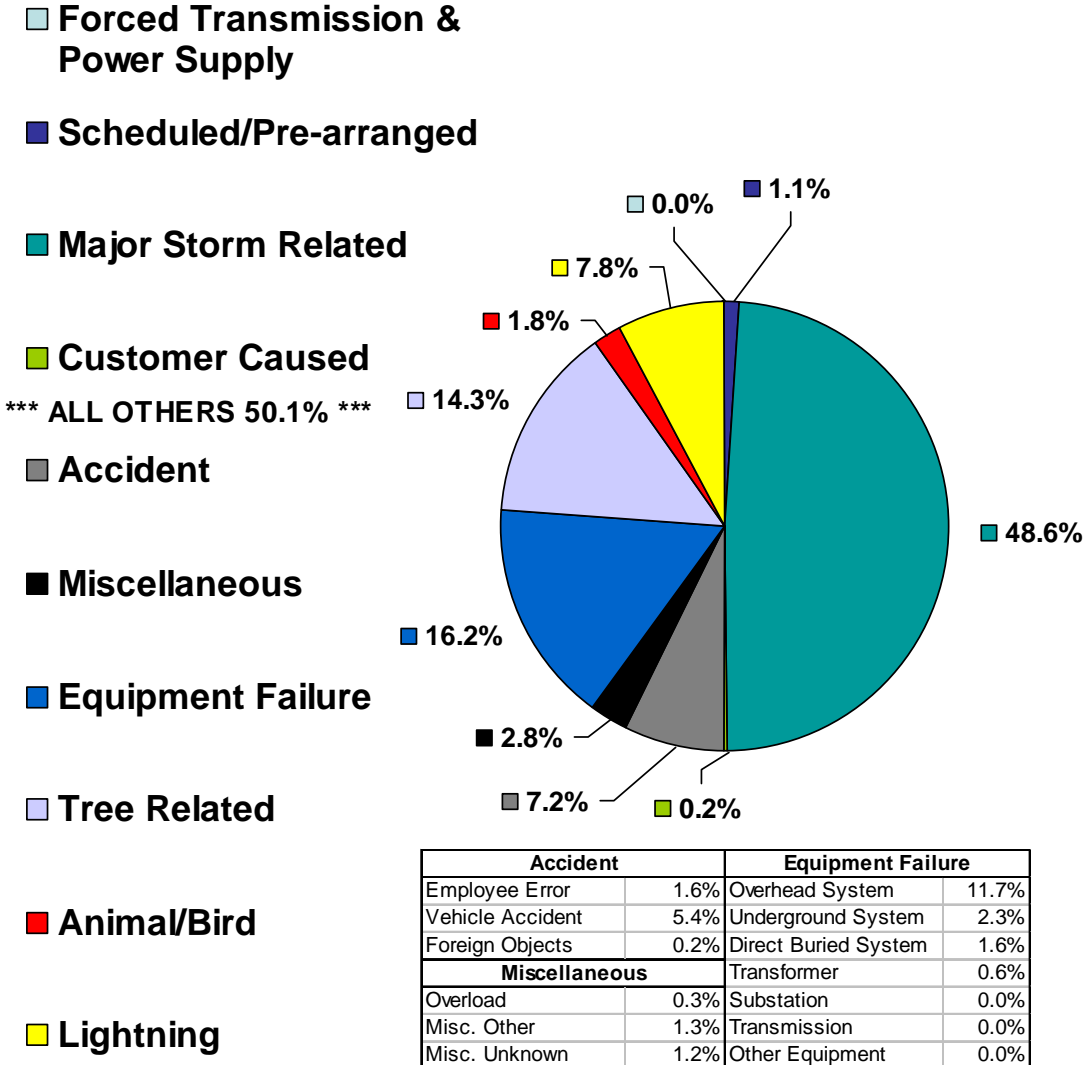
Chart V-3.1 – Causes of Outages by Meter Time Lost (2008)

Cause Of Outages 2008 By Meter Time Lost

Percentage of outages caused by each category can be seen on Charts V-1.1 and 1.2, V-2.1 and 2.2, and V-3.1 and 3.2. As is evident from these charts, the category "All Others," which corresponds to "Distribution System," contains the majority of customer interruptions and lost meters. Lost meter-time can be greatly affected by major storms, but barring a major storm, lost meter-time is affected to the greatest degree by the "Distribution System" category.
