Post-Mod Antenna Mount Analysis Report and PMI Requirements

Mount Fix

Site ID: 469074-VZW / BRANFORD SW CT
Site Name: BRANFORD SW CT
Carrier Name: Verizon Wireless
Address: 850 West Main Street
Branford, Connecticut 06405
New Haven County
Latitude: 41.277792°
Longitude: -72.836878°

Tower Type: Monopole
Mount Type: 14.00-Ft Platform

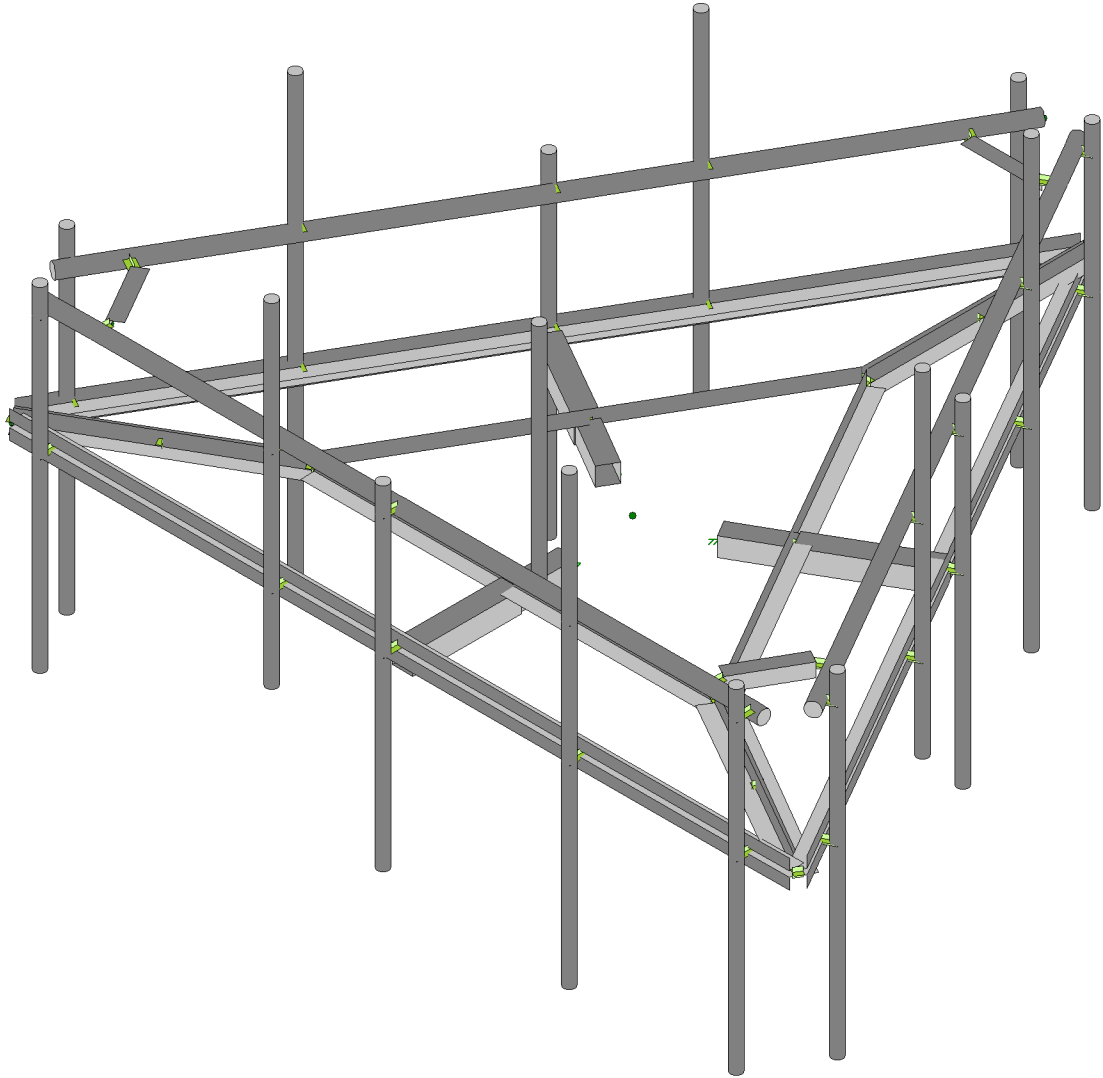
SK - 1

469074-VZW_MT_LO_H

MOD_Loaded_469074-VZW_MT_L...

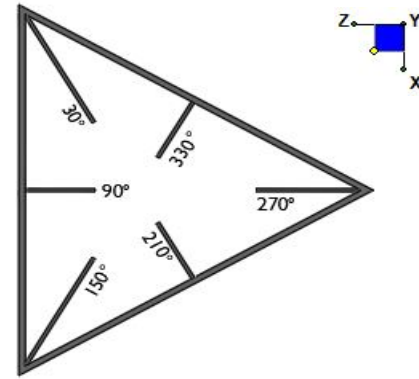
TYPICAL PLATFORM

Nodes (labeled per RISA)	Orientation (per graphic of typical platform)
N7	90
N71	330
N39A	210

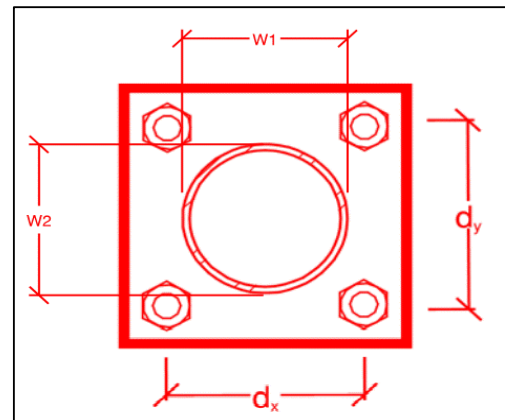
Tower Connection Plate and Weld Check

Weld Capacity:

Rect
4
4
36
4
5.57
3.34
60.0%

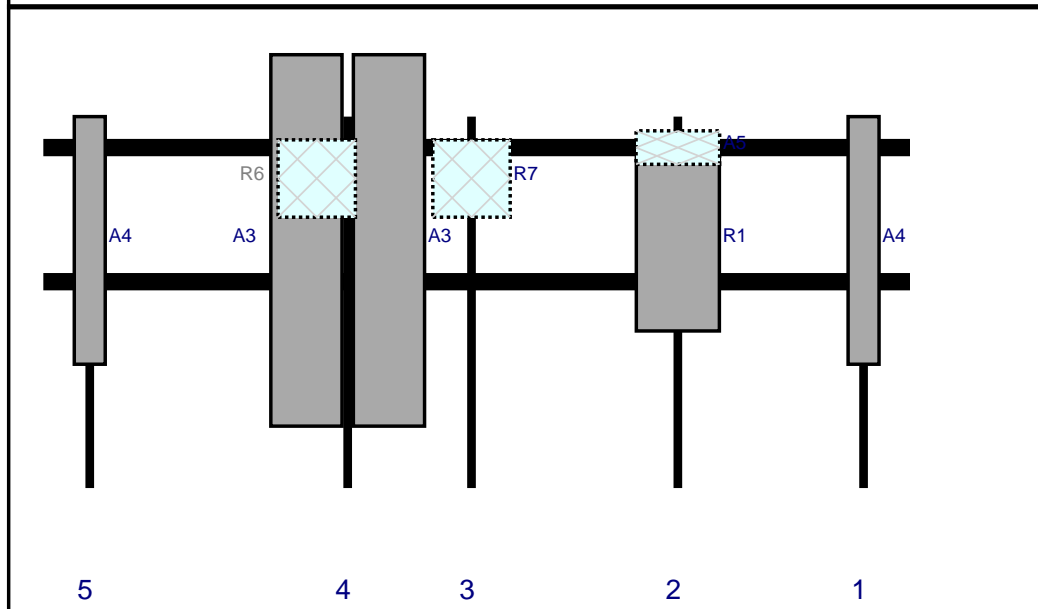
Front View
Looking at Structure

Ref#	Model	Height (in)	Width (in)	H Dist Frm L.	Pipe #	Pipe Pos V	Ant Pos	C. Ant Frm T.	Ant H Off	Status	Validation
A4	APL868013 (42327)	48	6	9	5	a	Front	24	0	Retained	02/18/2021
A4	APL868013 (42327)	48	6	159	1	a	Front	24	0	Retained	02/18/2021
R1	MT6407-77A	35.1	16.1	123	2	a	Front	24	0	Added	
A5	FDJ85020Q4-S1	6.5	16.2	123	2	a	Behind	6	0	Retained	02/18/2021
R7	B5/B13 RRH-BRO4C	15	15	83	3	a	Behind	12	0	Retained	02/18/2021
A3	JAHH-65B-R3B	72	13.8	59	4	a	Front	24	8	Retained	02/18/2021
A3	JAHH-65B-R3B	72	13.8	59	4	b	Front	24	-8	Retained	02/18/2021
R6	B2/B66A RRH-BRO49	15	15	59	4	a	Behind	12	-6	Retained	02/18/2021
