**Re: National Environmental Policy Act (NEPA) Statutory Checklist for 6 Beach Road  
West, Old Saybrook, CT**

GEI Consultants, Inc. (GEI), at the request of Eagle Environmental Inc. (Eagle), has completed National Environmental Policy Act (NEPA) requirements associated with the rehabilitation of the above-listed property under the HUD-DR Program. GEI reviewed information specific to the proposed, funded rehabilitation activities associated with the property, and completed a NEPA Statutory Checklist. Based on the information gathered, it appears that this project cannot convert to Exempt because one or more statutes/authorities requires consultation or mitigation. Because the property is within a floodzone and located within the designated coastal zone, Connecticut Department of Energy and Environmental Protection (CTDEEP) program-wide General Permit and local zoning review are required for the project. Complete consultation and lead-based paint and mold mitigation requirements, publish NOI/RROF and obtain Authority to Use Grant Funds (HUD 7015.16) per ss58.70 and 58.71 before drawing down funds.

Figure 1: Site Detail	6
Figure 2: USGS Topographic map	7
Figure 3: FEMA FIRM	8
Figur

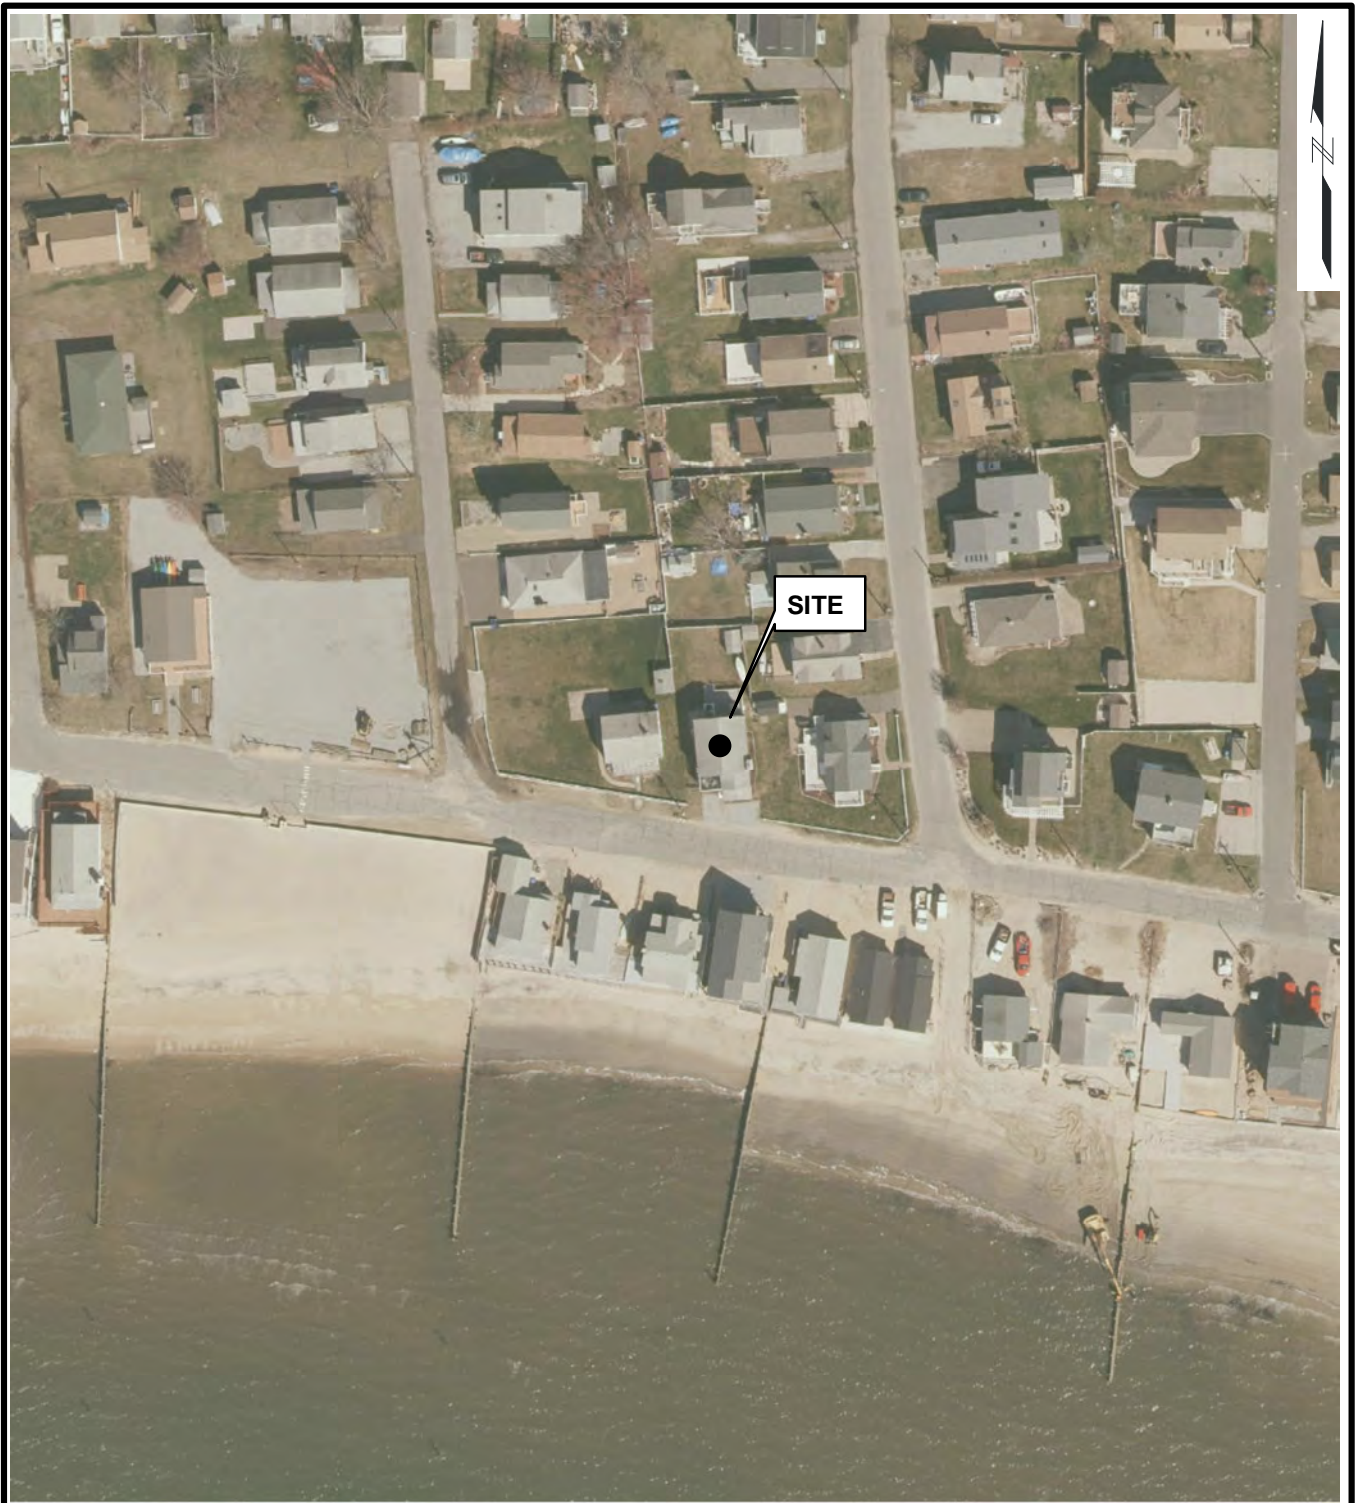
Fig. 1

**SOURCE:**

1. 2016 ESRI WORLD IMAGERY

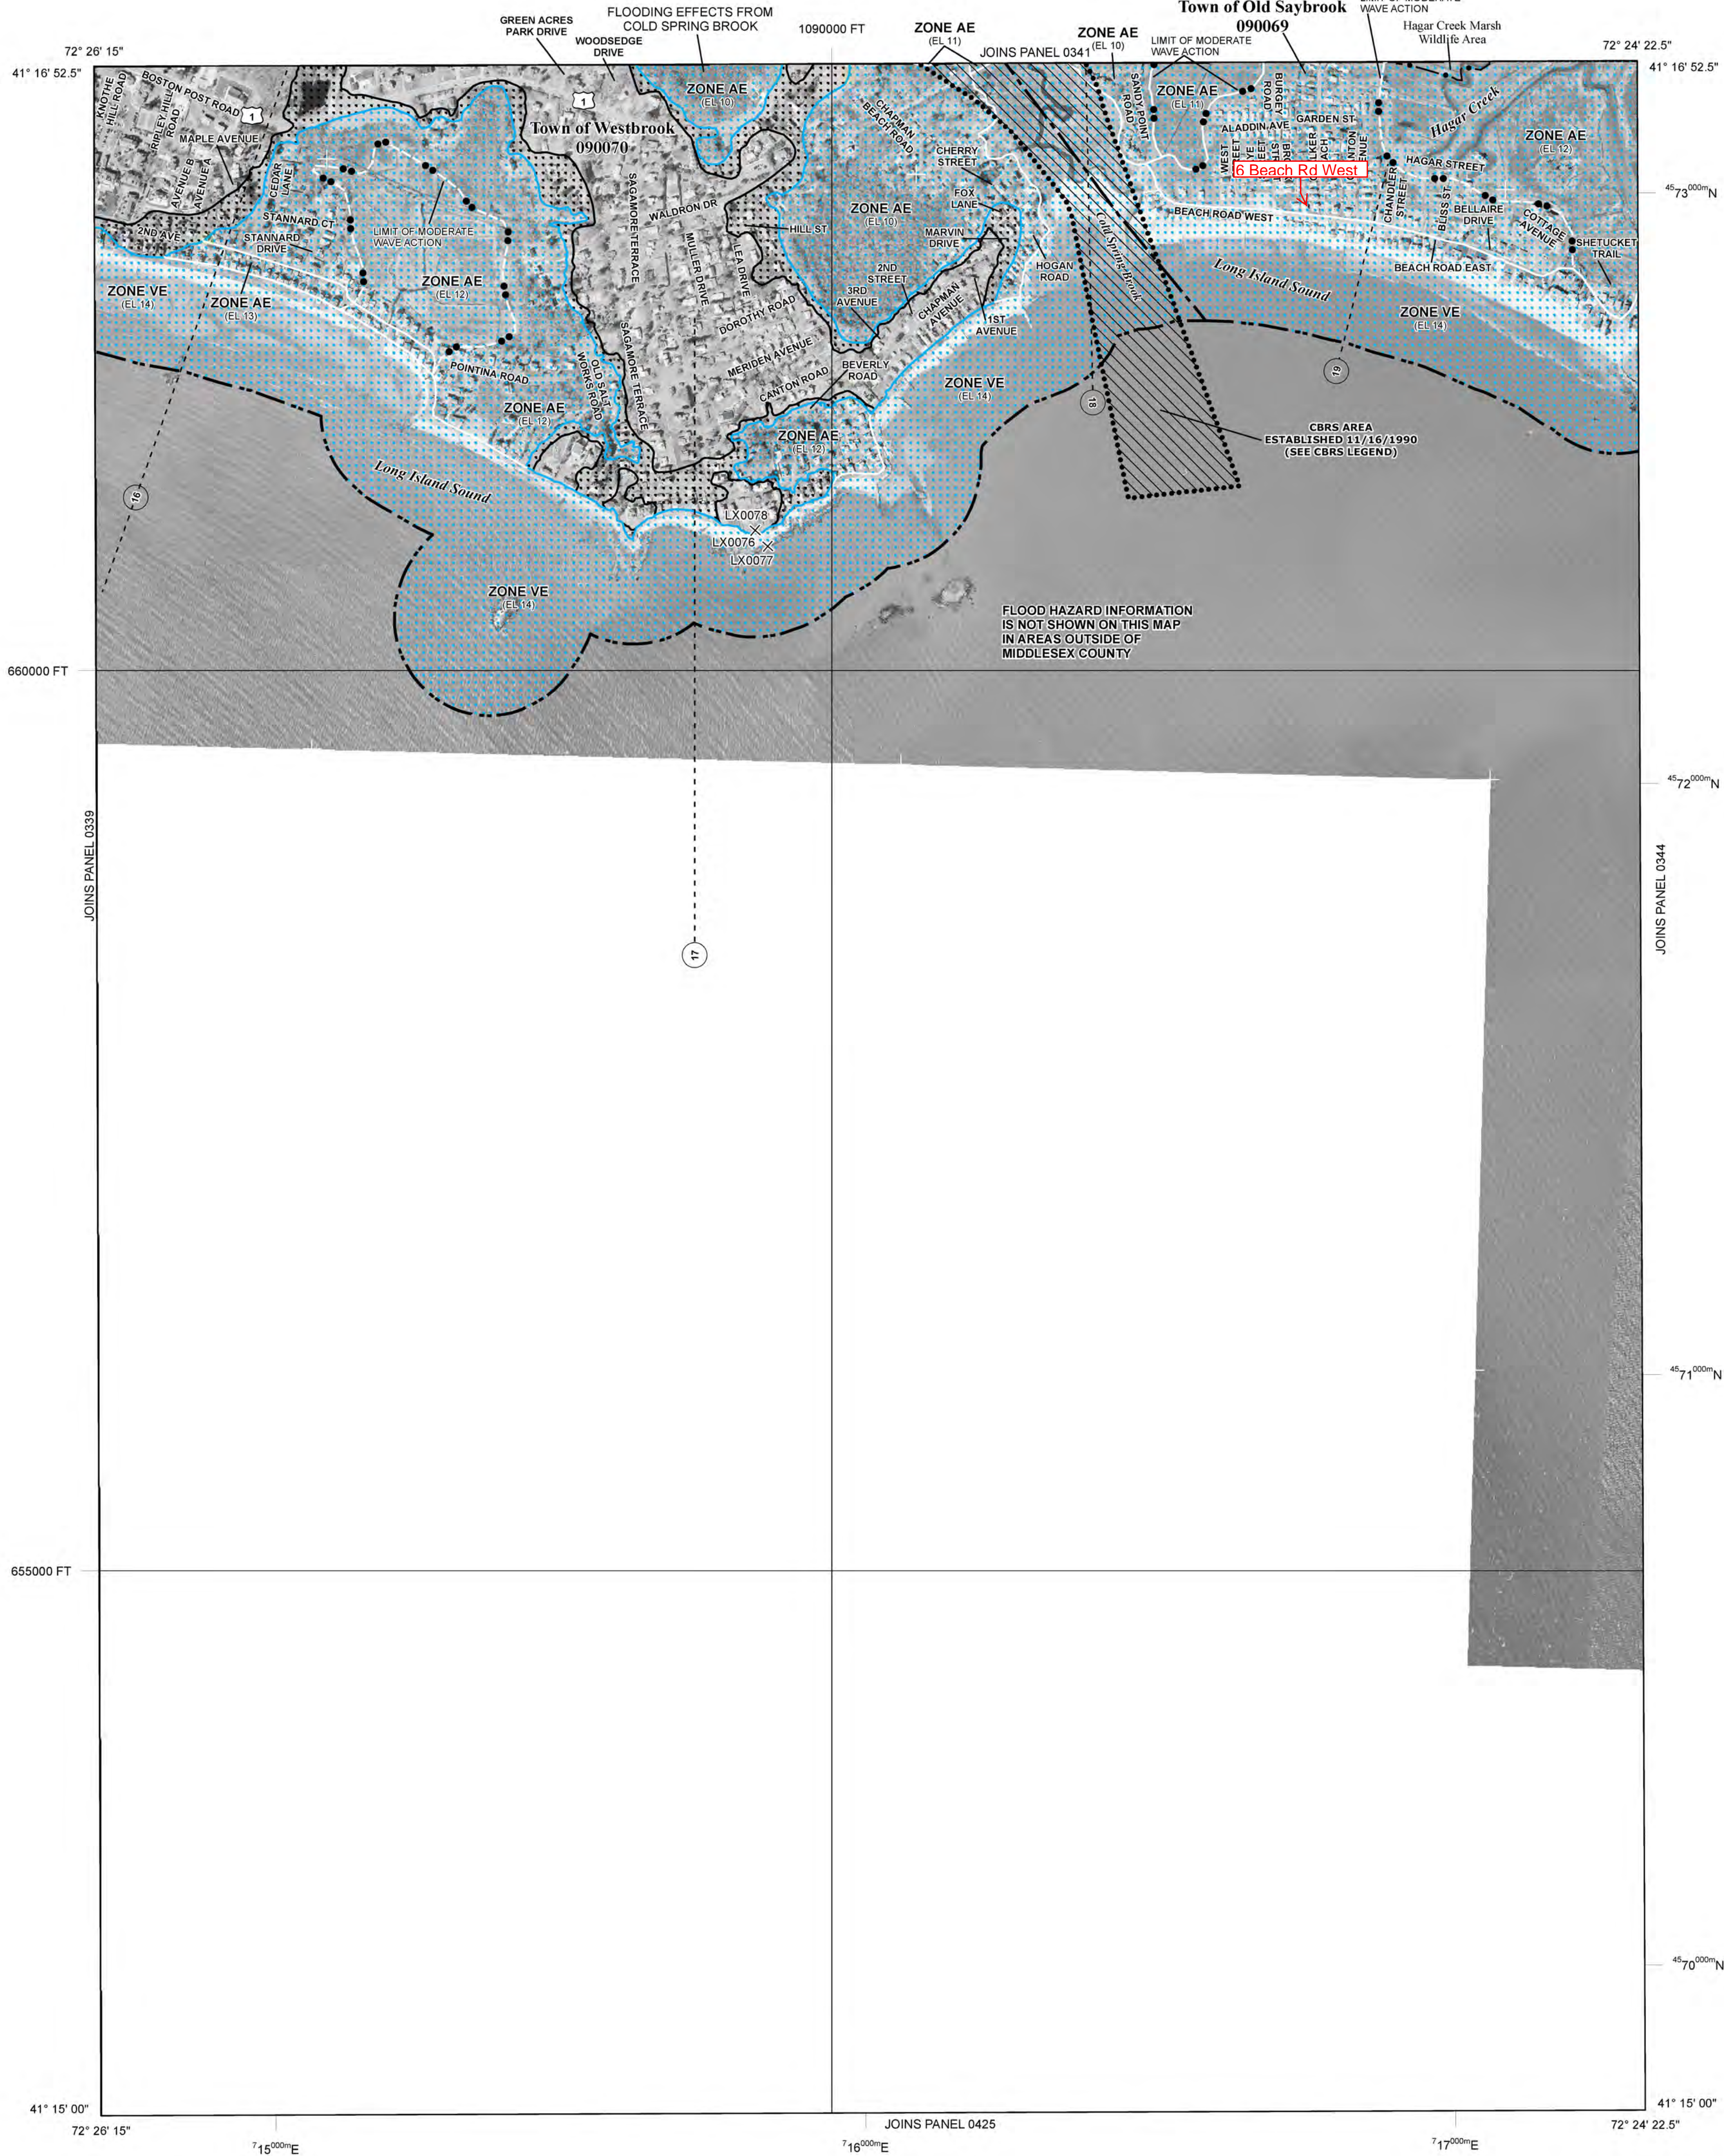
The AE Zone category has been divided by a **Limit of Moderate Wave Action (LIMWA)**. The LIMWA represents the approximate landward limit of the 1.5 foot breaking wave. The effects of wave hazards between the VE Zone and the LIMWA (or between the shoreline and the LIMWA for areas where VE Zones are not identified) will be similar to, but less severe than those in the VE Zone.

**11-16-1990 CBRS Area**  
FLOOD INSURANCE NOT AVAILABLE FOR STRUCTURES NEWLY BUILT OR SUBSTANTIALLY IMPROVED ON OR AFTER NOVEMBER 16, 1990 IN DESIGNATED CBRS AREAS.

Boundaries of the John H. Chafee Coastal Barrier Resources System (CBRS) shown on this FIRM were transferred from the official CBRS source map(s) for this area and are depicted on this FIRM for informational purposes only. The official CBRS maps are enacted by Congress via the Coastal Barrier Resources Act, as amended, and maintained by the U.S. Fish and Wildlife Service (FWS). The official CBRS maps used to determine whether or not an area is located within the CBRS are available for download at <http://www.fws.gov>. For an official determination of whether or not an area is located within the CBRS, or for any questions regarding the CBRS, please contact the FWS field office for this area at 603-223-2541.

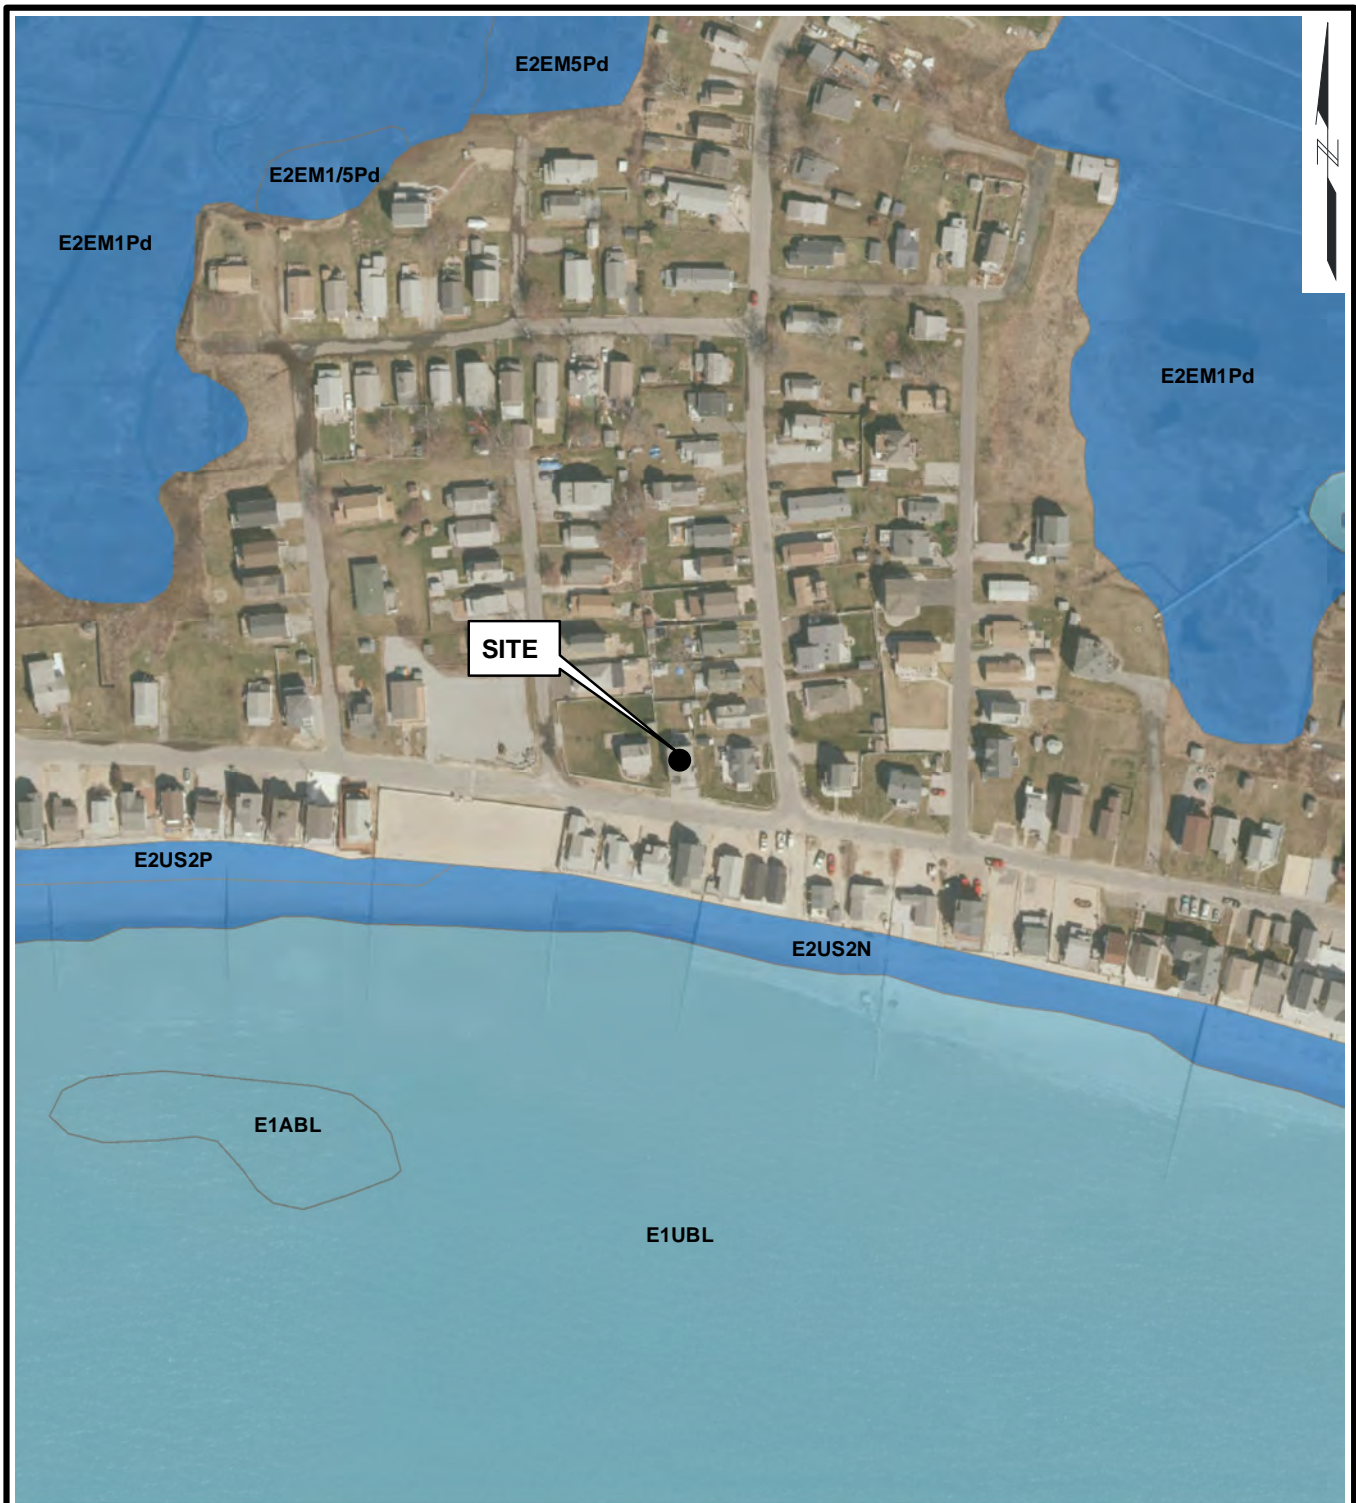
Fig. 4

**SOURCE:**  
 1. 2012 US FISH AND WILDLIFE (USFWS)  
 NATIONAL WETLANDS INVENTORY  
 WWW.FWS.GOV/WETLANDS, ACCESSED JULY  
 2014.

14 D. Local inland wetlands/watercourses [CGS 22a-42]	<input checked="" type="checkbox"/>	<input type="checkbox"/>	<input type="checkbox"/>	<input type="checkbox"/>	<input type="checkbox"/>	<input type="checkbox"/>	No apparent inland wetlands on the project site based review of NWI data (Figure 4) and NRCS soils data (Figure 9). Project rehabilitation work is not expected to impact wetlands/watercourses.
14 E. Various Municipal Zoning Approvals	<input checked="" type="checkbox"/>	<input type="checkbox"/>	<input type="checkbox"/>	<input type="checkbox"/>	<input type="checkbox"/>	<input type="checkbox"/>	No change of use or building expansion that would require zoning approvals noted.
