PRESENTATION OVERVIEW

- Historical
- Selected Catenary & Bridge Replacement

In Connecticut, there are approximately 200 track miles of mainline overhead catenary powering our trains.

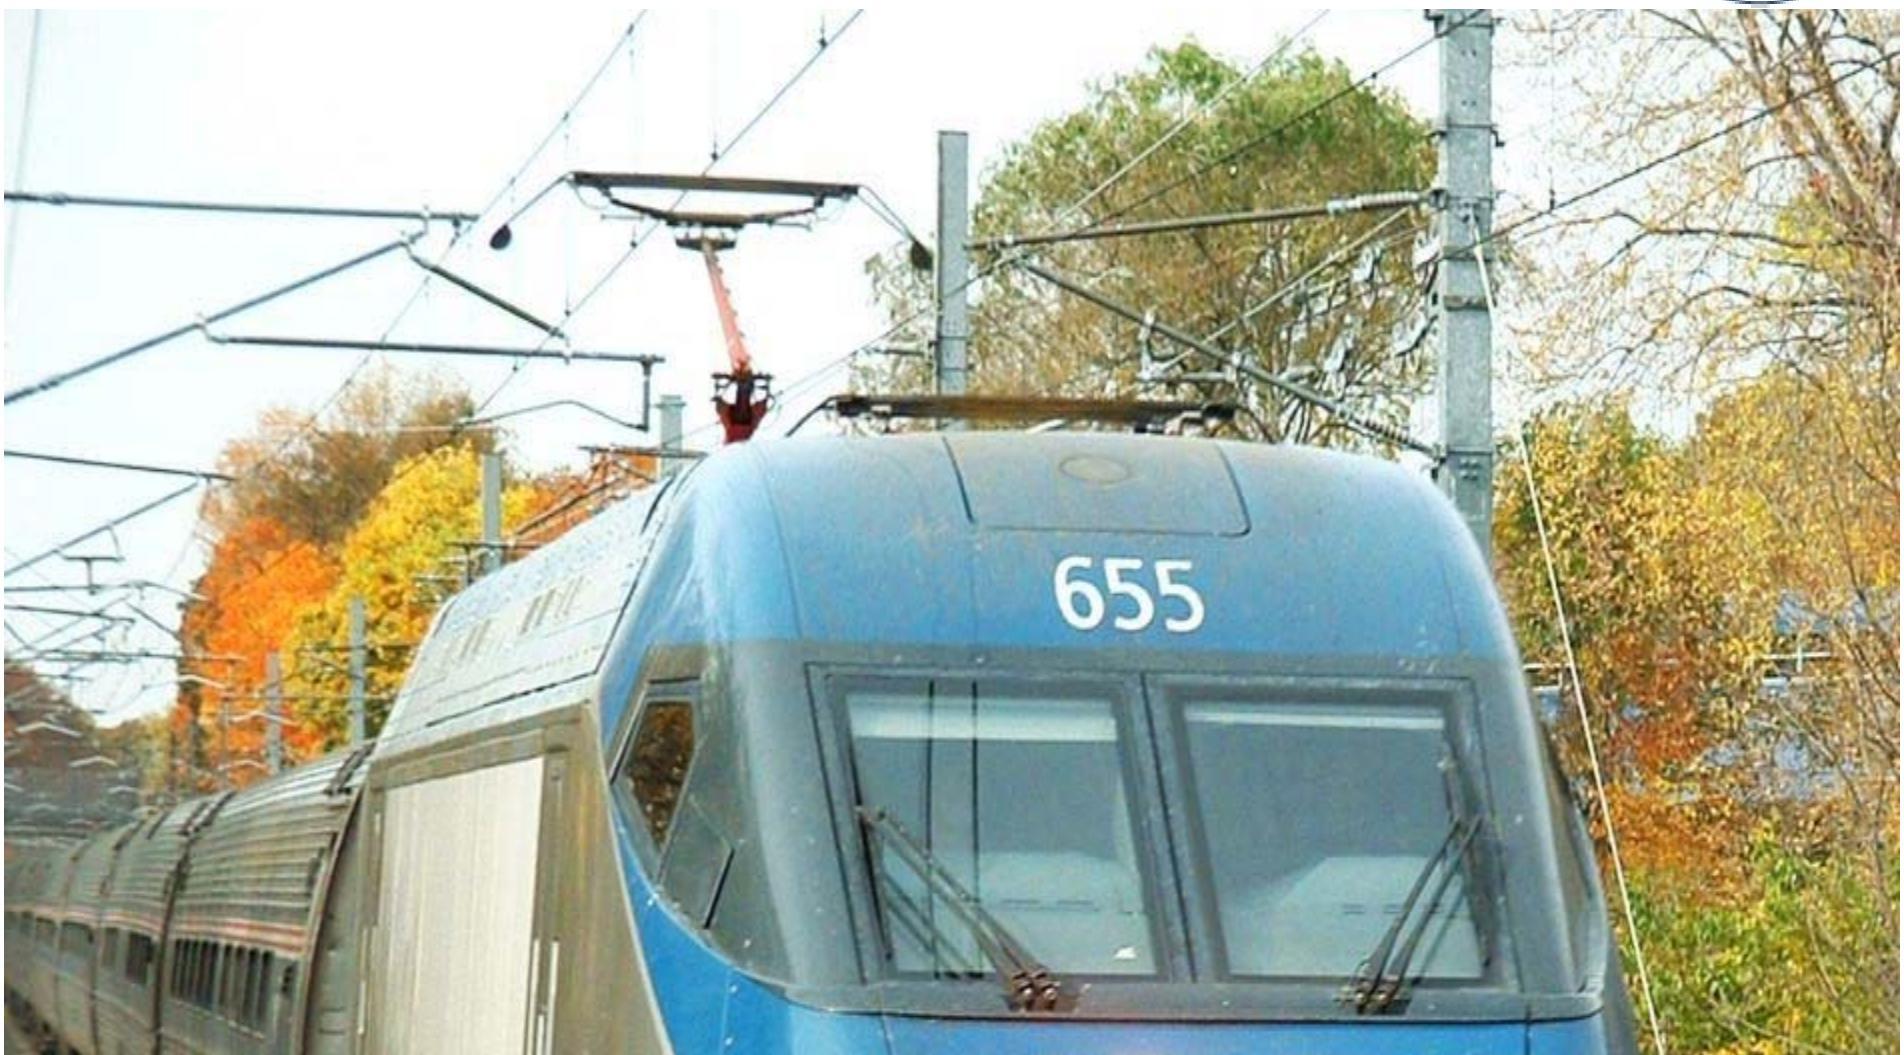
Traction power to propel trains is delivered from overhead wires known as Catenary and transferred through the Pantograph.

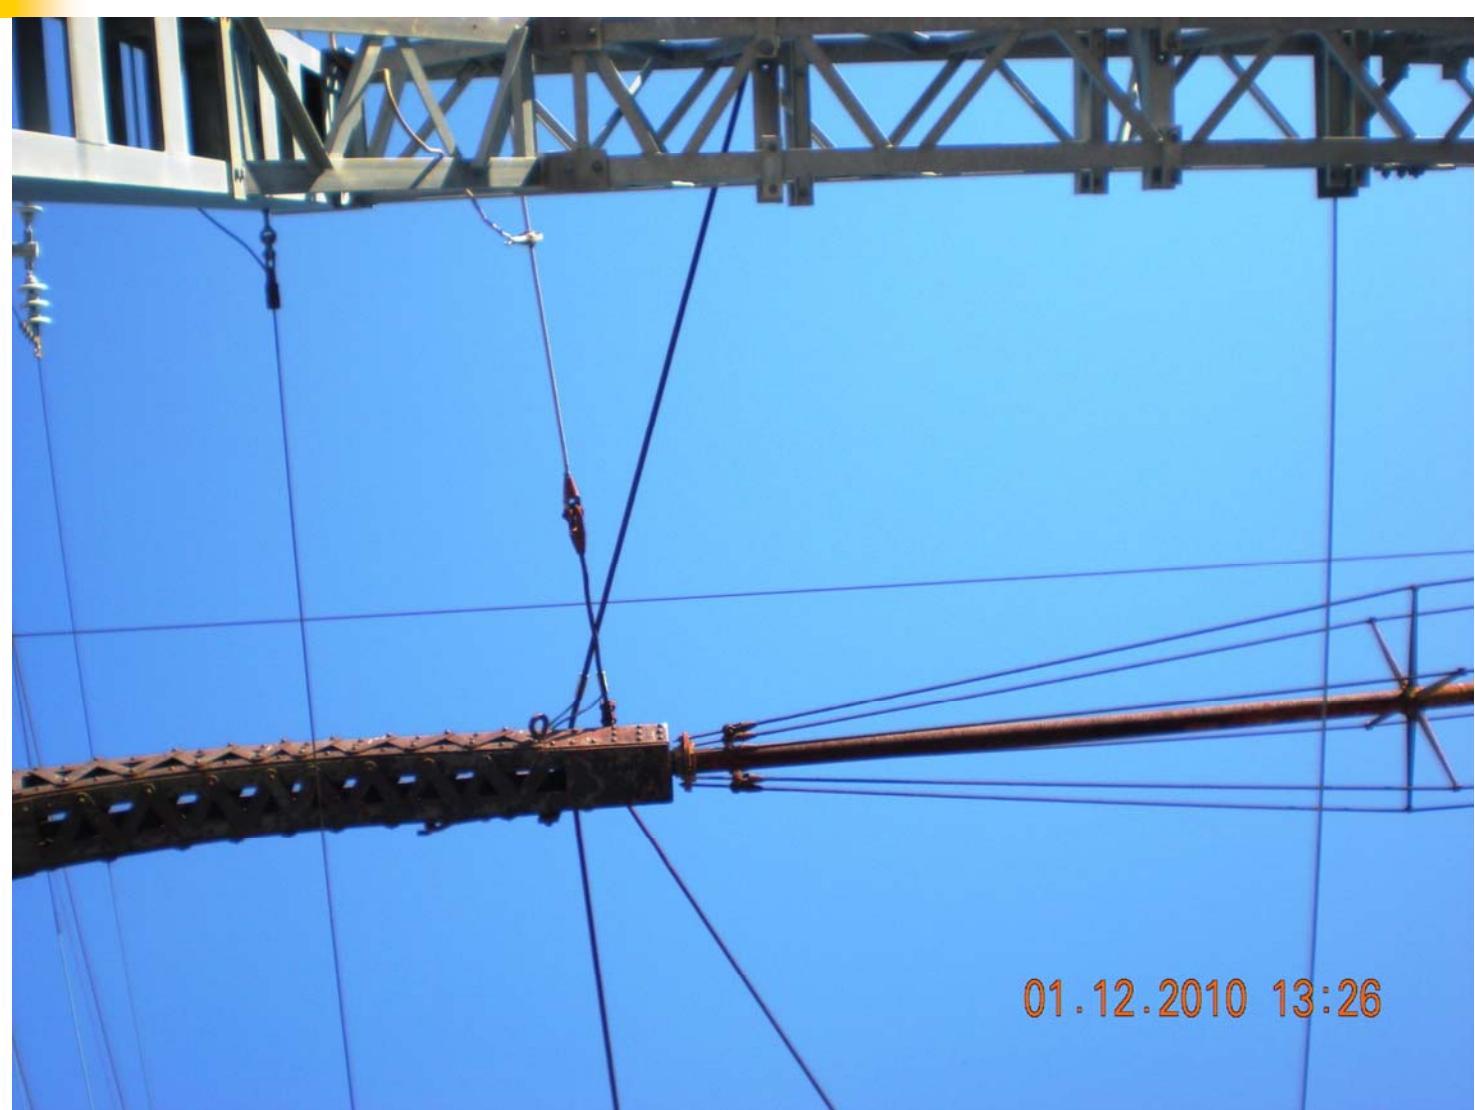
Underside view of "Experimental" type

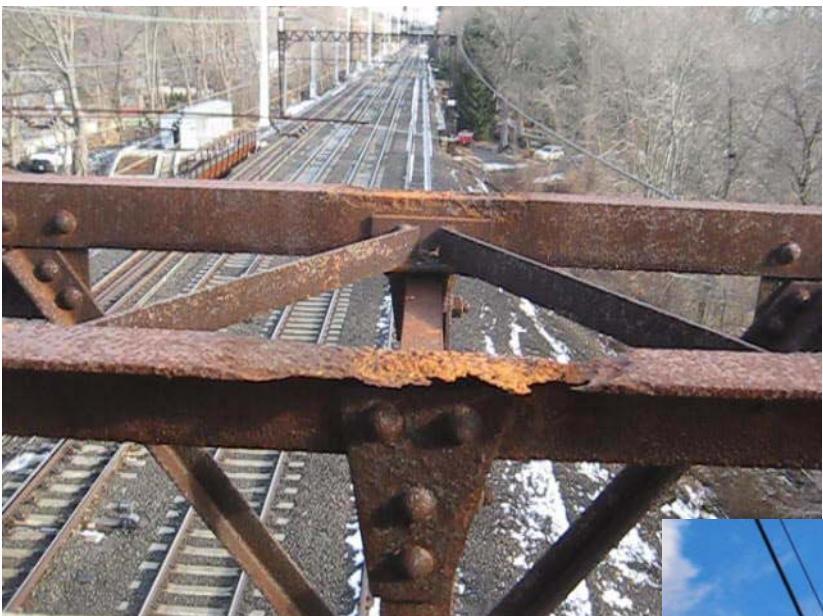
Left – view of deterioration of steel in catenary portal bridge before repair.

Right – view of catenary portal bridge after repair.

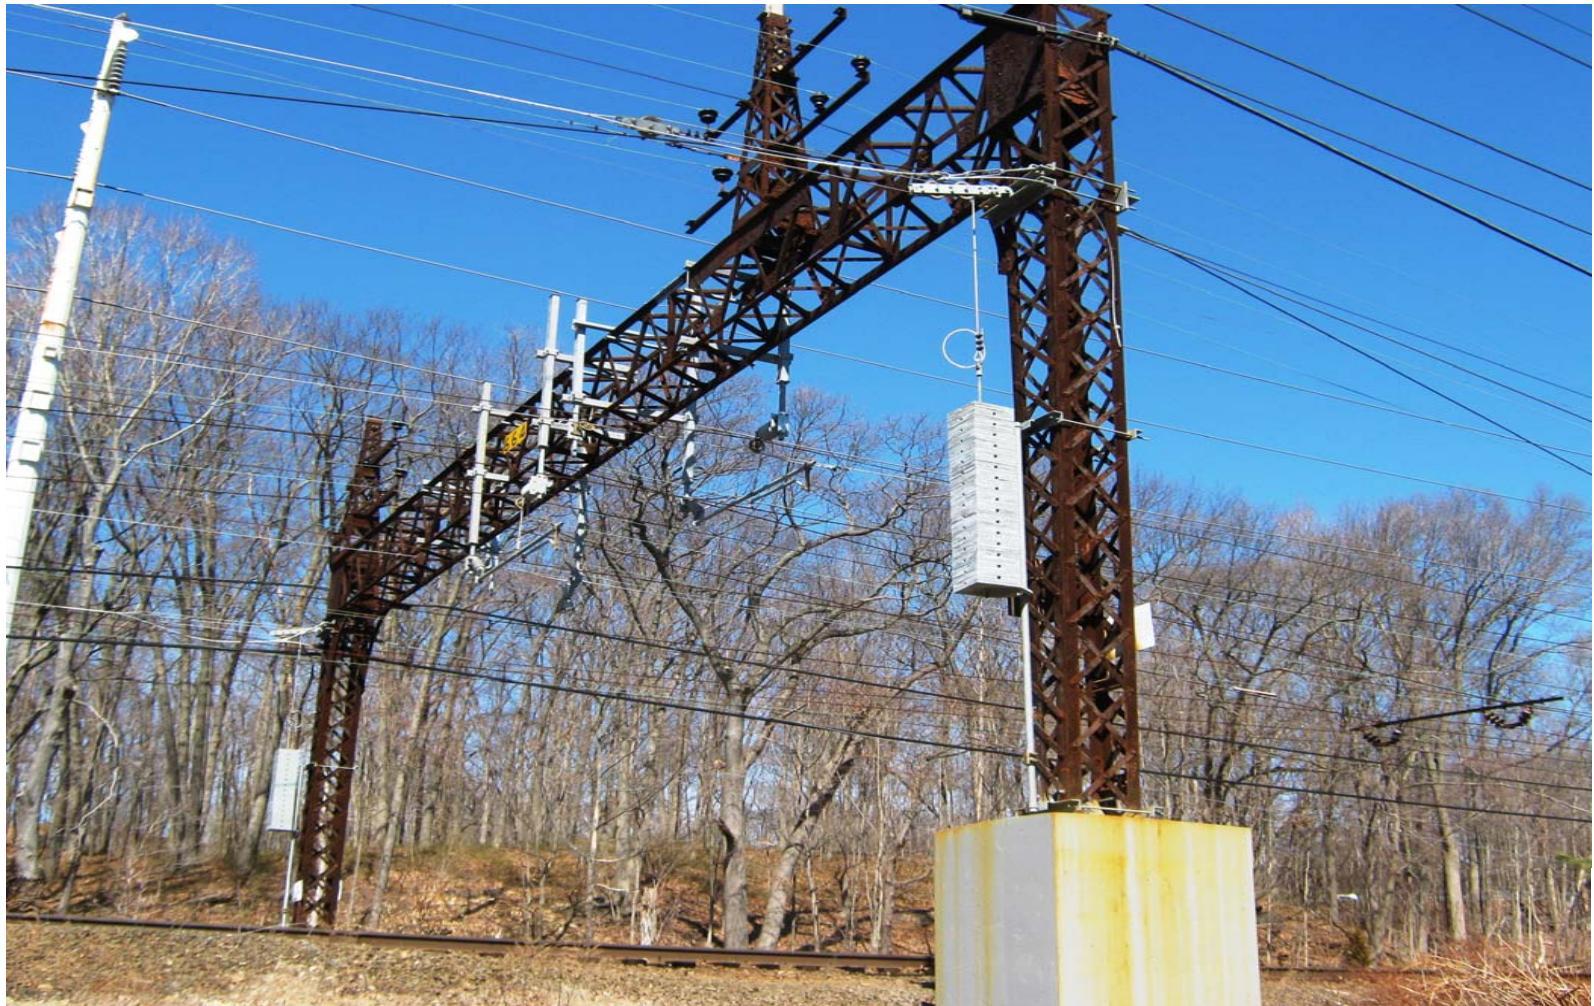
Existing catenary portal retrofitted to accept the new constant tension catenary wires and the counterweight assembly.

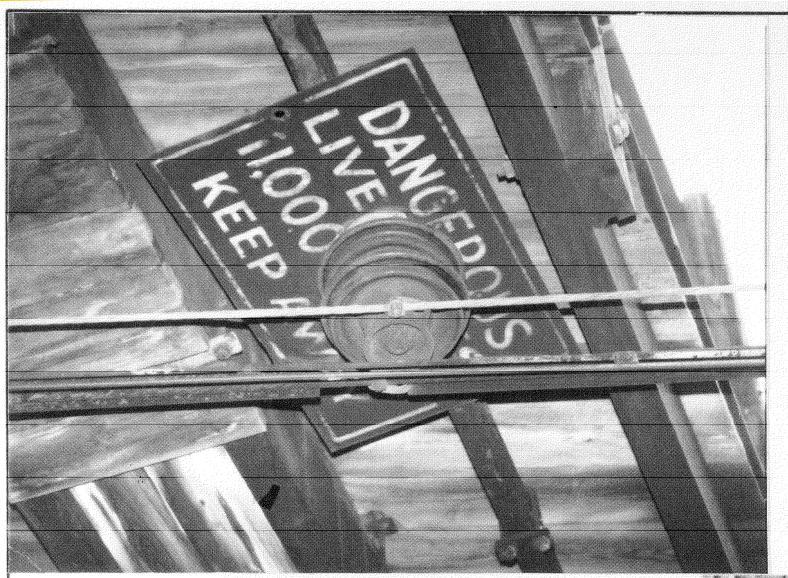
Many wooden deck bridges cause severe problems to the system during the winter months. Power outages occur as a result of icicle formation caused by water leakage through the bridge decking.

This photograph is a good example of the maintenance forces ingenuity. Utilizing this warning sign as a drip shield they have attempted to divert the water leakage from the deck of the wooden bridge away from the catenary.

A drip shield constructed of plywood to protect the catenaries from water run-off from the bridge deck and corrosive de-icing salts during the winter months. The use of this type of material is not satisfactory for long term protection of the catenary beneath the bridge.

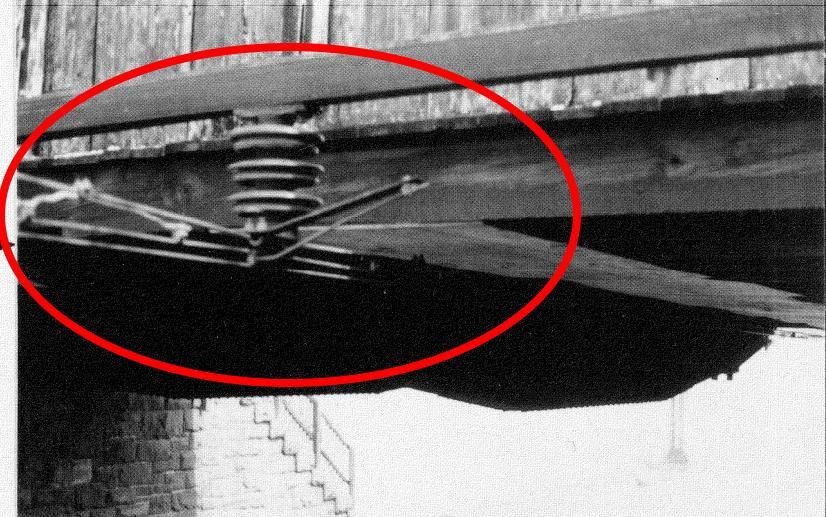
Low overhead structure (i.e. bridges) compress the system creating hard spots (see lower right photo). 17

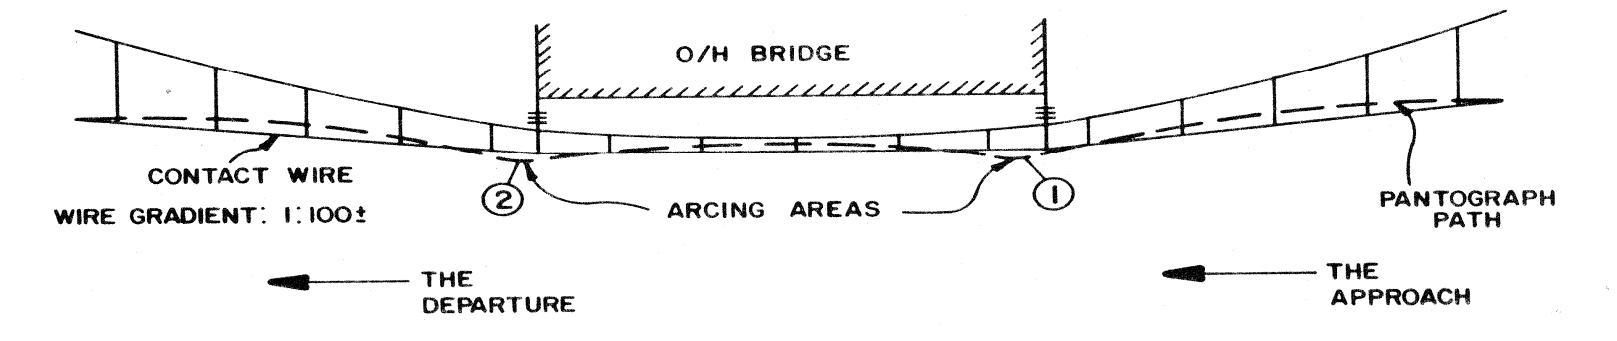
TYPICAL PANTOGRAPH TRACKING AT OVERHEAD BRIDGES

- AT LOCATION () THE PANTOGRAPHS DOWNWARD INERTIA FORCES IT TO LEAVE THE CONTACT WIRE.
- AT LOCATION (2) THE PANTOGRAPH CANNOT RESPOND FAST ENOUGH TO THE SHARP CHANGE IN WIRE GRADIENT.

Contact Wire Gradient

The majority of the overhead bridges have contact wire gradients of 1:100+ relative to track.

These gradients are excessive and result in the pantographs being forced down sharply on the approach side of the bridge. On the departure side of the bridge, the tendency is for the pantograph to lose contact with the contact wire as the wire is rising at a faster rate than the dynamic trajectory of the pantograph.

The net result is severe arcing, contact wire pitting and rapid wear of the contact wire in the vicinity of the overhead bridge.

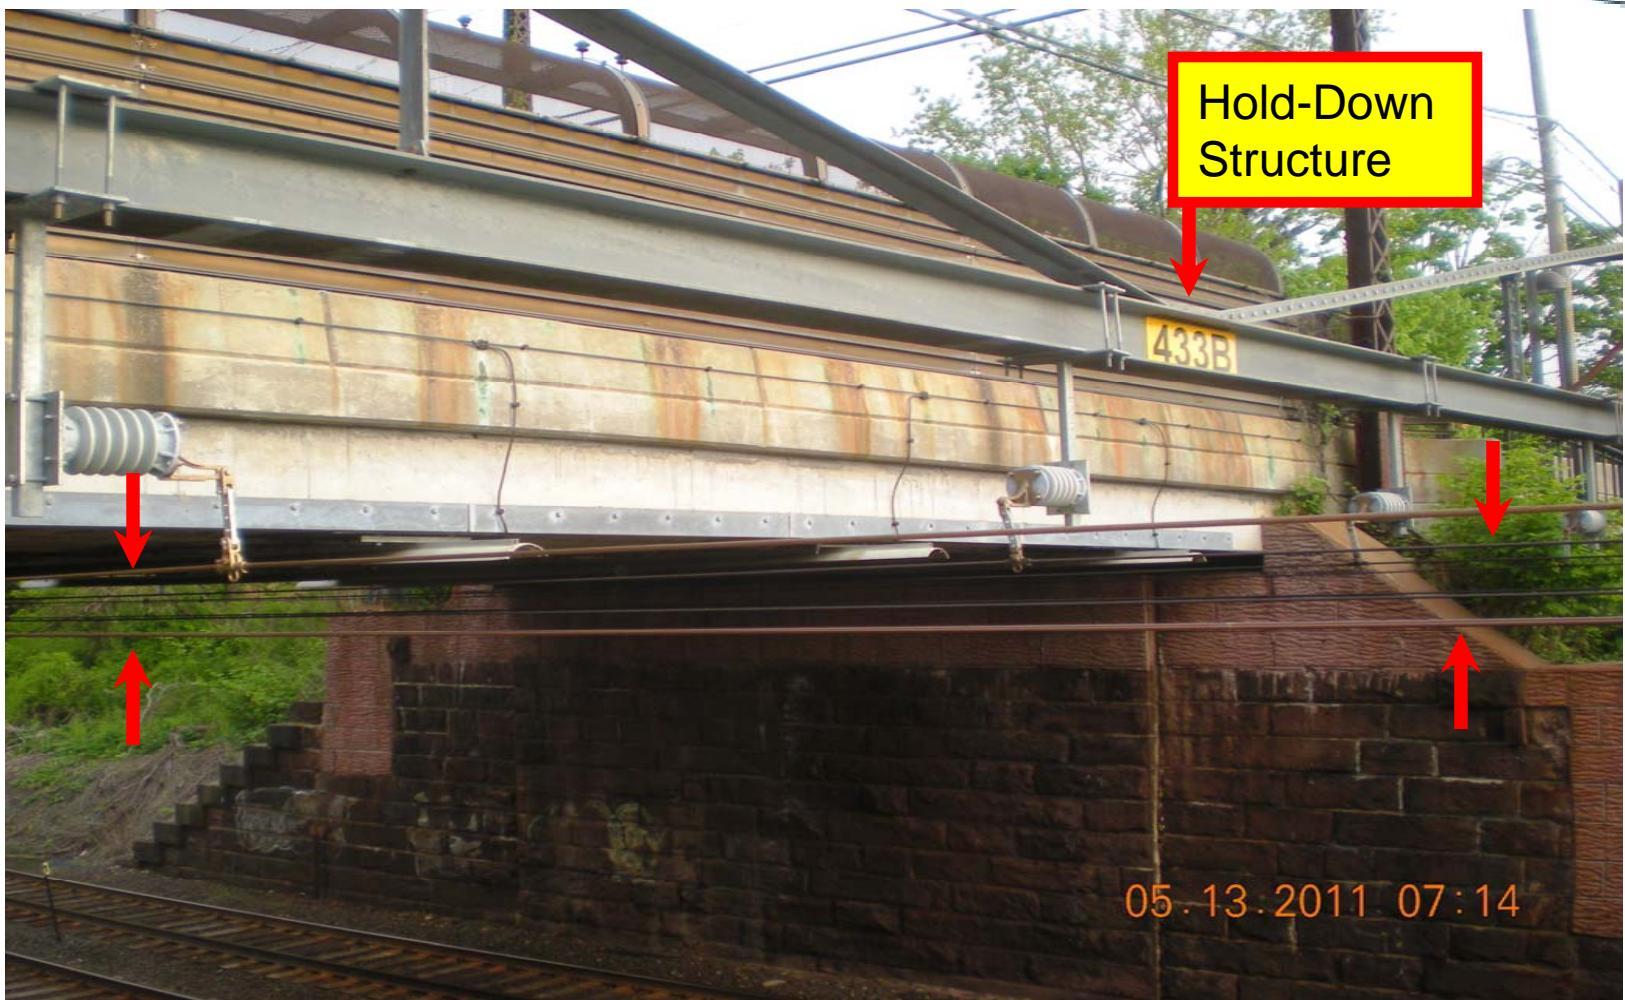
Fixed overhead structures are cause for great concern when designing the catenary system (shows system wire compression approaching bridge).

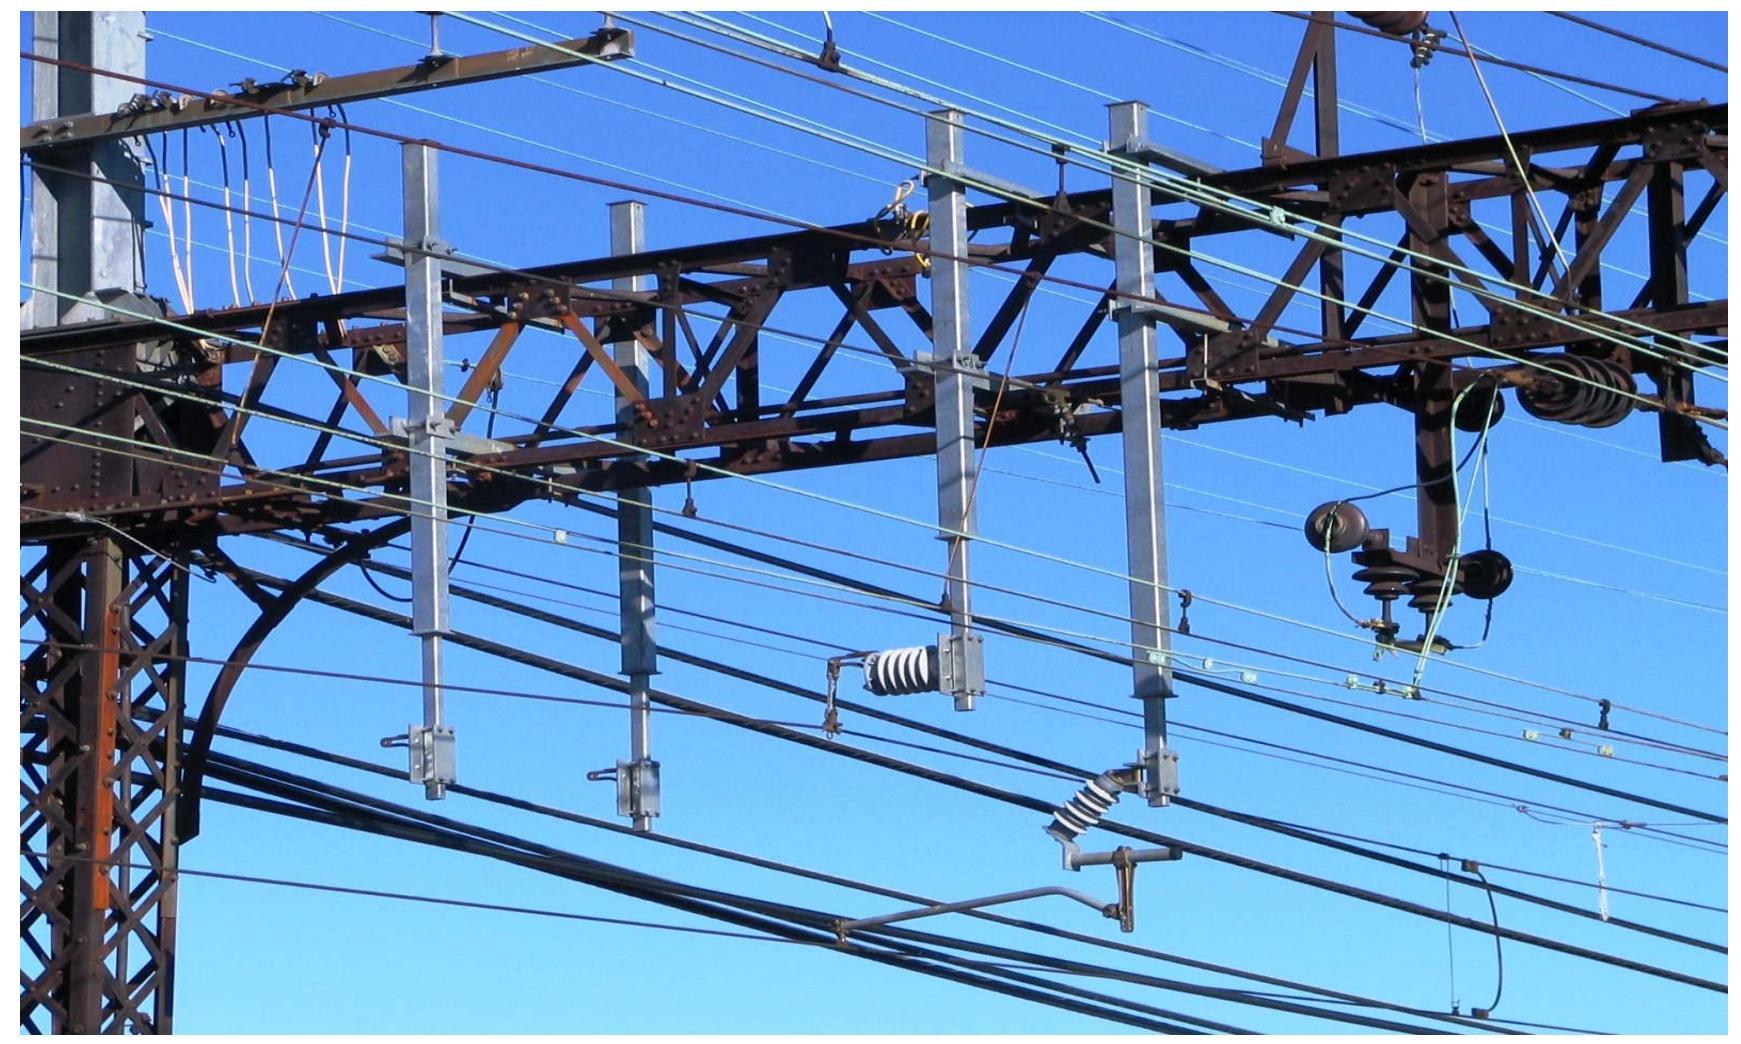
<u>Blending old with new</u> - Existing portal close-up, showing new drop tube assemblies retrofitted to the trusses of existing portals.

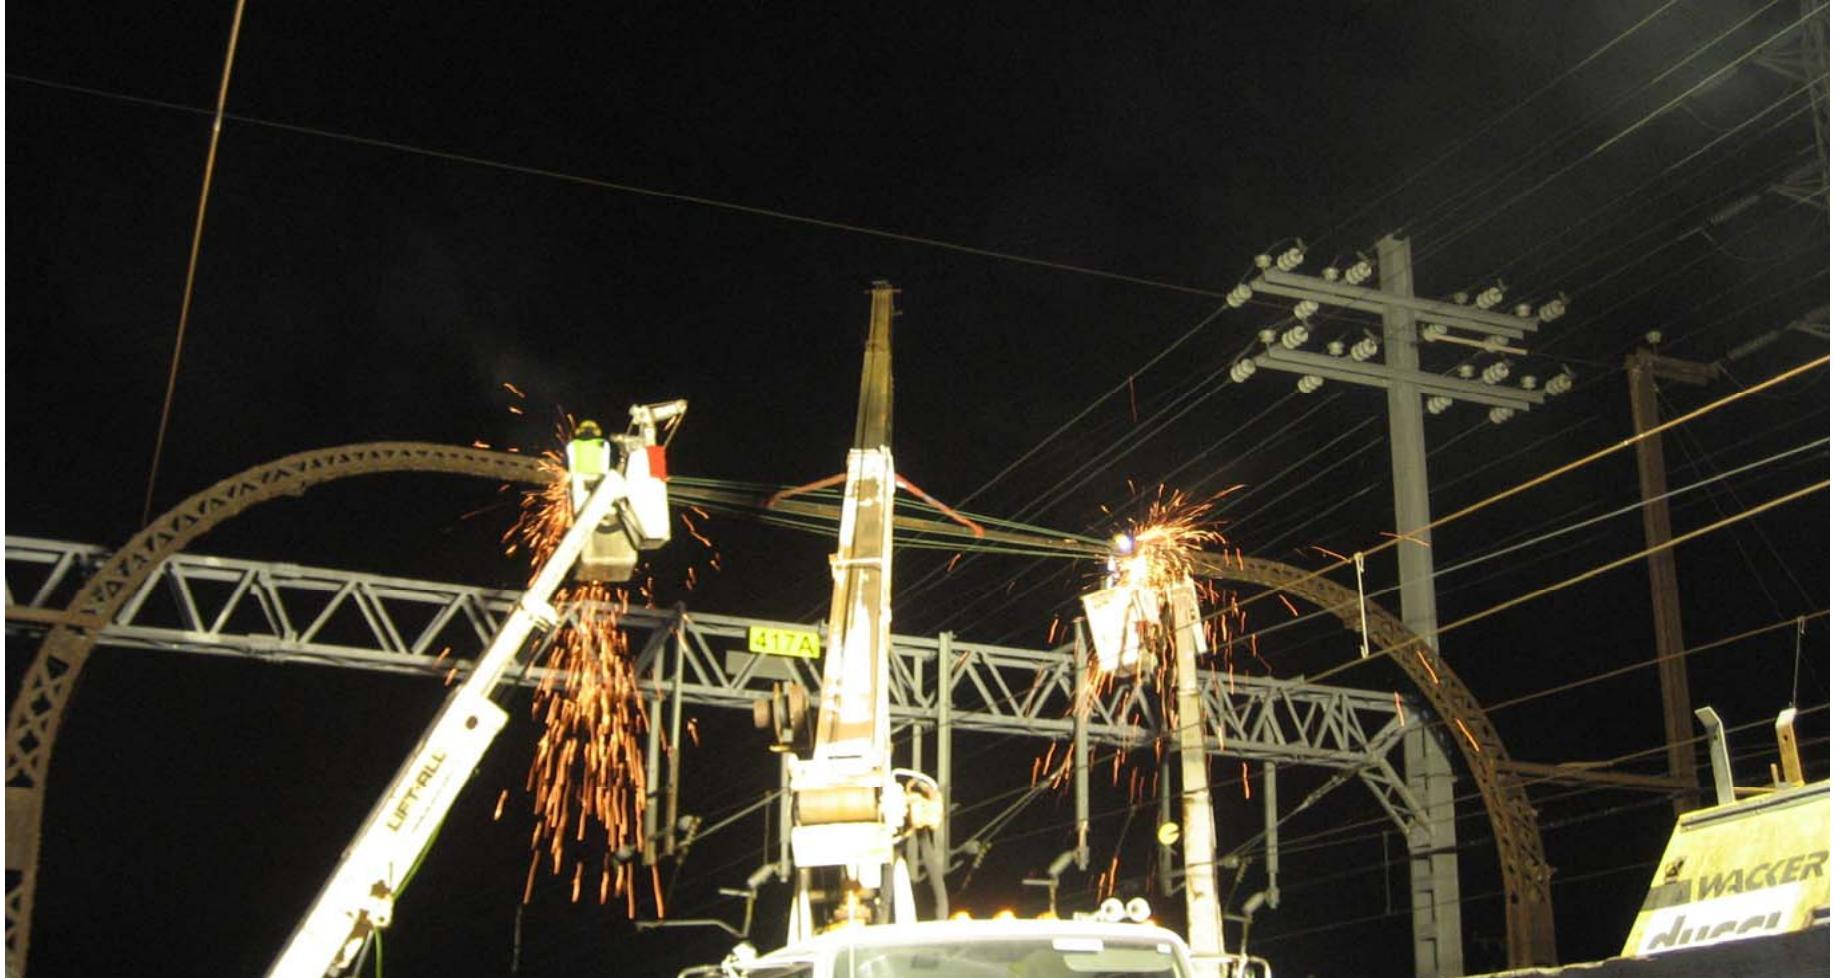
Night work required for demolition of "Experimental" portal – Four Track outages are necessary to undertake such work.

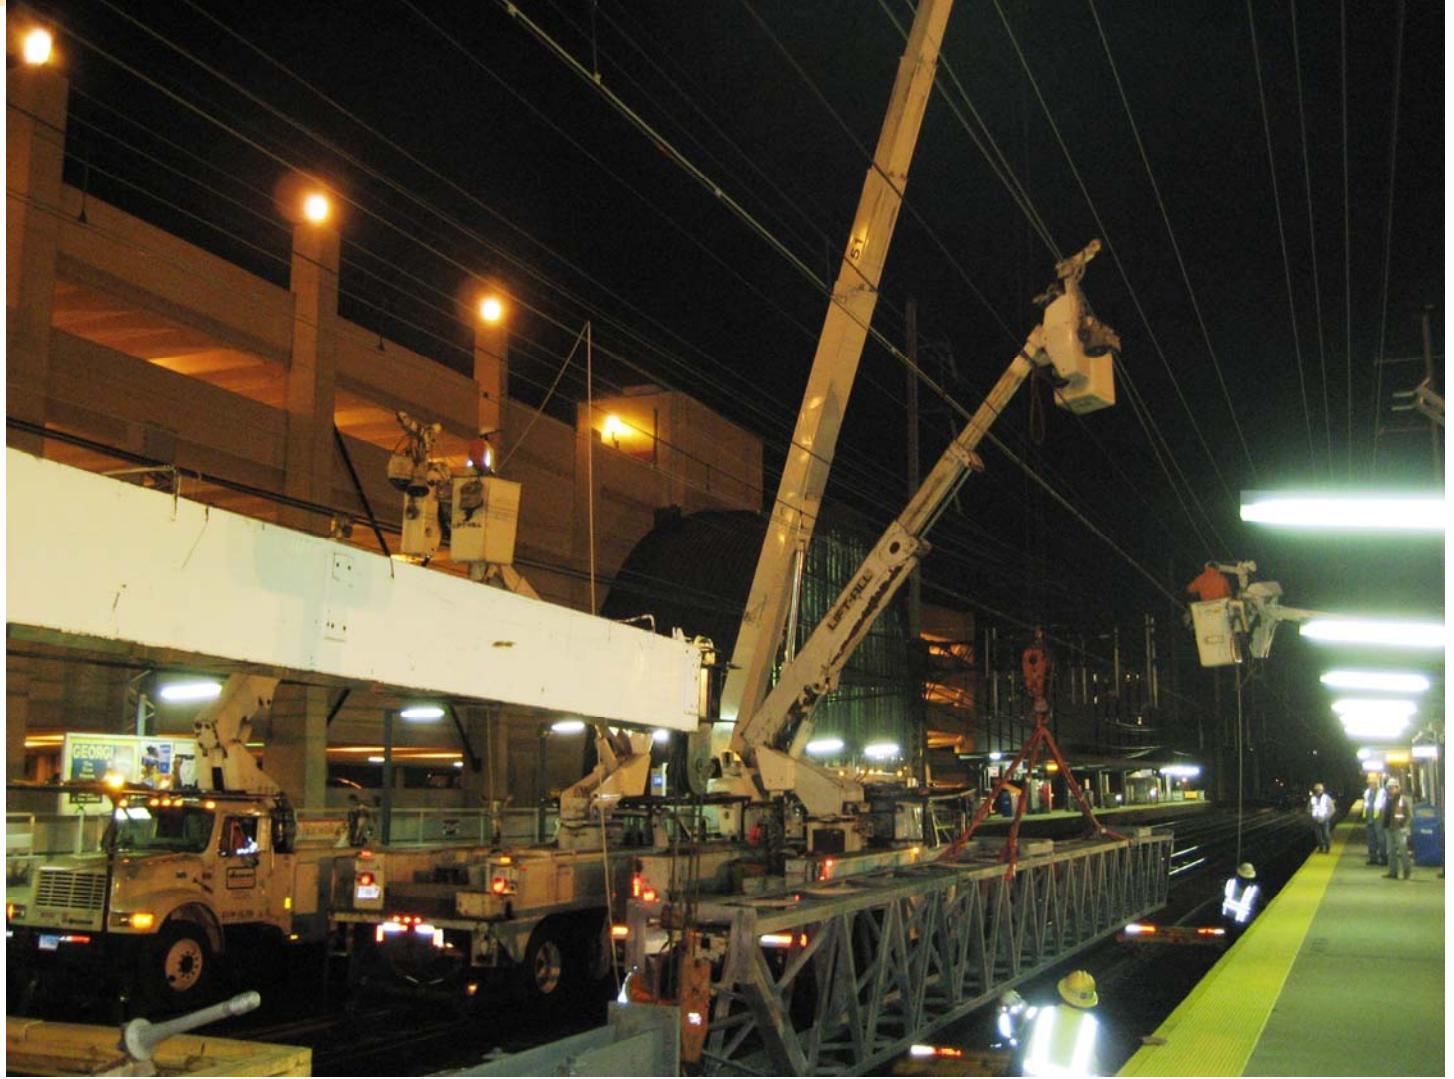
Preparing to lift new catenary truss.

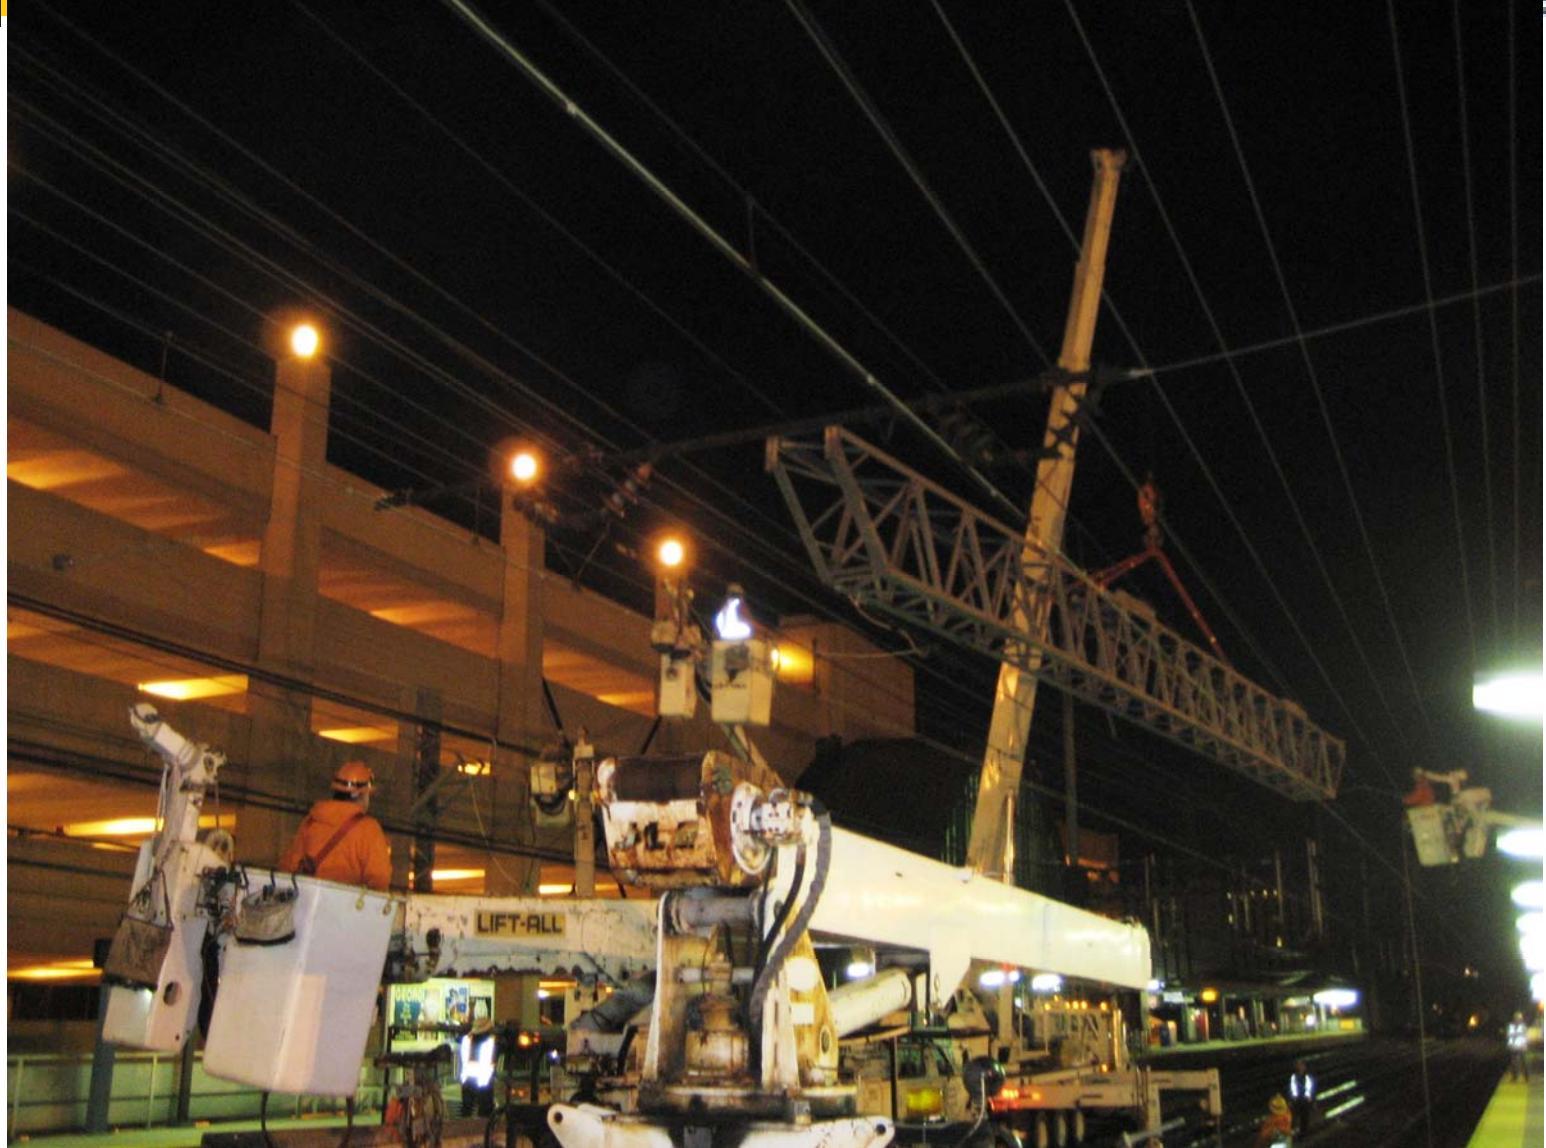
New catenary truss is lifted vertically to clear existing catenary.

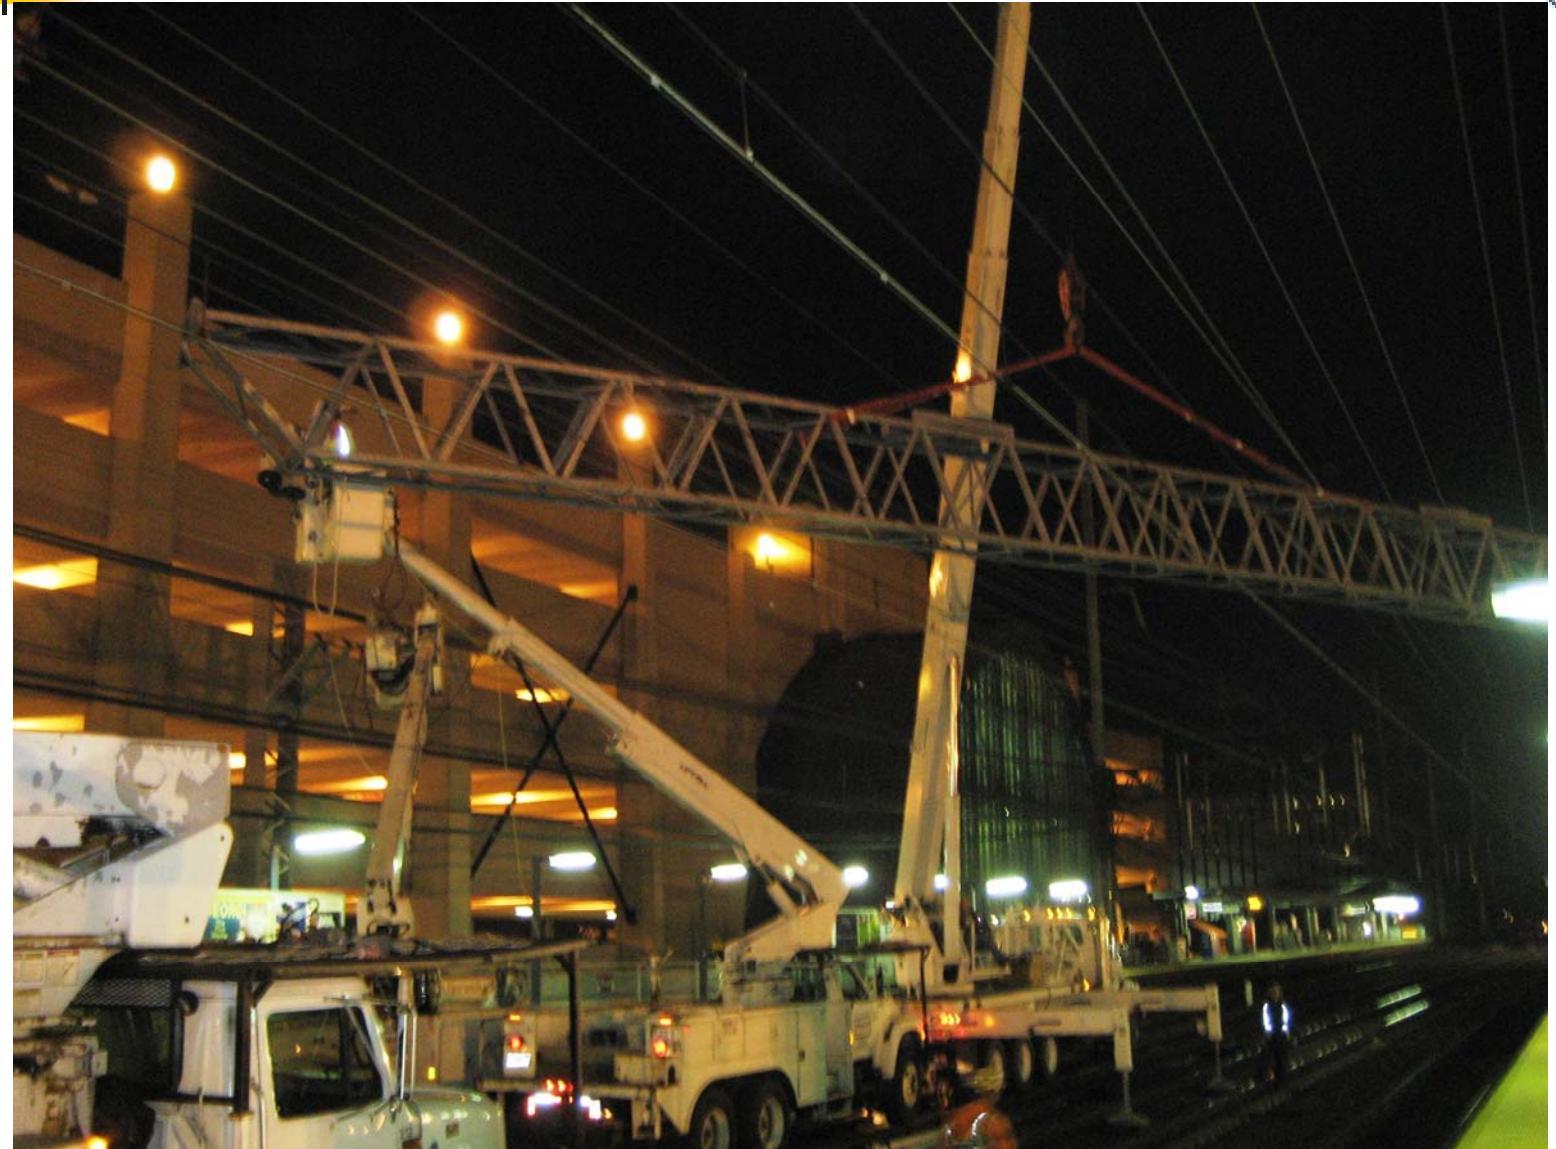
Spinning new portal truss over to its vertical columns.

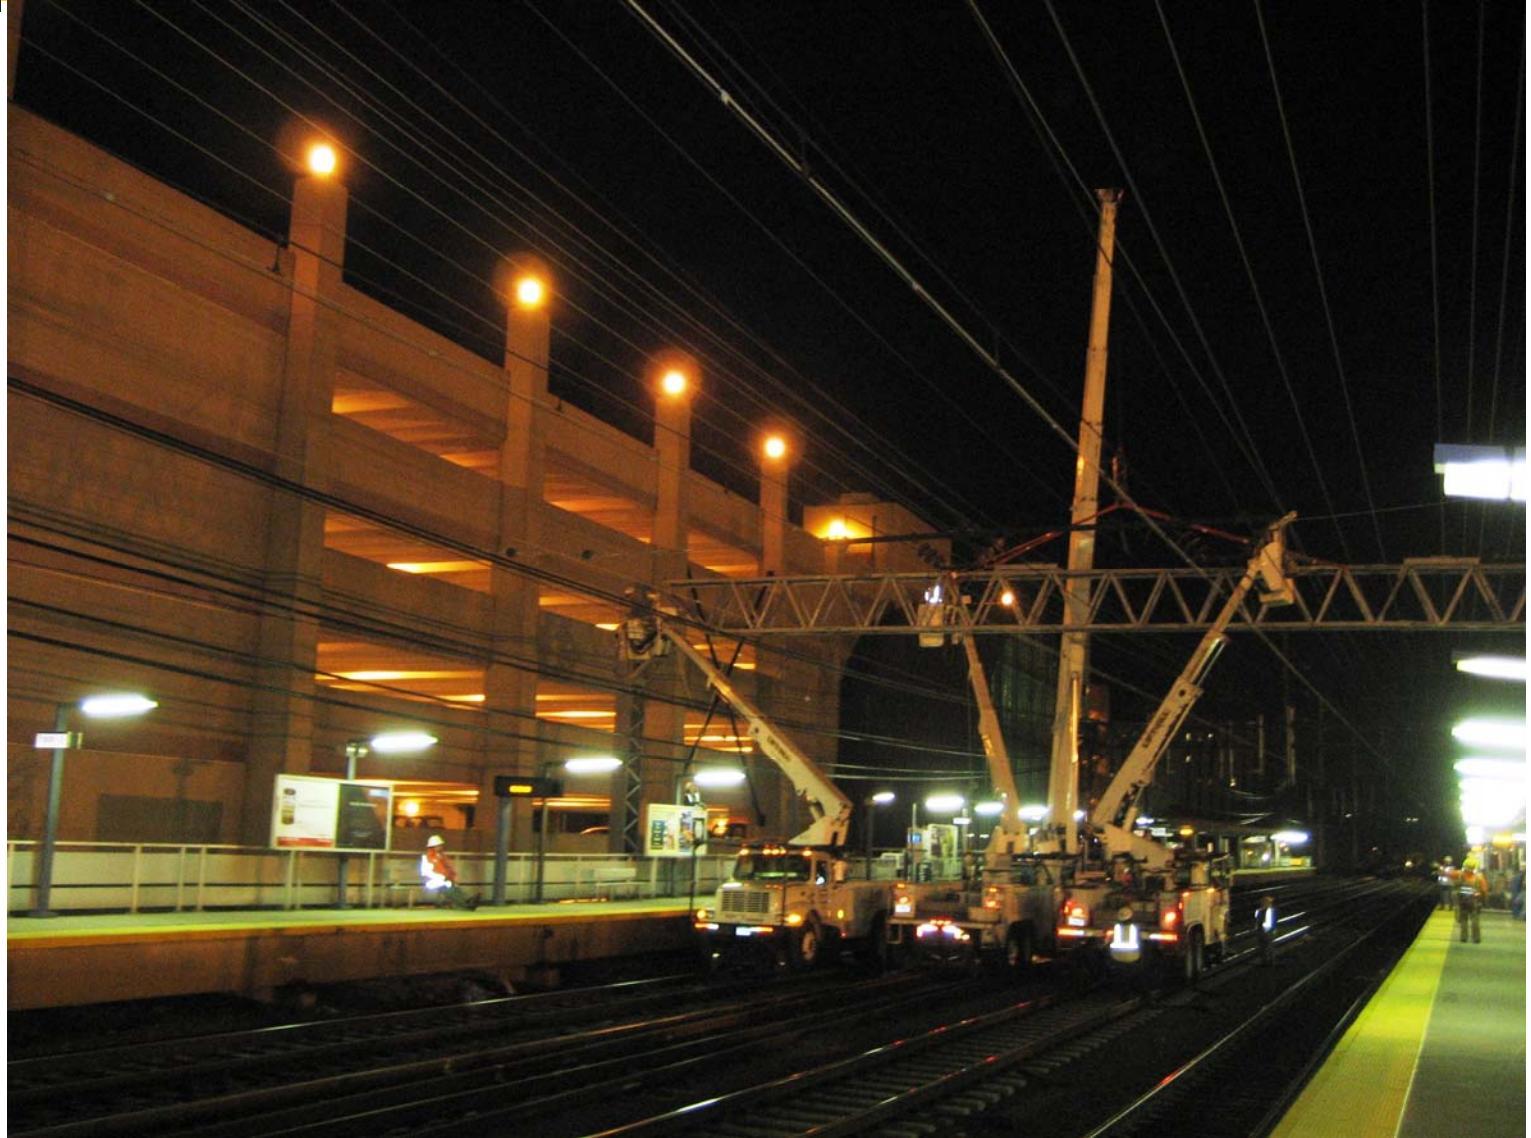
New catenary truss set in final location on support columns.

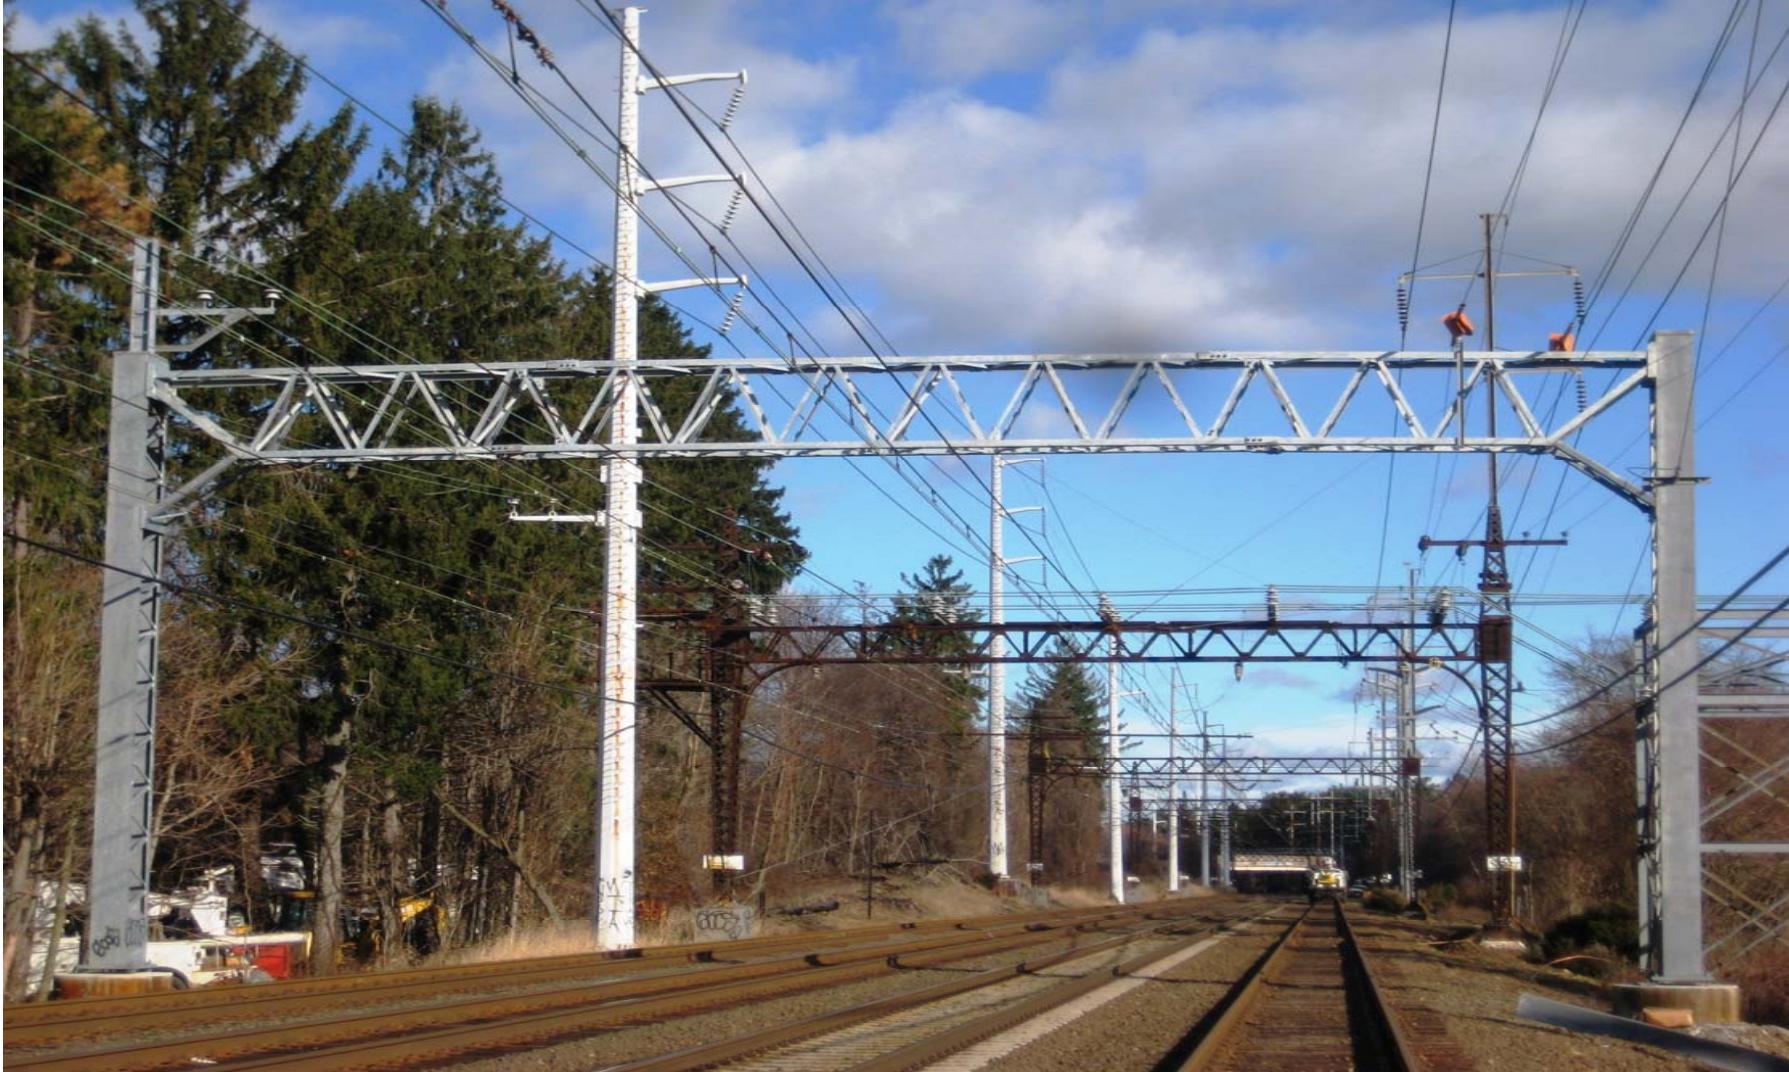
New catenary Truss type portal
