PRESENTATION OVERVIEW

- Historical
- Selected Catenary & Bridge Replacement

In Connecticut, there are approximately 200 track miles of mainline overhead catenary powering our trains.

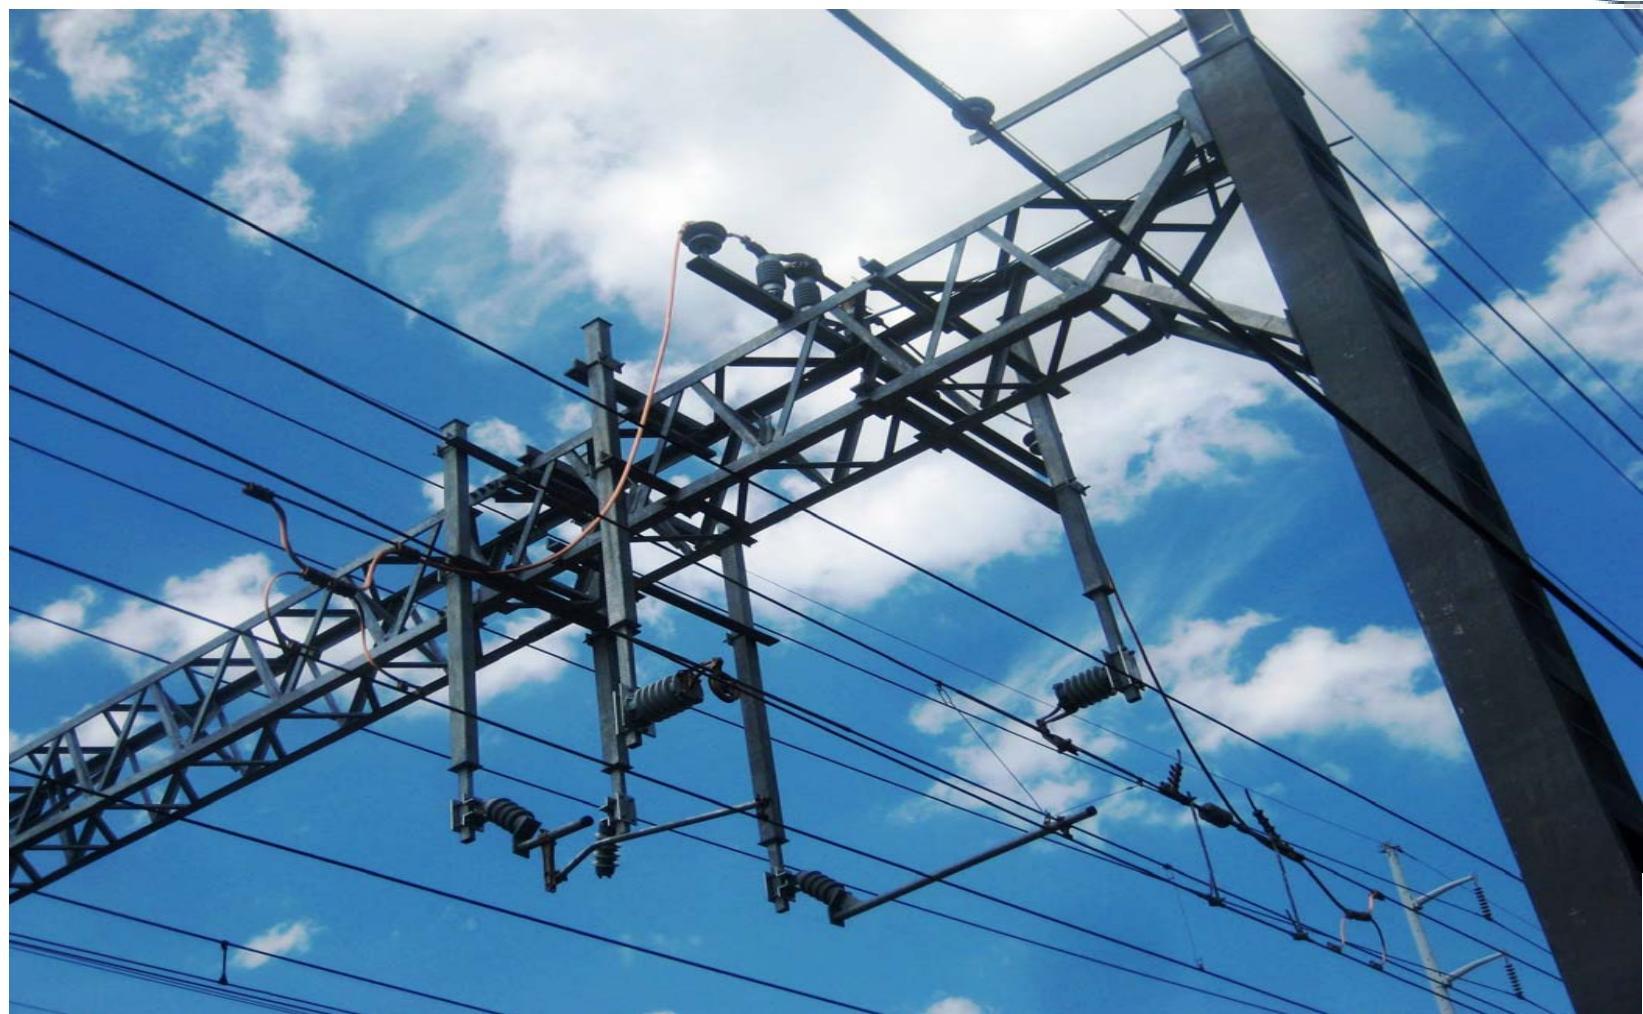
New catenary portal close-up, showing catenary hanger drop tube assemblies used to replace the old antiquated triangular system.

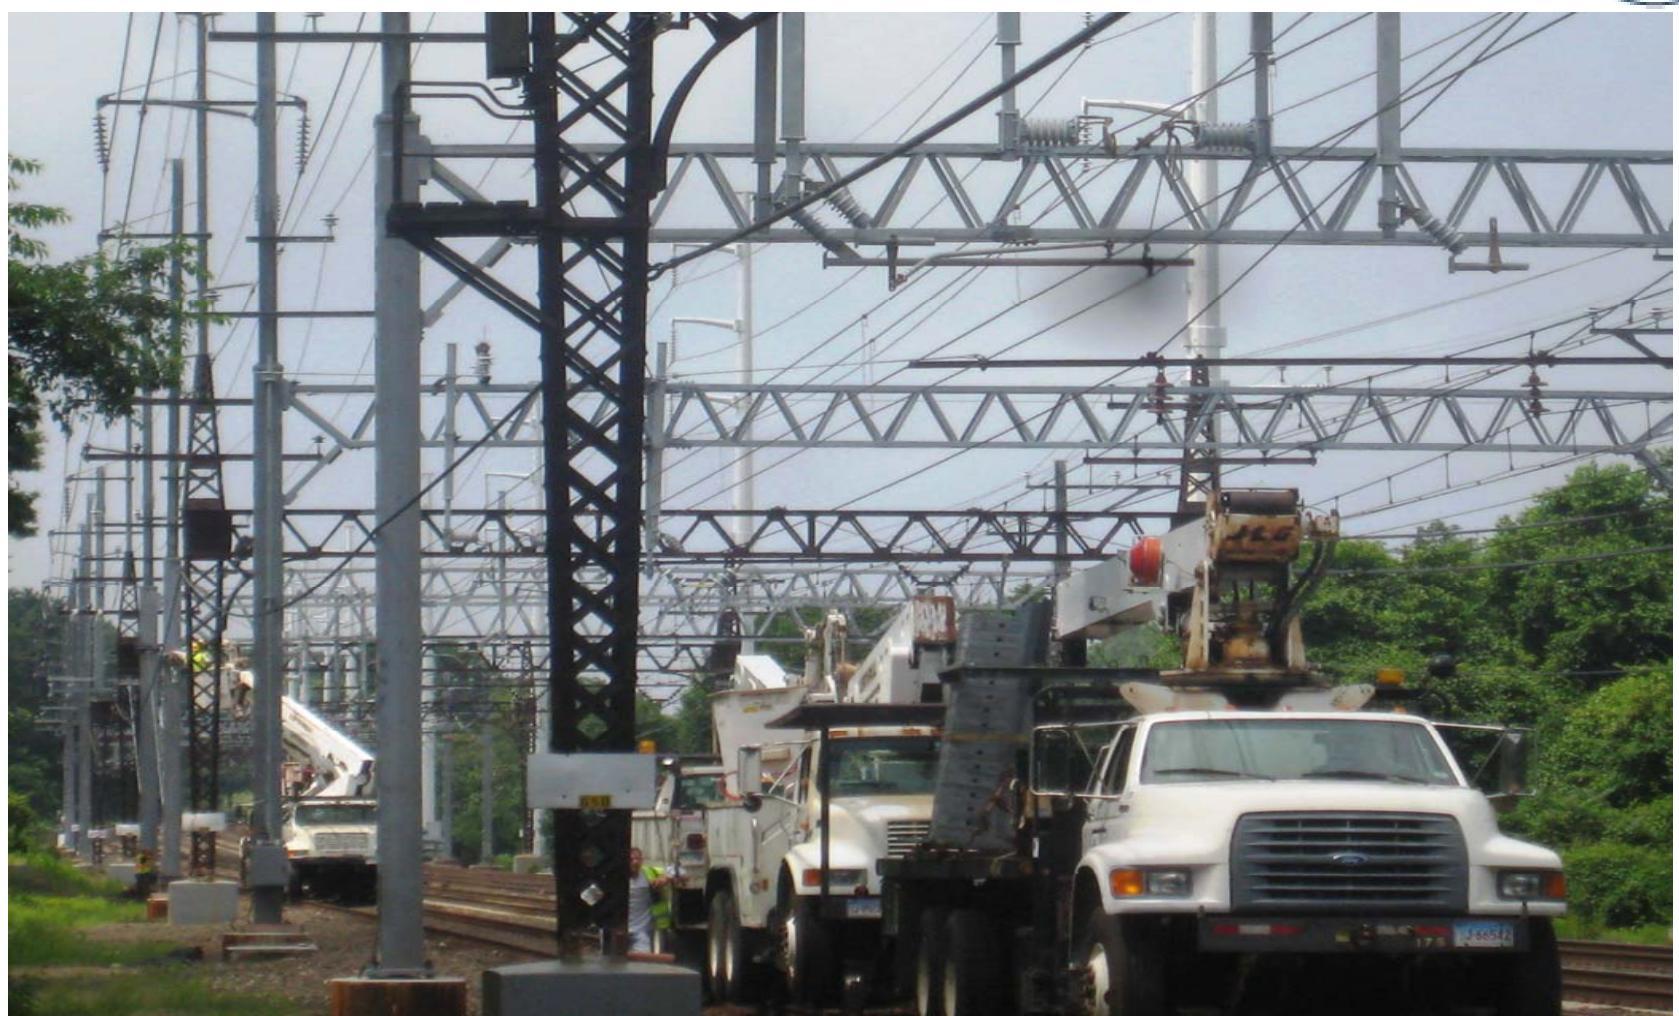
Complex and diverse array of catenary structures, utility overbuild and utility monopoles.

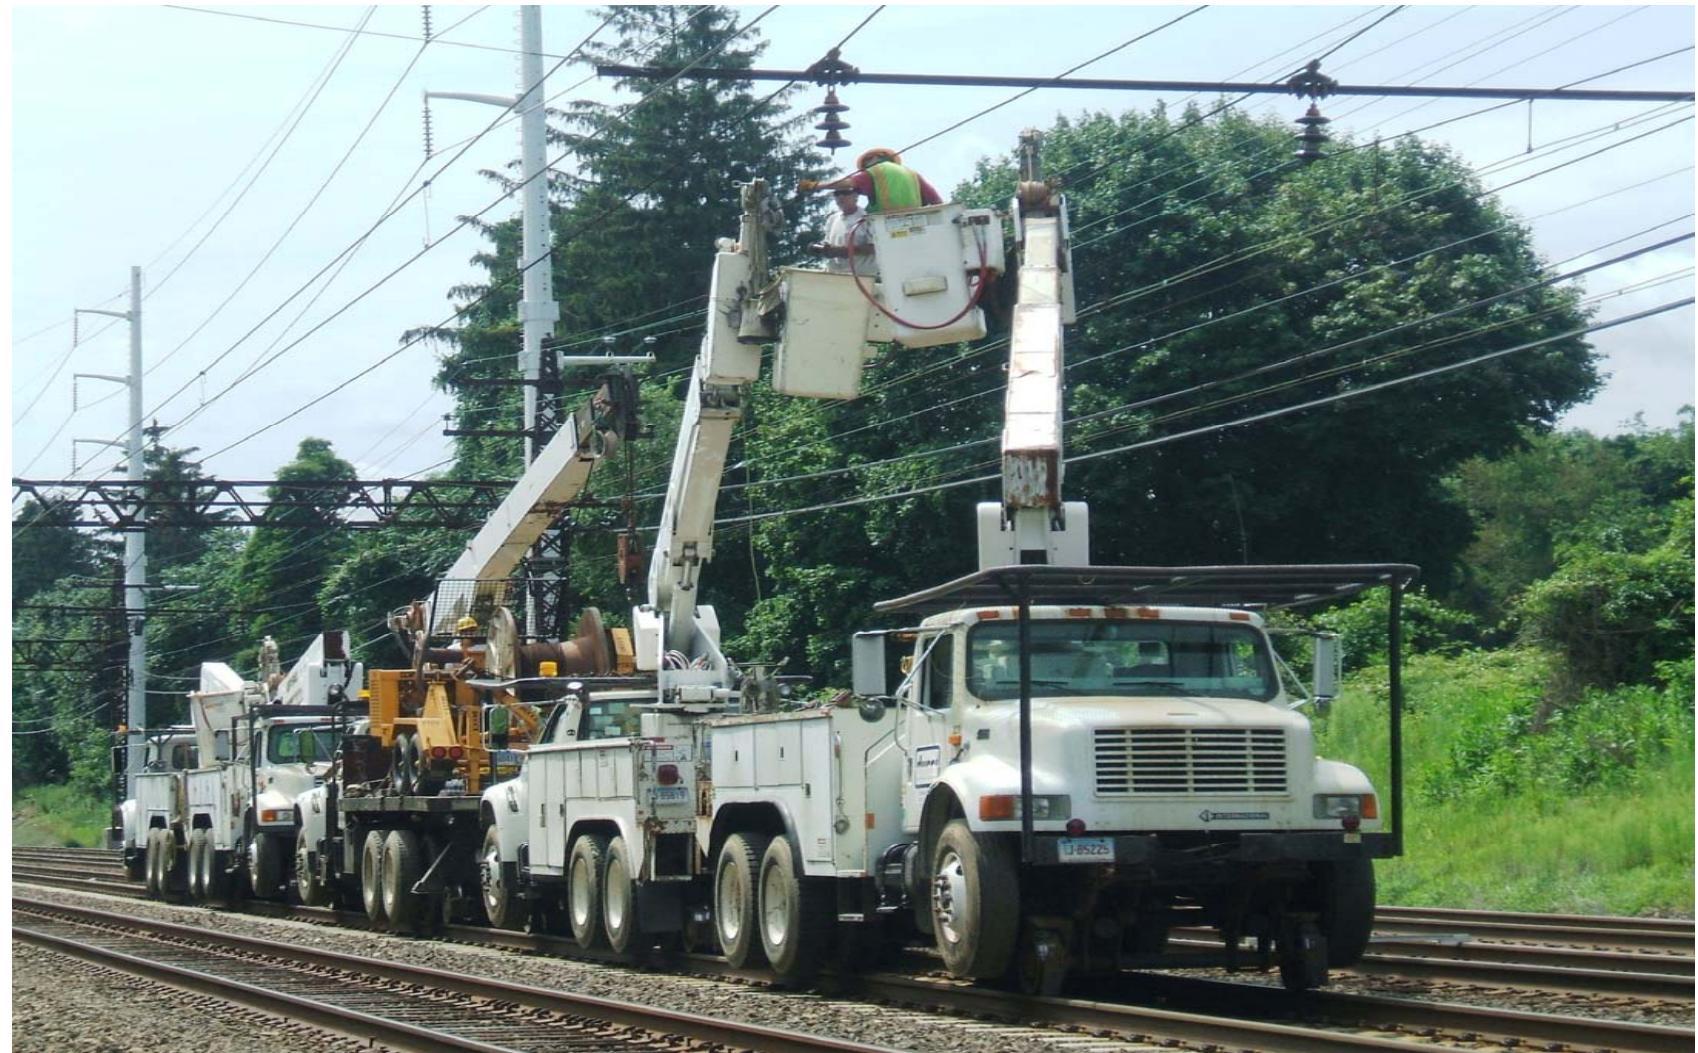
Contractors must possess specialized equipment of their own. The installation of new catenary wire is shown above.

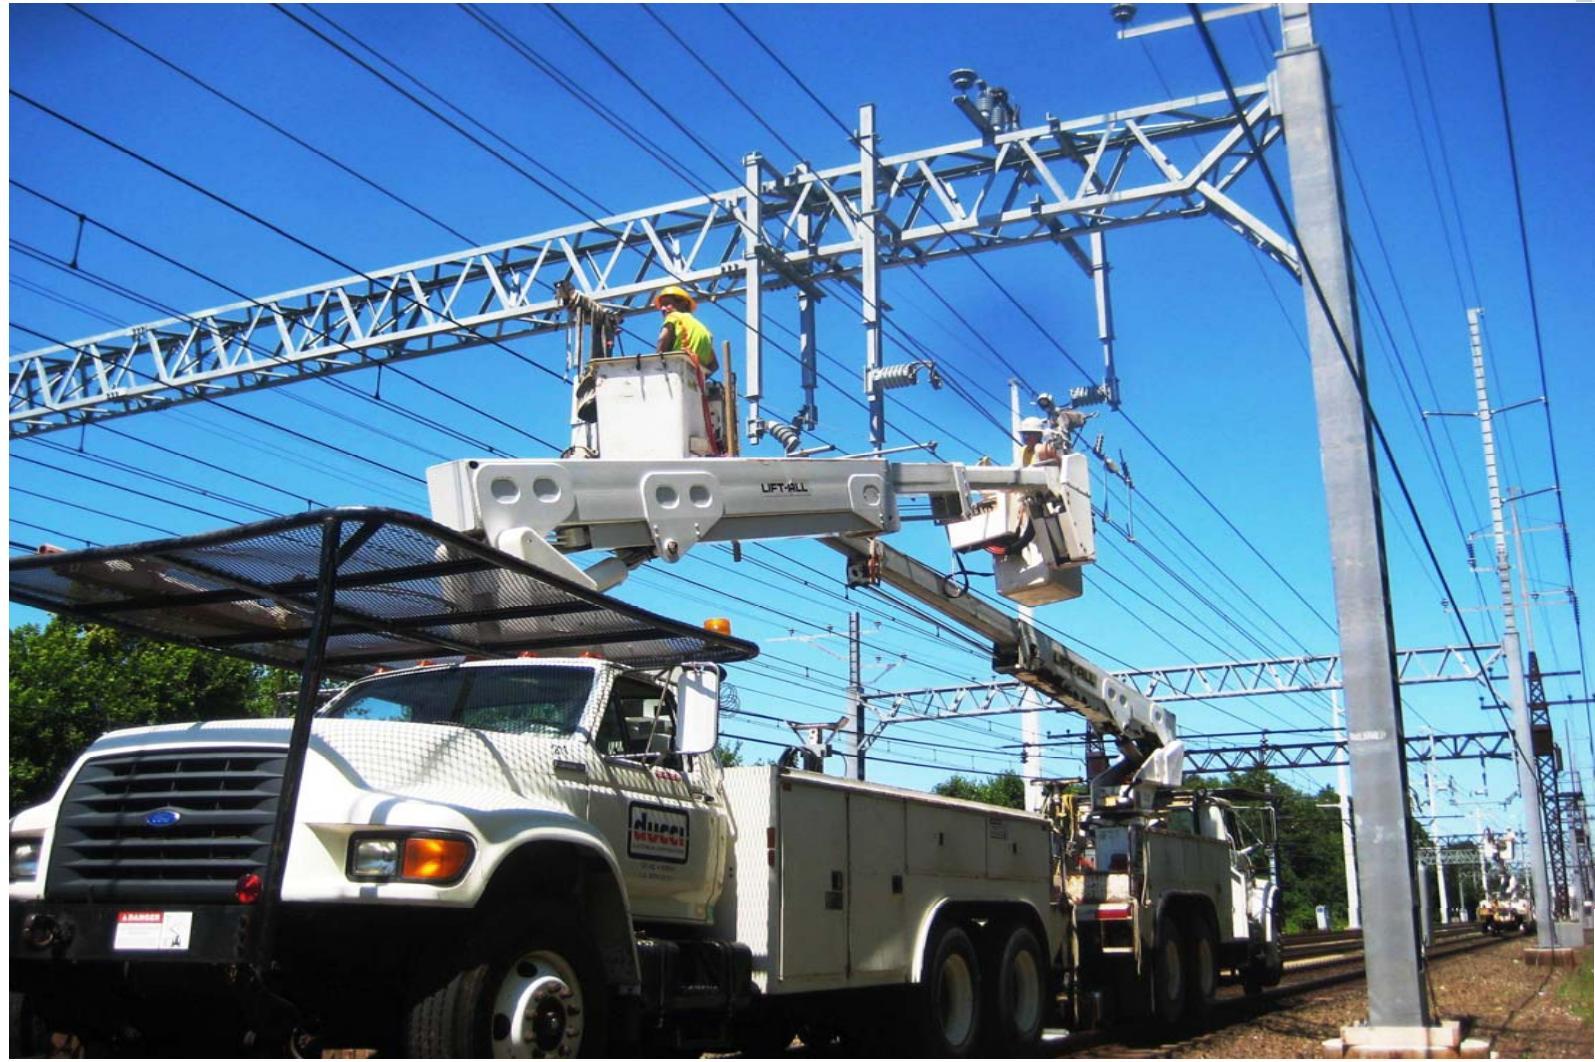
Workers install and adjust new catenary wire.

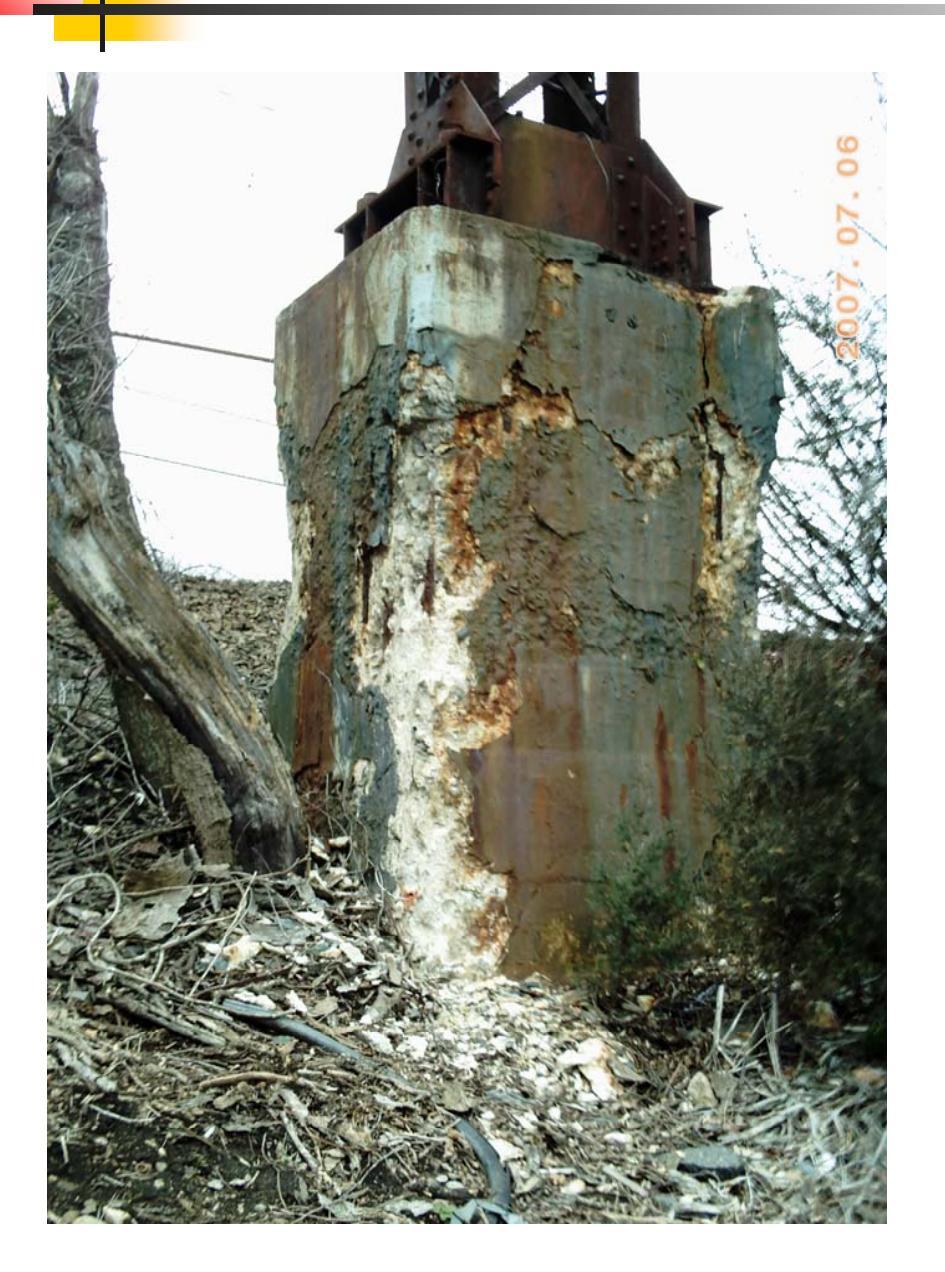
FOUNDATIONS

- Existing foundations exhibit severe concrete spalling, efflorescence and exposed reinforcing bars.
- Repairs involve removal of unsound concrete, drilling and grouting of new steel reinforcement, forming and pouring concrete, and final sealing of new concrete.

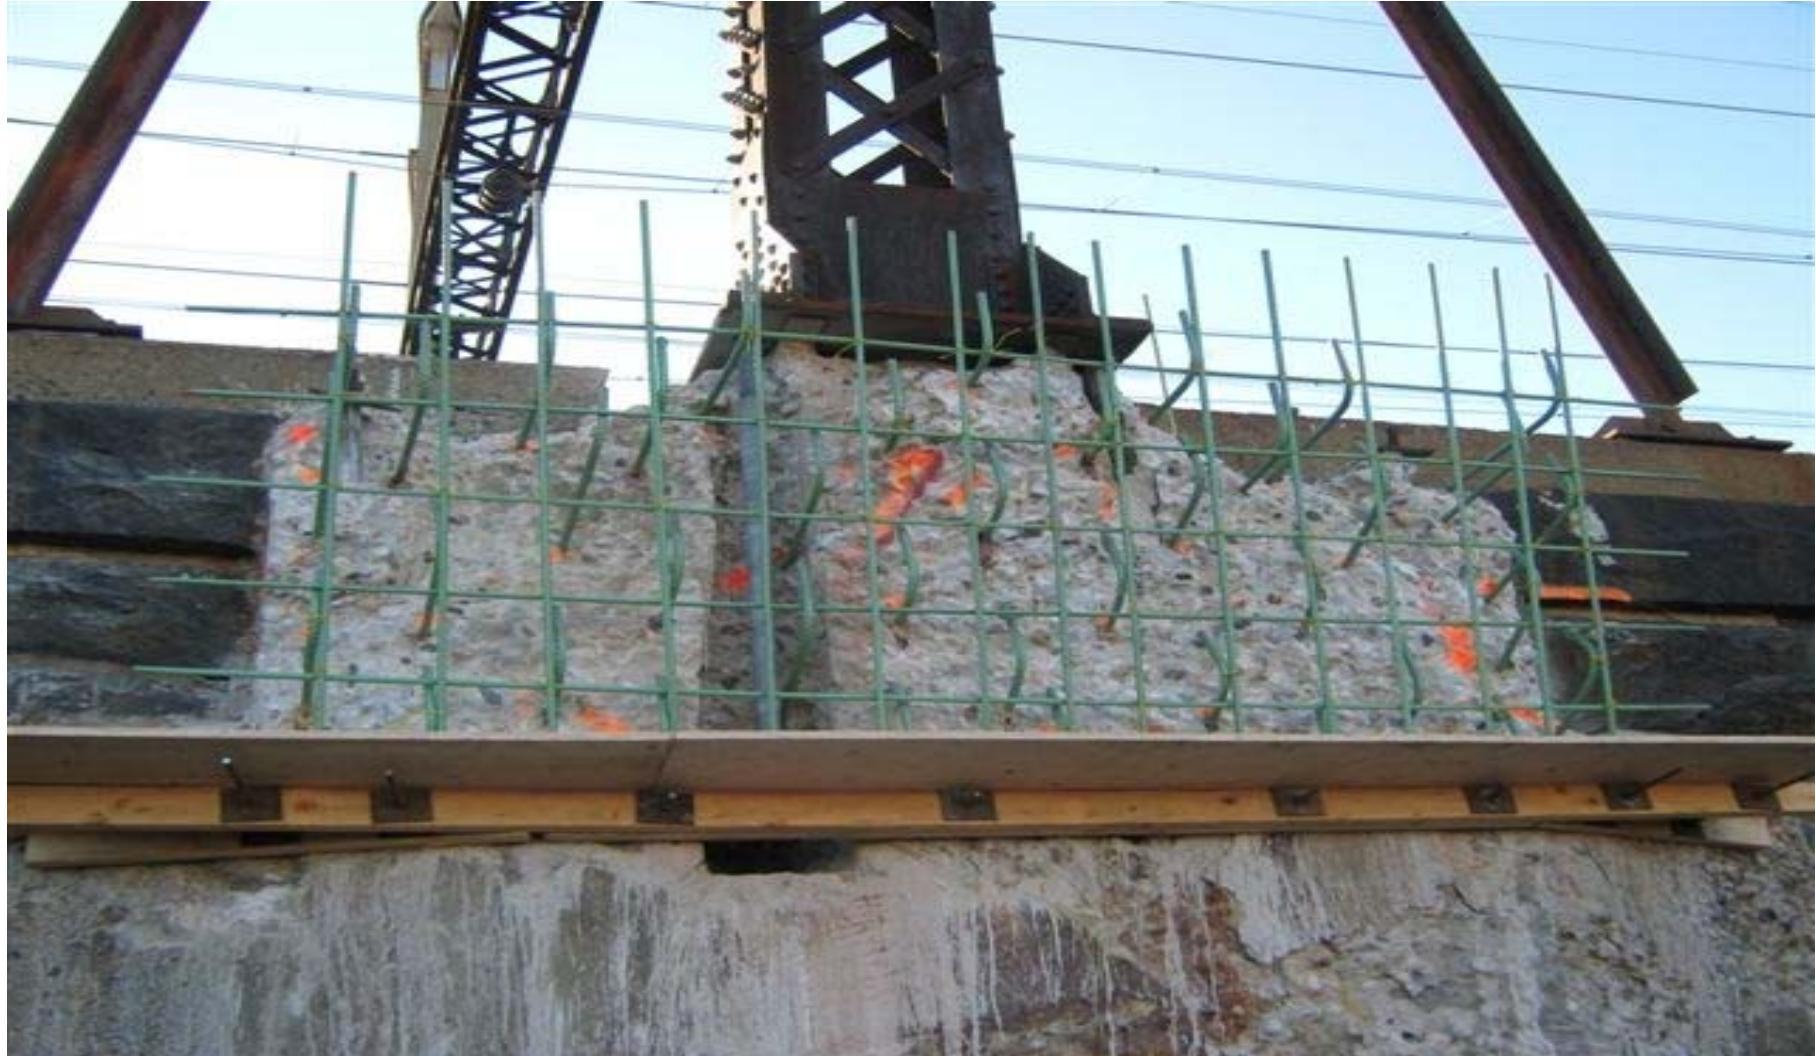
Catenary foundation under repair - unsound concrete has been removed, new rebar installed. Foundation is now ready to be formed and poured. 33

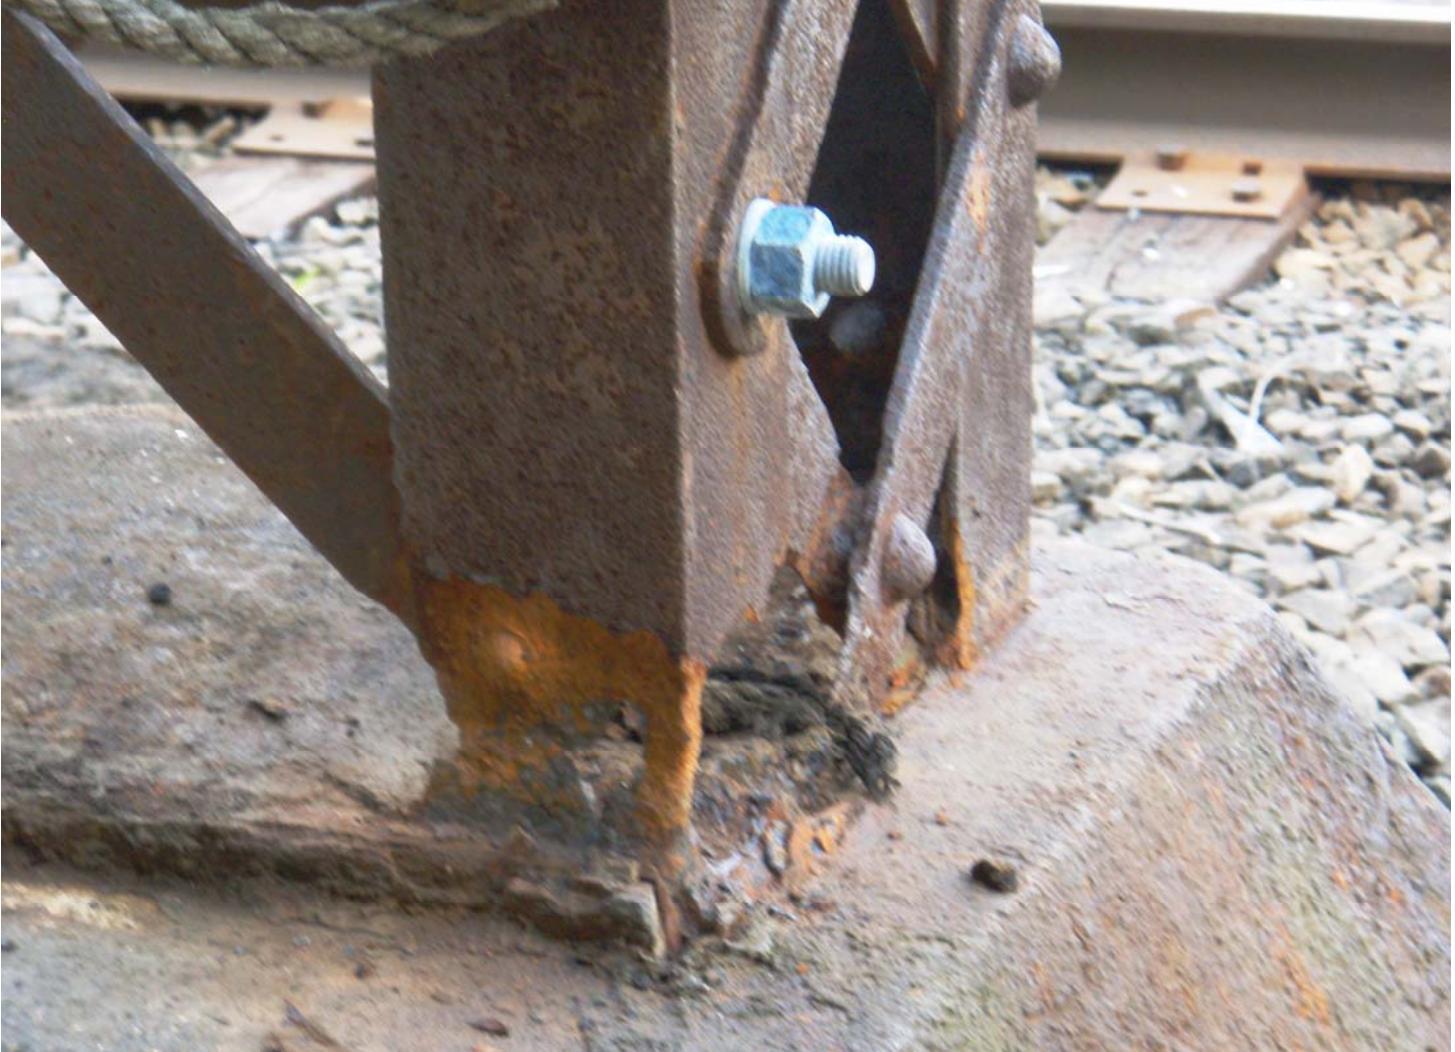
Catenary foundation base with severe deterioration of structural steel.

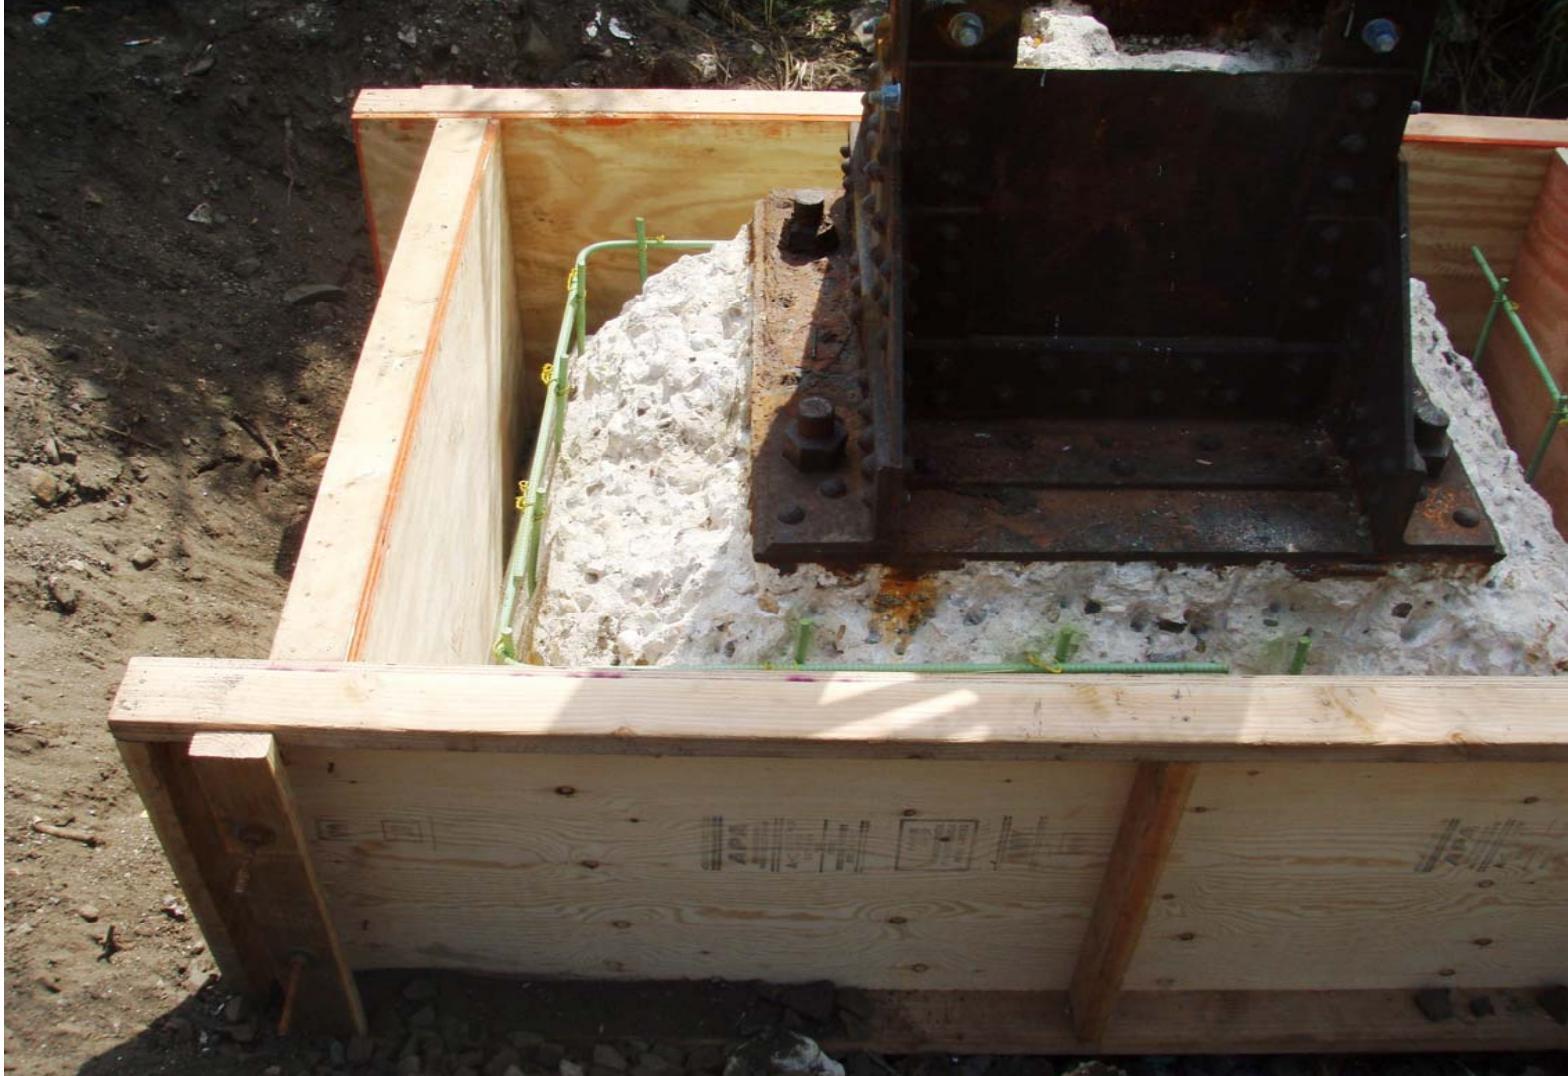
Foundation repairs – formed and ready for concrete.

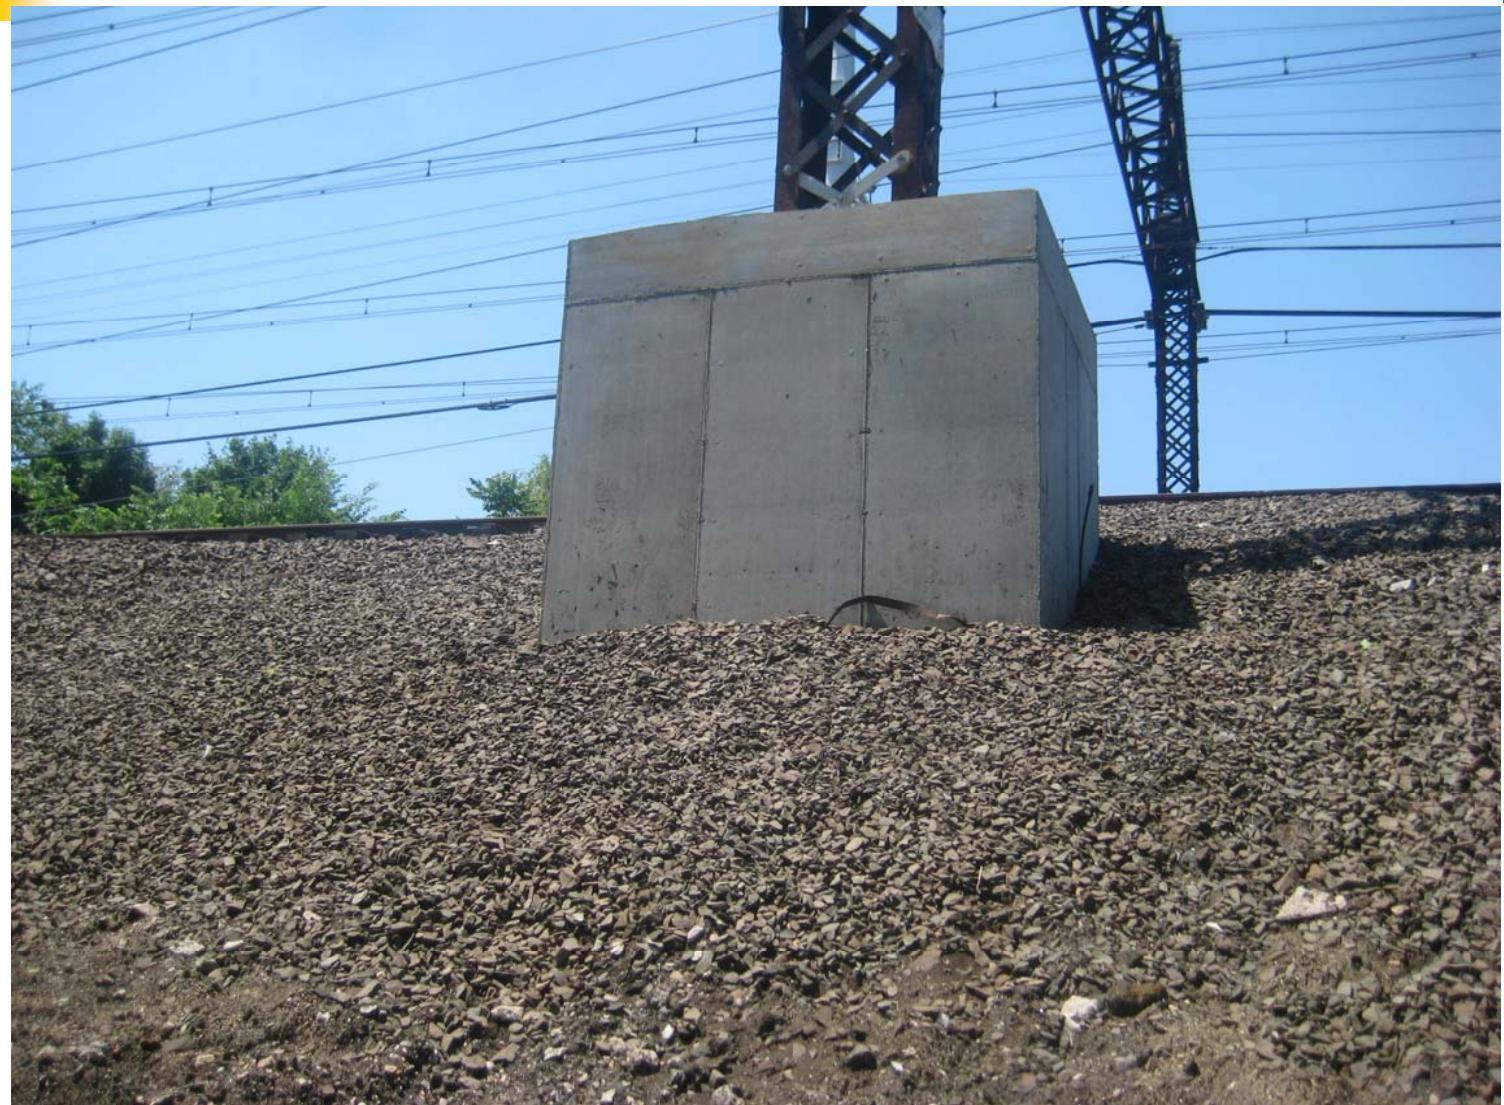
Completed foundation repair.

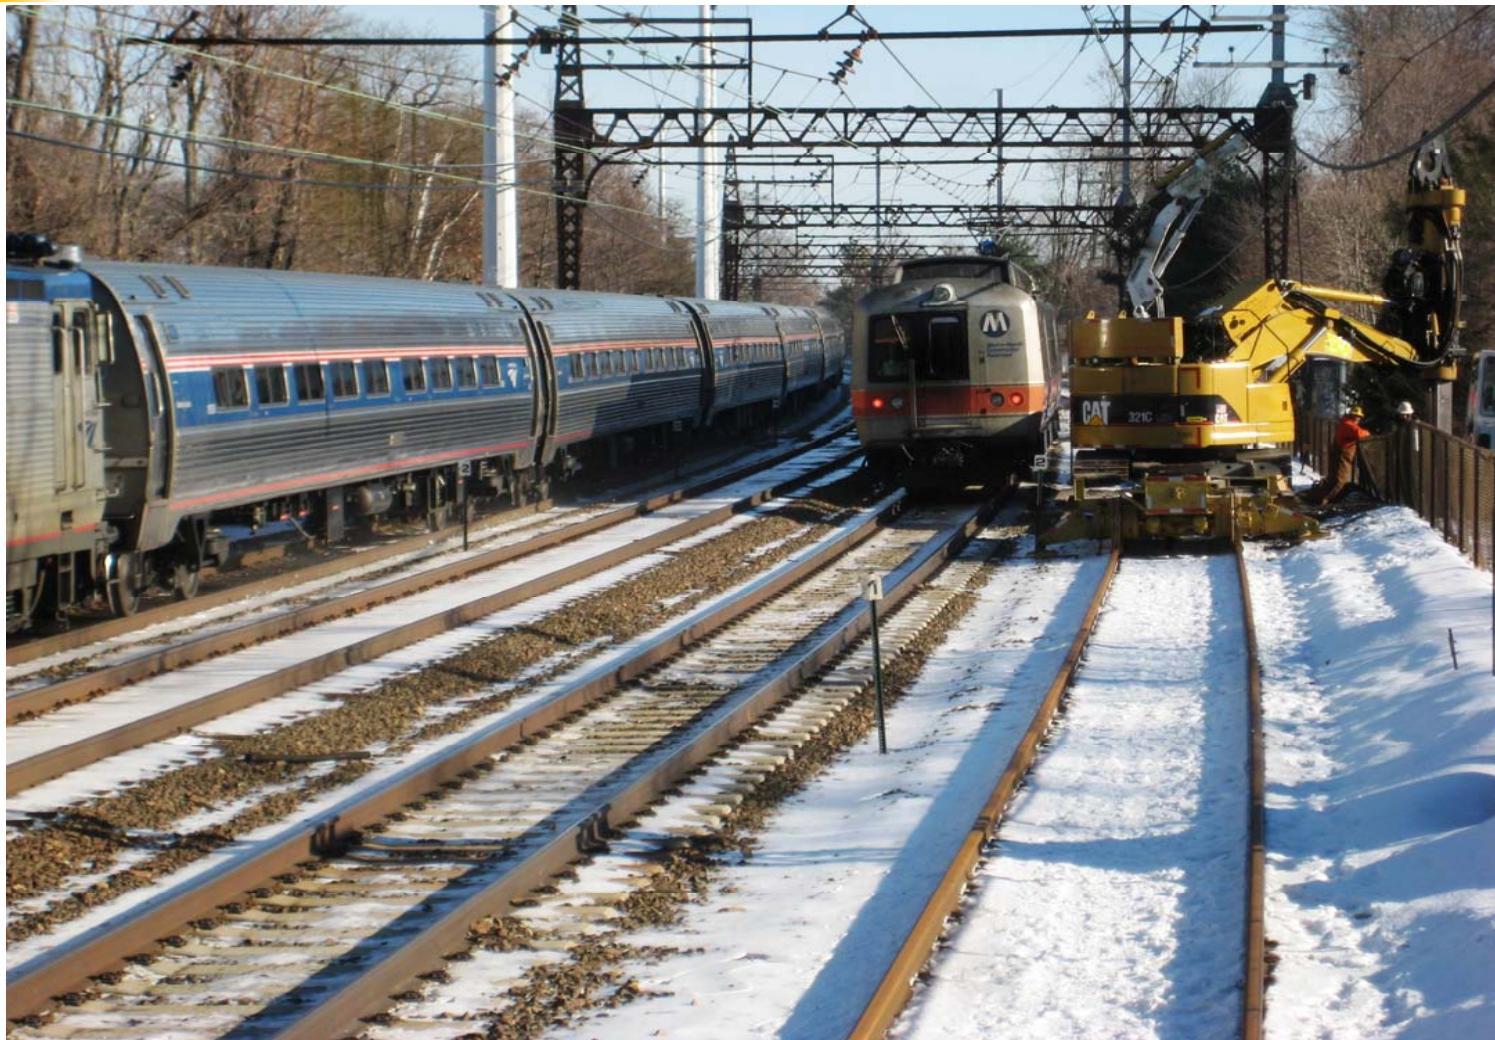
New catenary caisson foundation excavation.

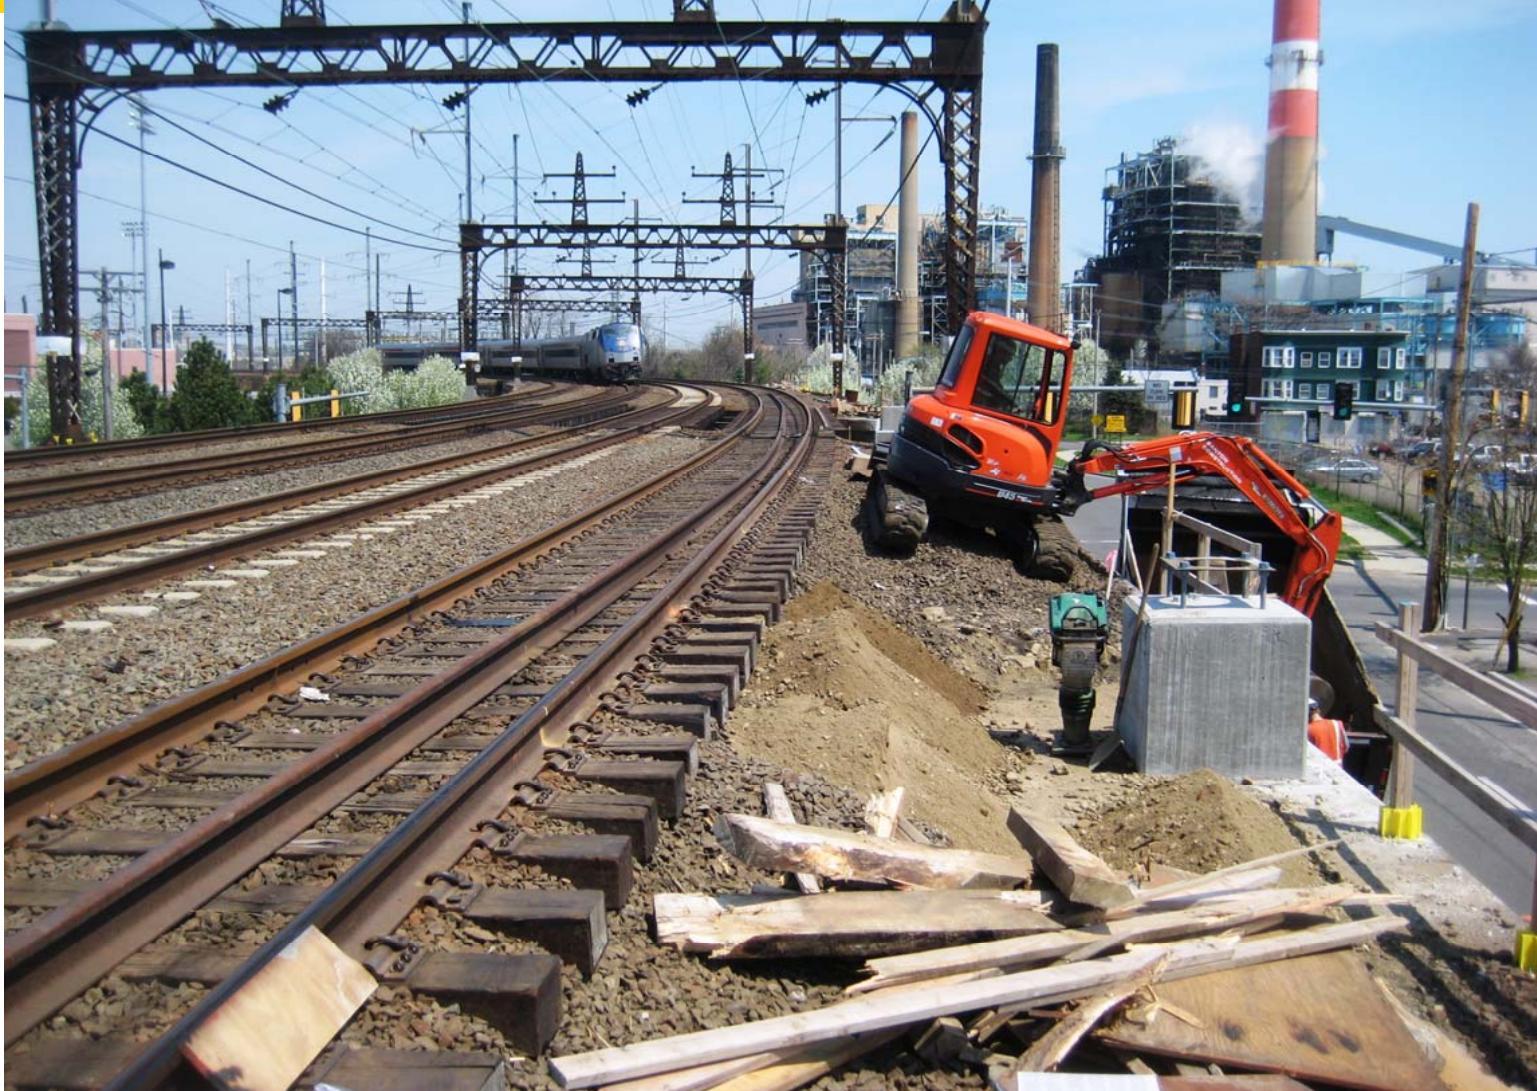
Completed catenary foundation in foreground, innovative use of machinery to get to tight and often difficult work locations.

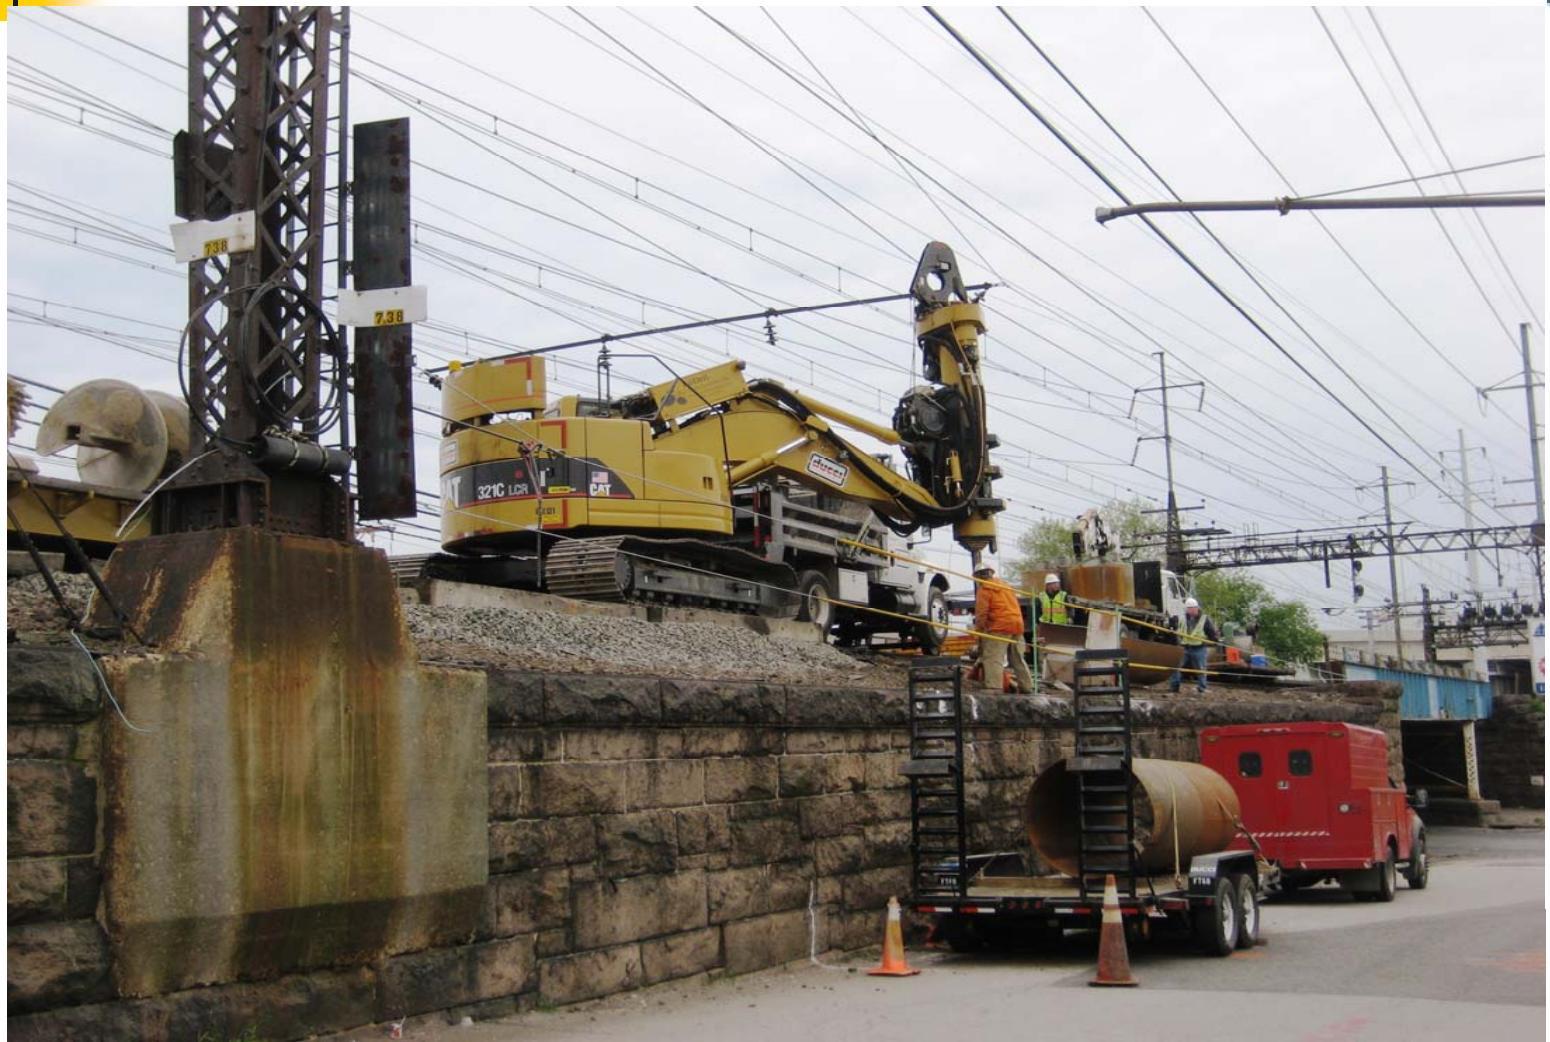
Specialized equipment required to work in tough locations and with limited headroom, notice the overhead wires.

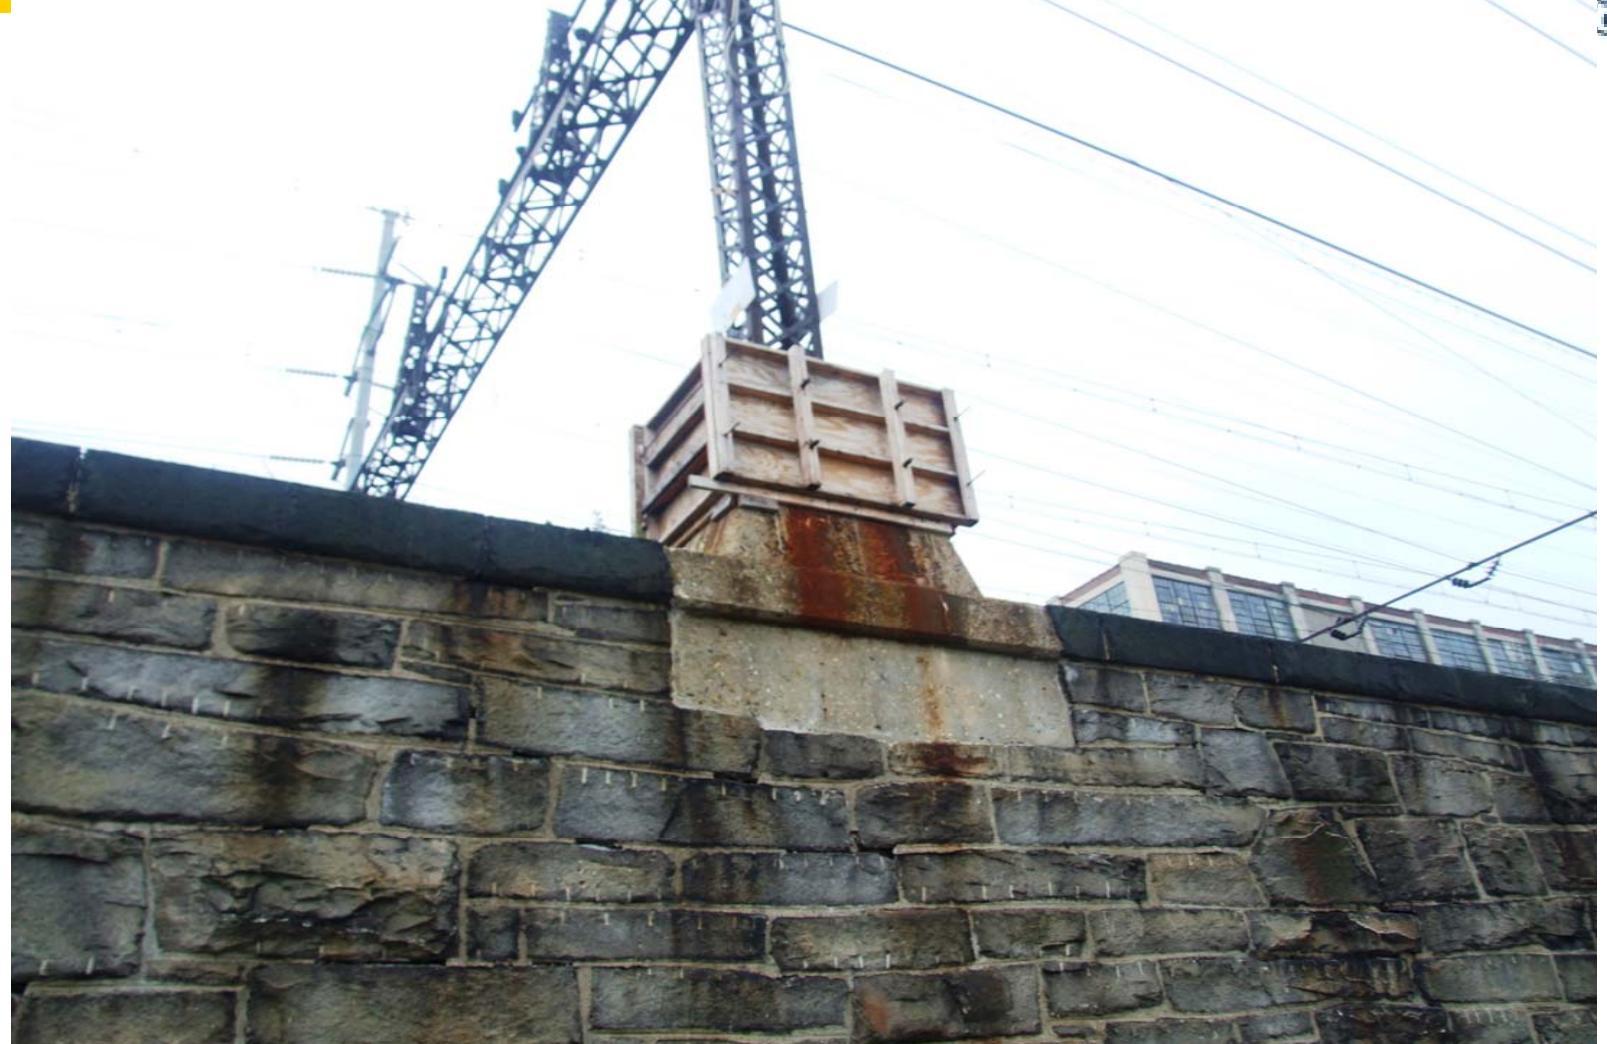
Catenary foundation atop a 20 foot retaining wall, formed and ready to receive concrete.
