PRESENTATION OVERVIEW

- Historical
- Selected Catenary & Bridge Replacement

In Connecticut, there are approximately 200 track miles of mainline overhead catenary powering our trains.

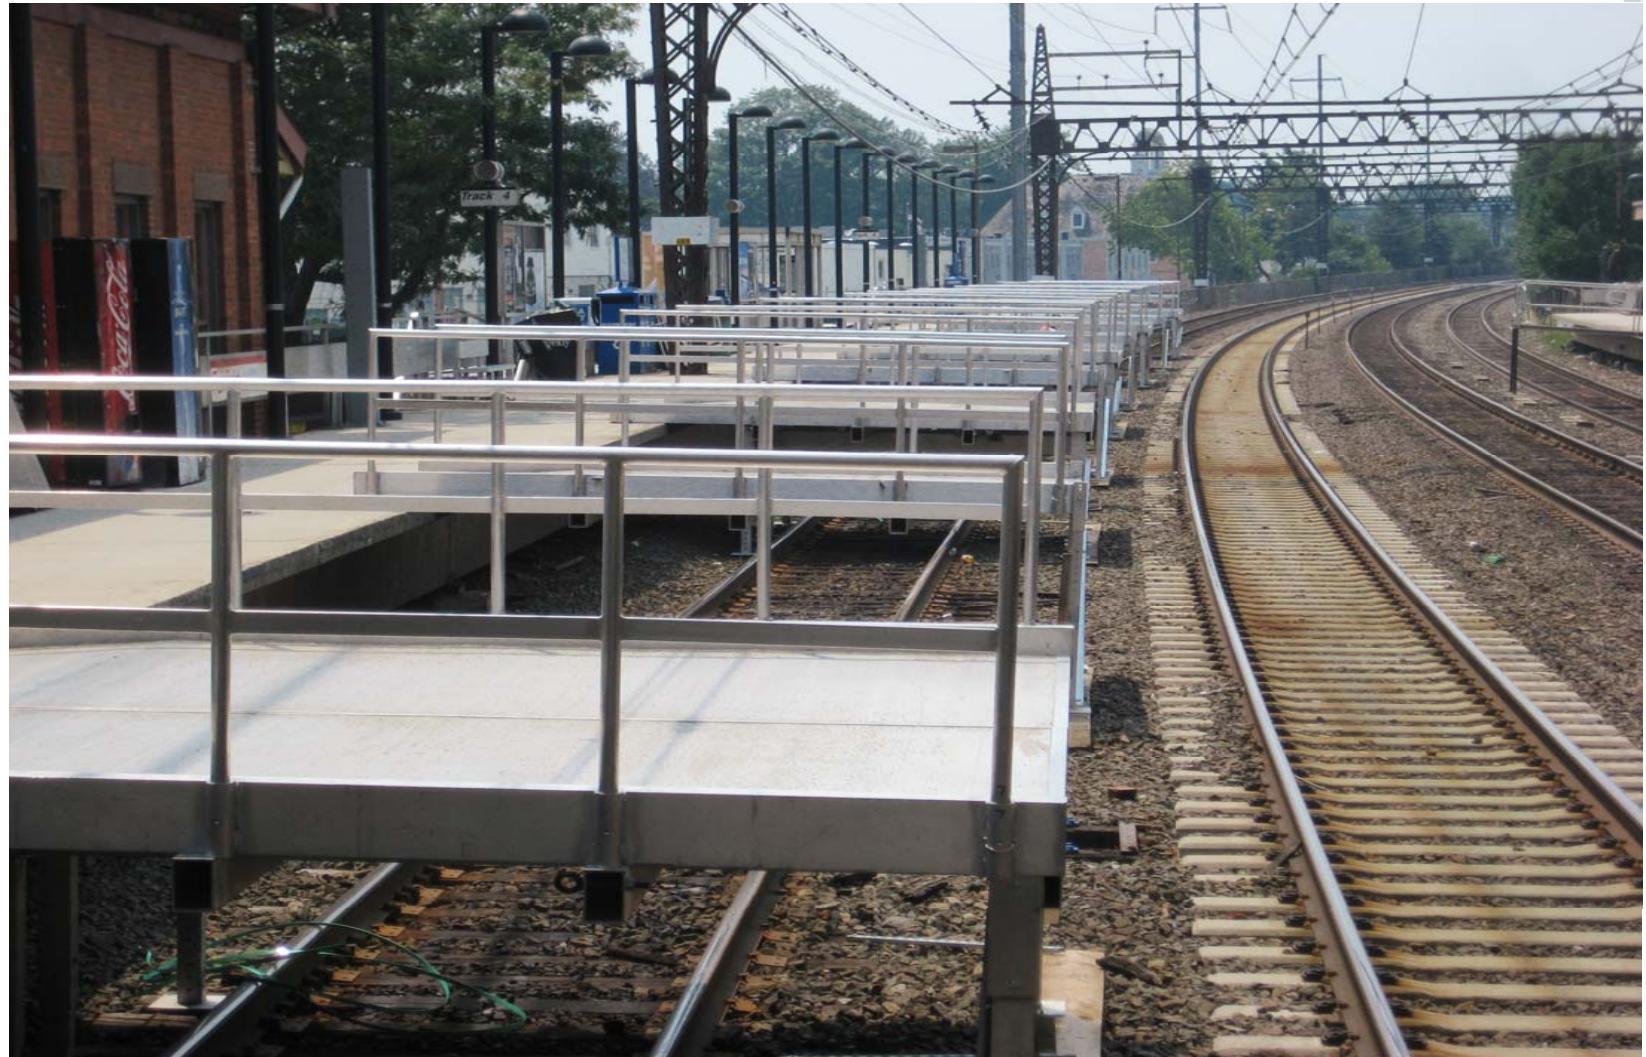
Continuous track outages require the deployment of station "Bridge Plates", shown here, that allow passengers to board train on inside tracks.41

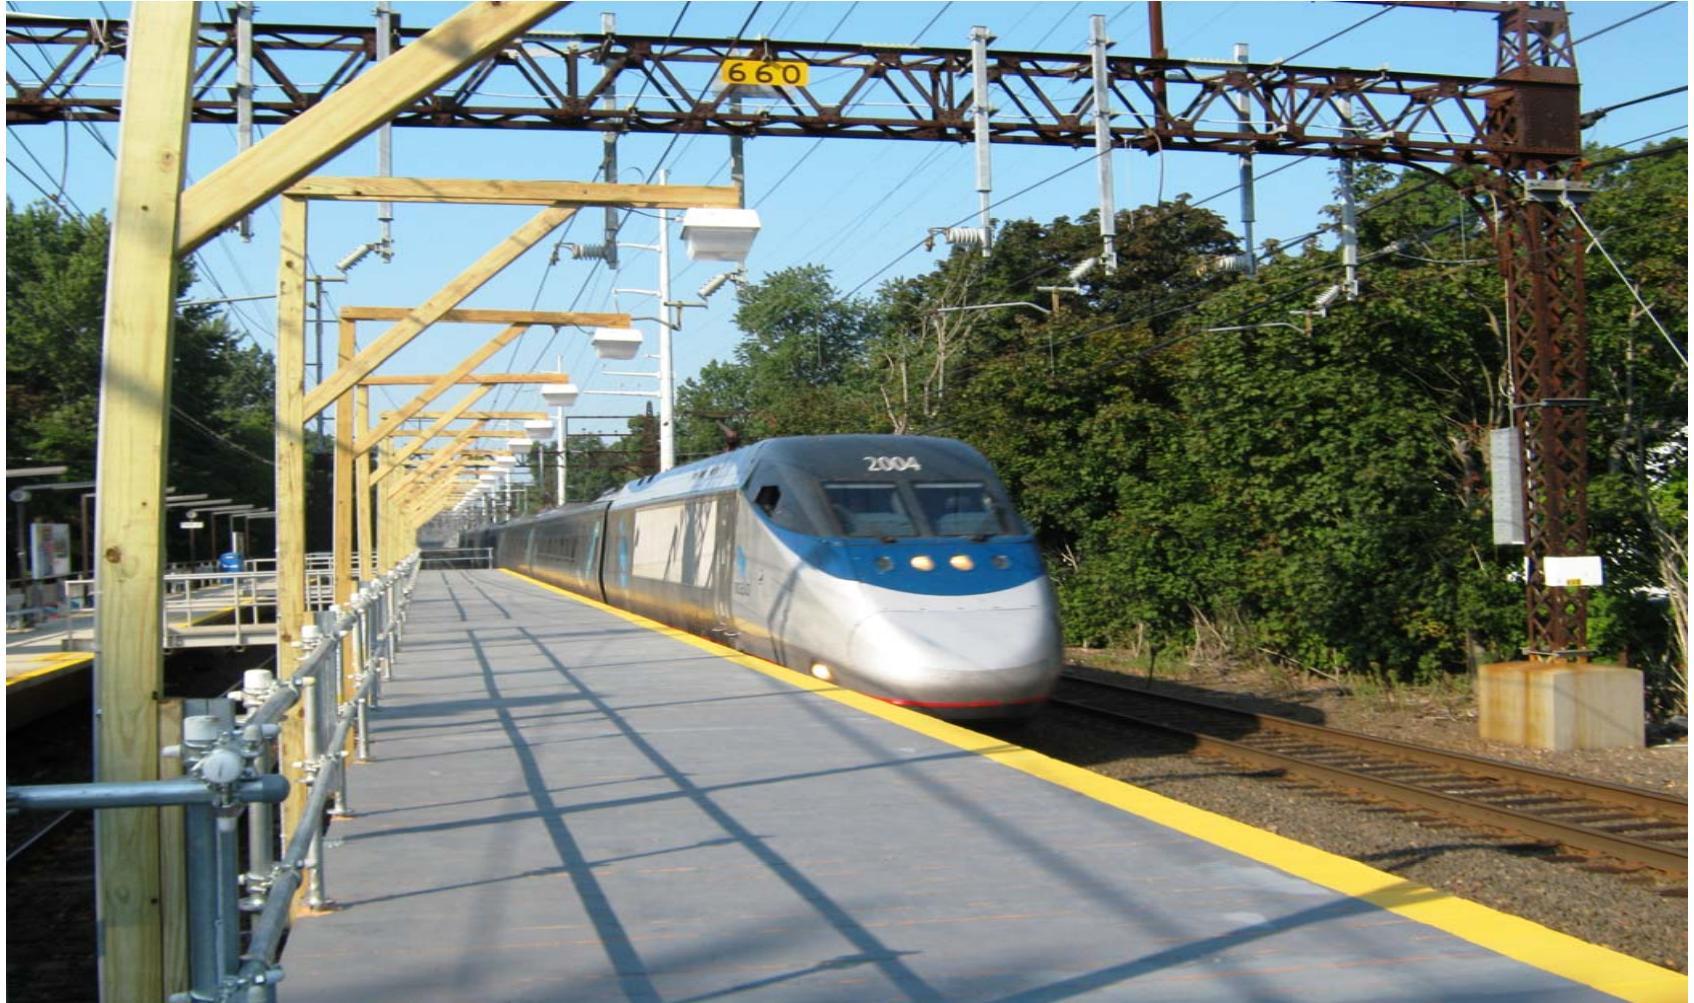
Continuous "Double Track" outages require the use of full length temporary platforms to be installed over inside track with use of bridge plates seen on left.

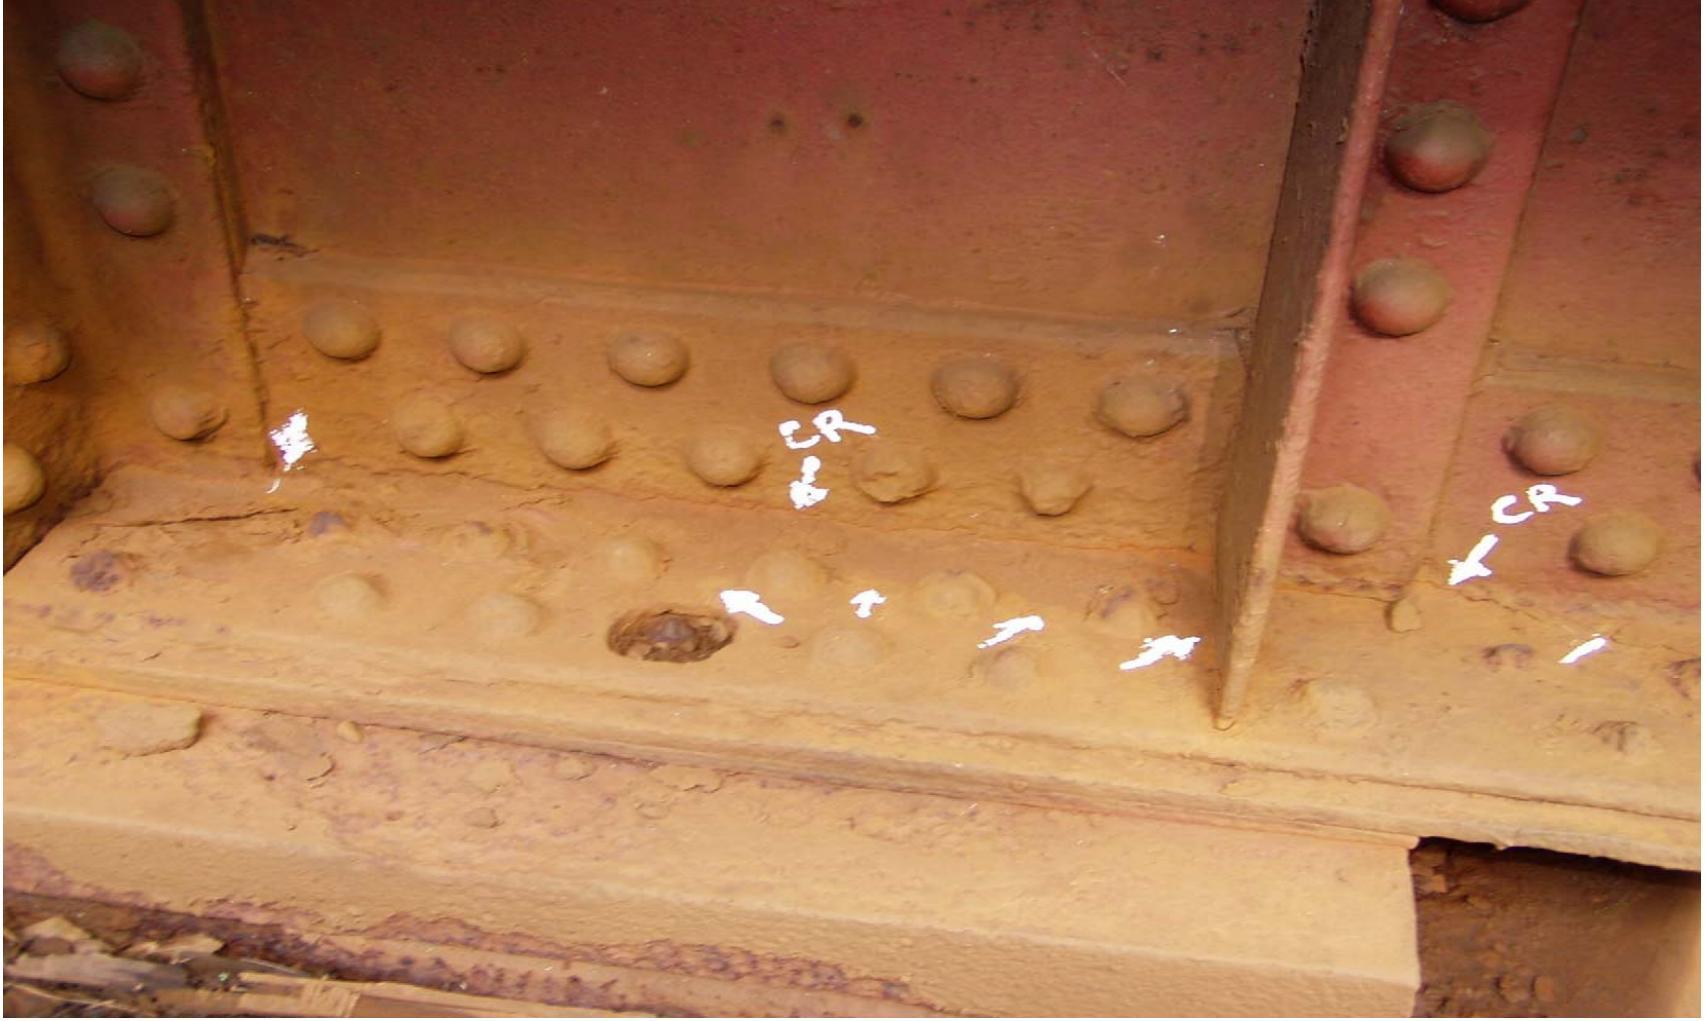
BRIDGE NO. 04132R – ROWAYTON AVE. MP 39.11, NORWALK

CONDITION - shows up as cracks often when a bridge has experienced stress cycles beyond its design life.

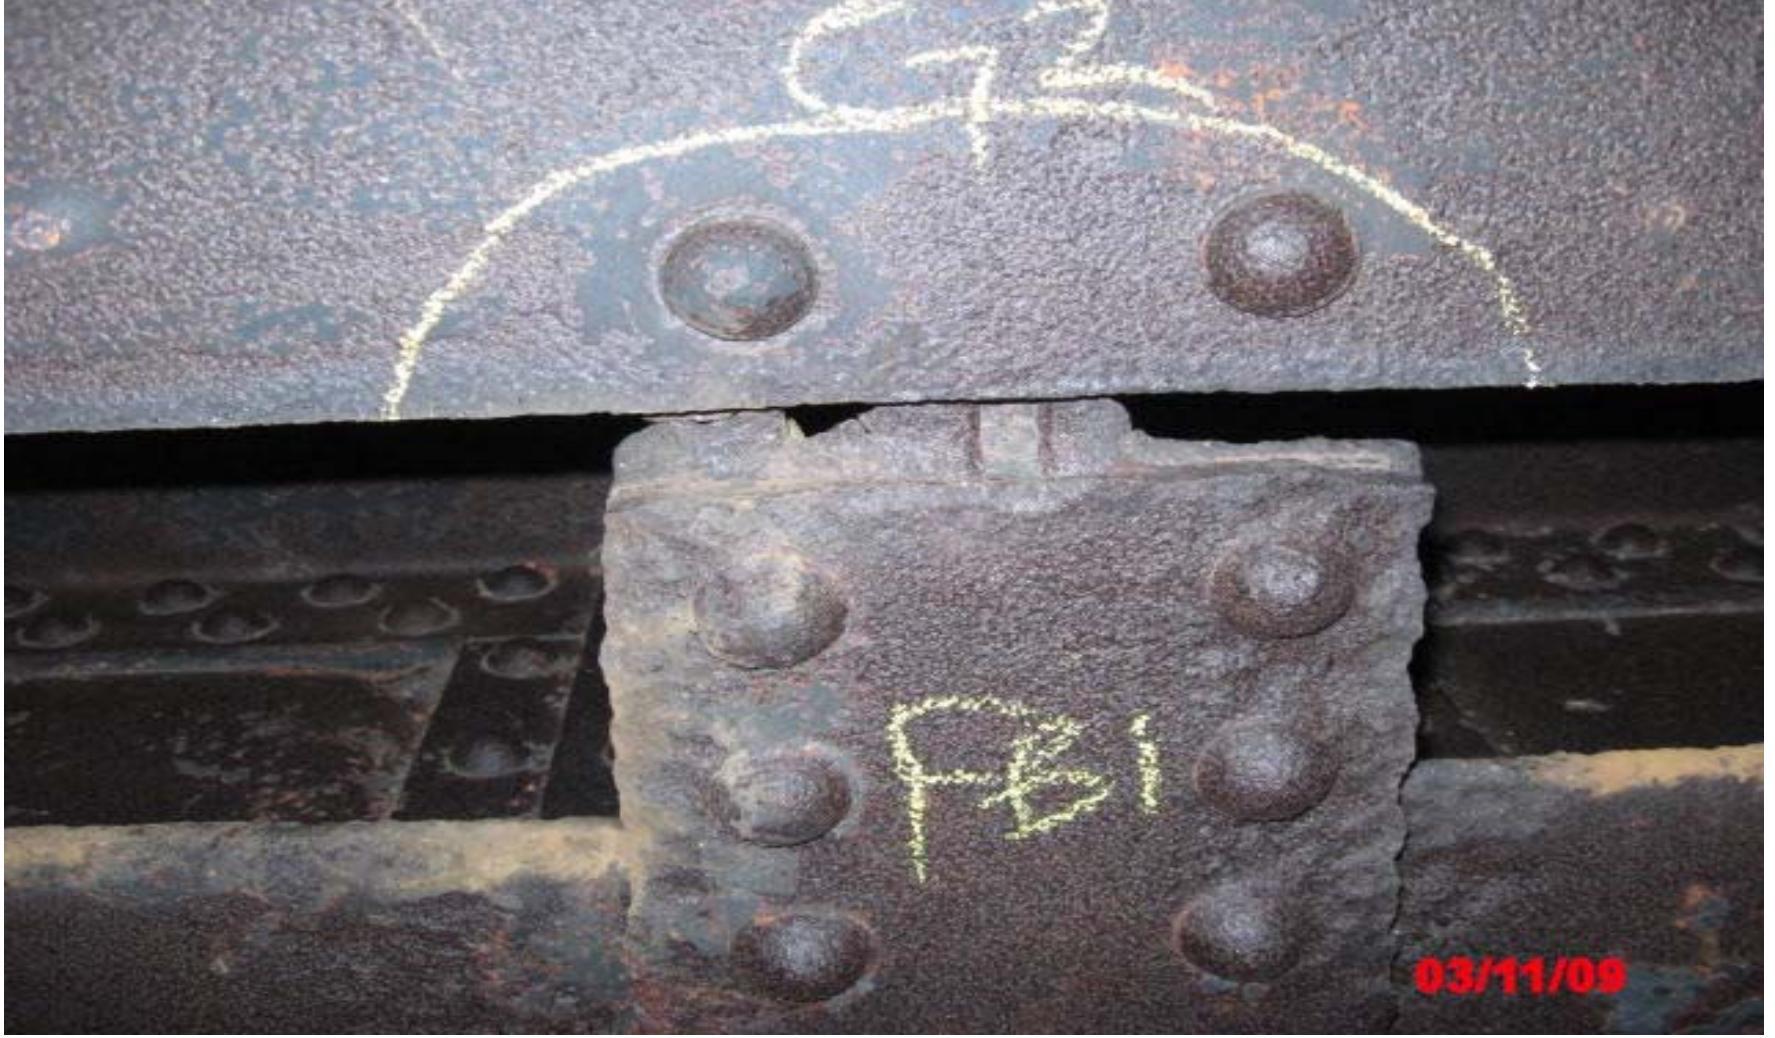
BRIDGE NO. 03691R – EAST AVE. MP 42.14, NORWALK

LOAD RATING - Section loss (rust) is a steel structures biggest enemy and reduces its load carrying capacity.

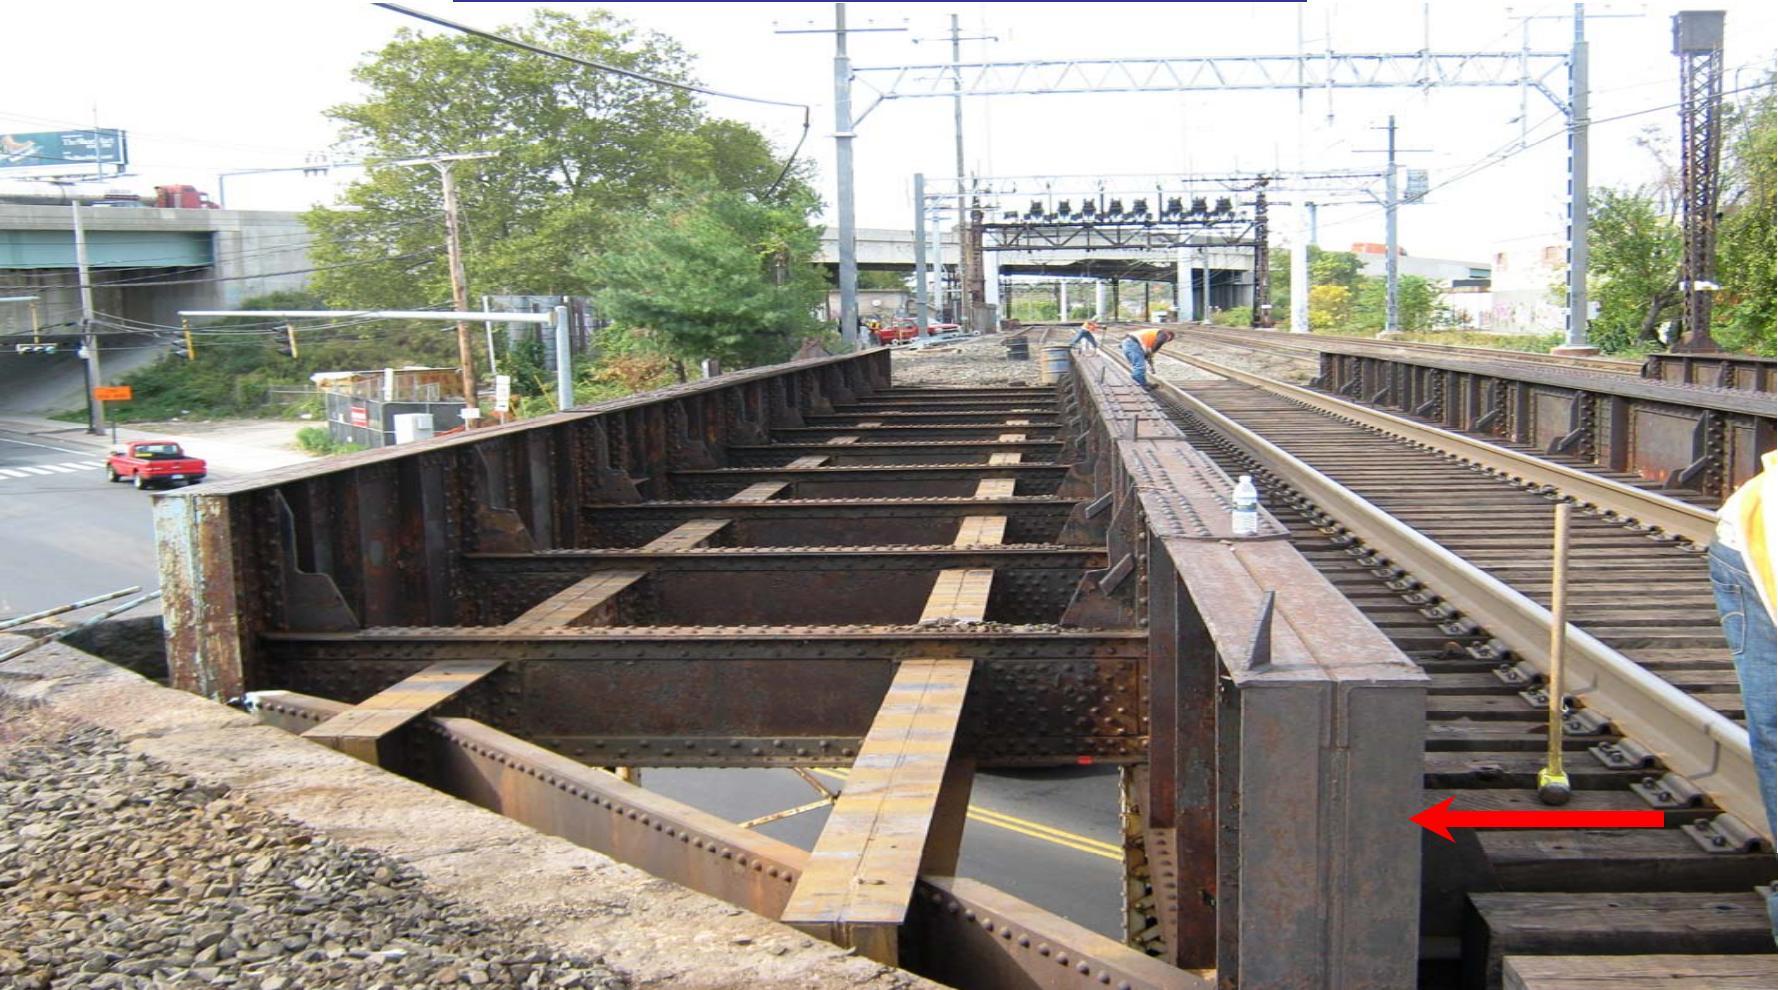
OPEN-DECK THRU GIRDER BRIDGE

OUT WITH THE OLD – existing bridge at Fairfield Avenue showing one track with deck removed, adjacent to track that still has the open deck timber structure. Of note is the common girder (red arrow) that supports both tracks and is non-redundant. 48

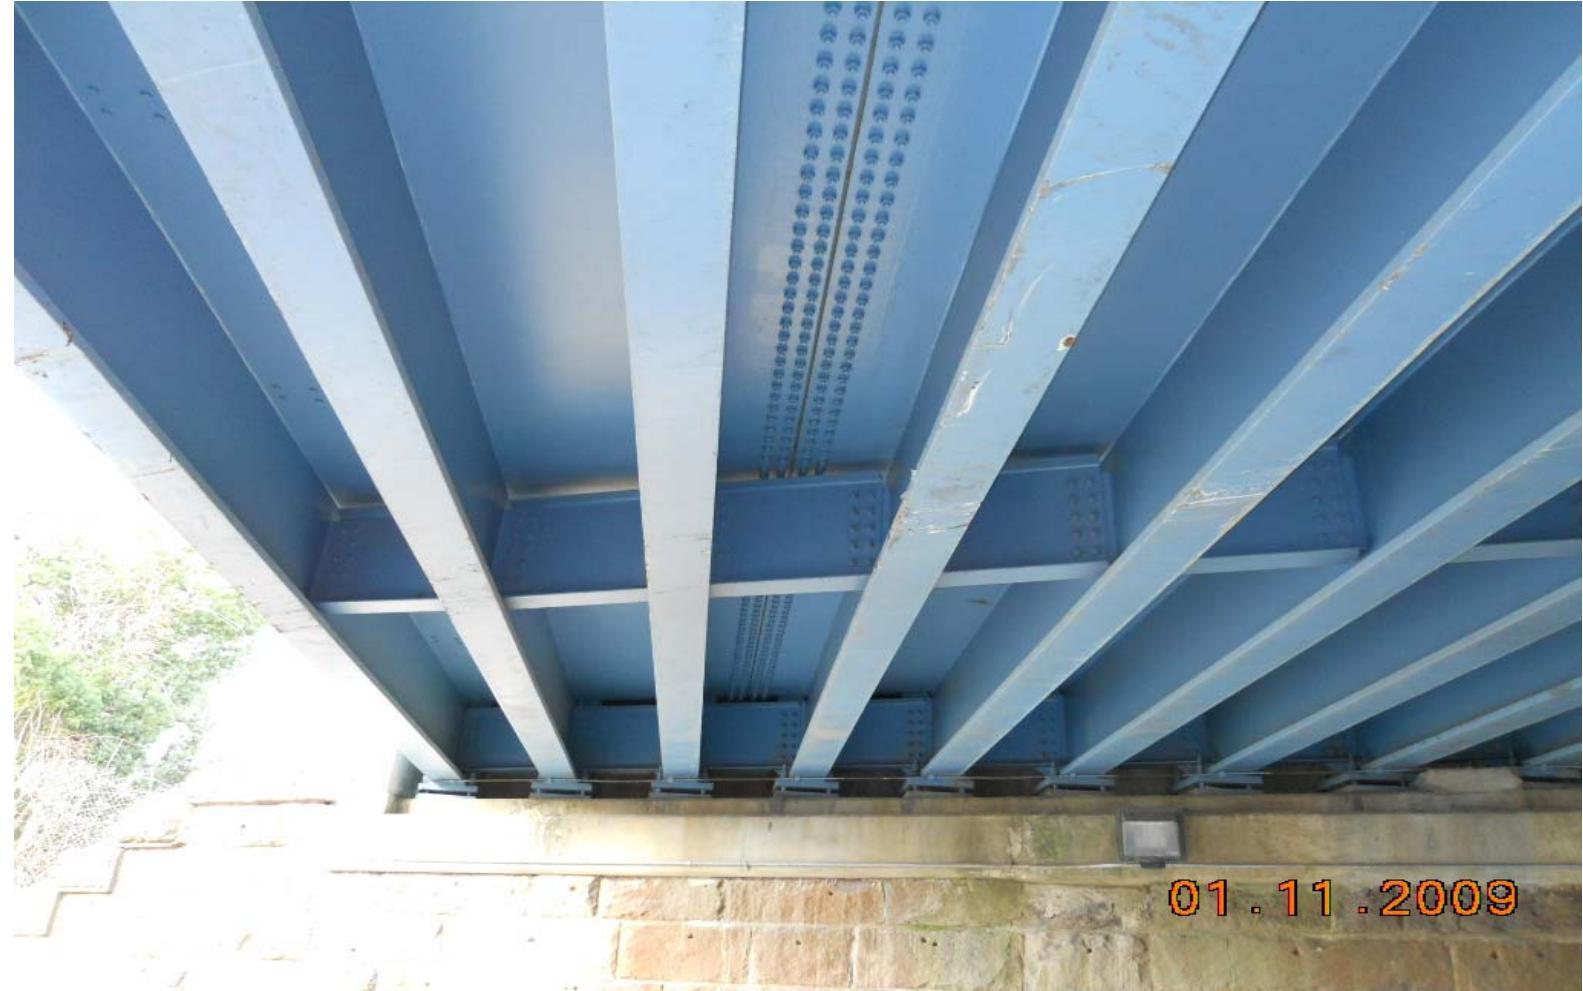
BRIDGE NO. 03943R – N. WATER ST. M.P. 26.1, GREENWICH

<u>NEW BRIDGE</u> – multi-beam deck girder construction, ballasted deck, built in redundancy against bridge failure. Easy to inspect and perform maintenance. COMPLETED 2004.

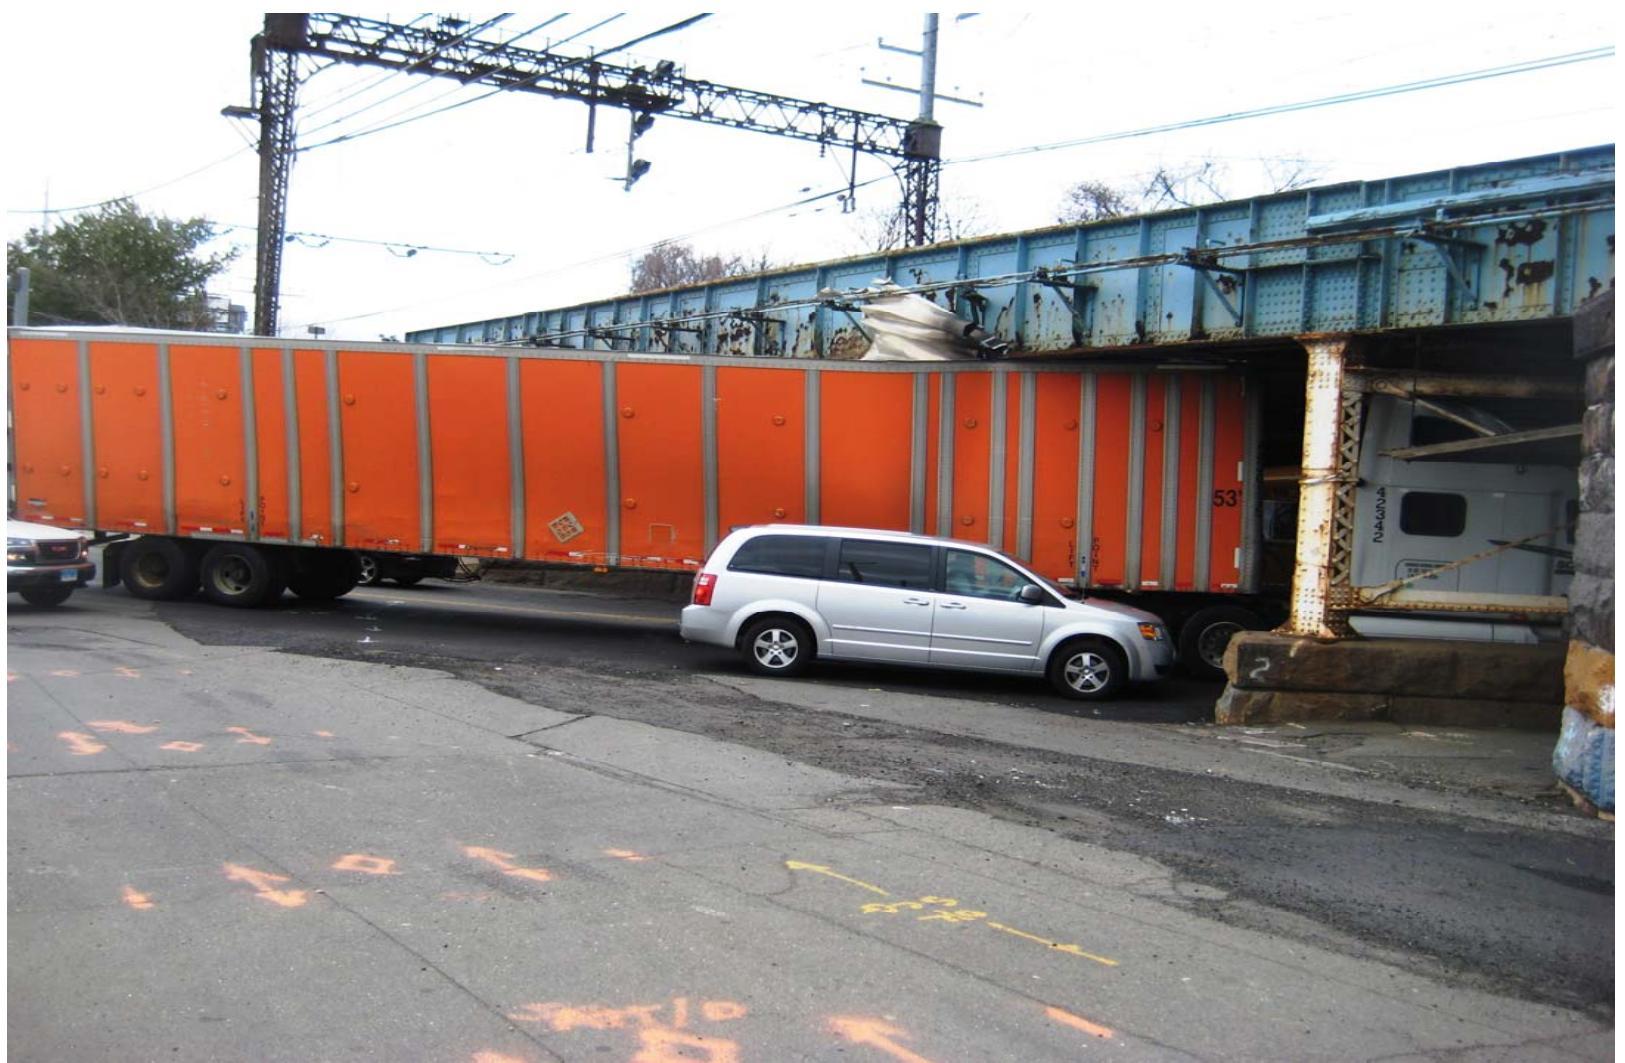
BRIDGE NO. 03635R – FAIRFIELD AVE. M.P. 53.42, BRIDGEPORT

VERTICAL CLEARANCE IS IMPORTANT

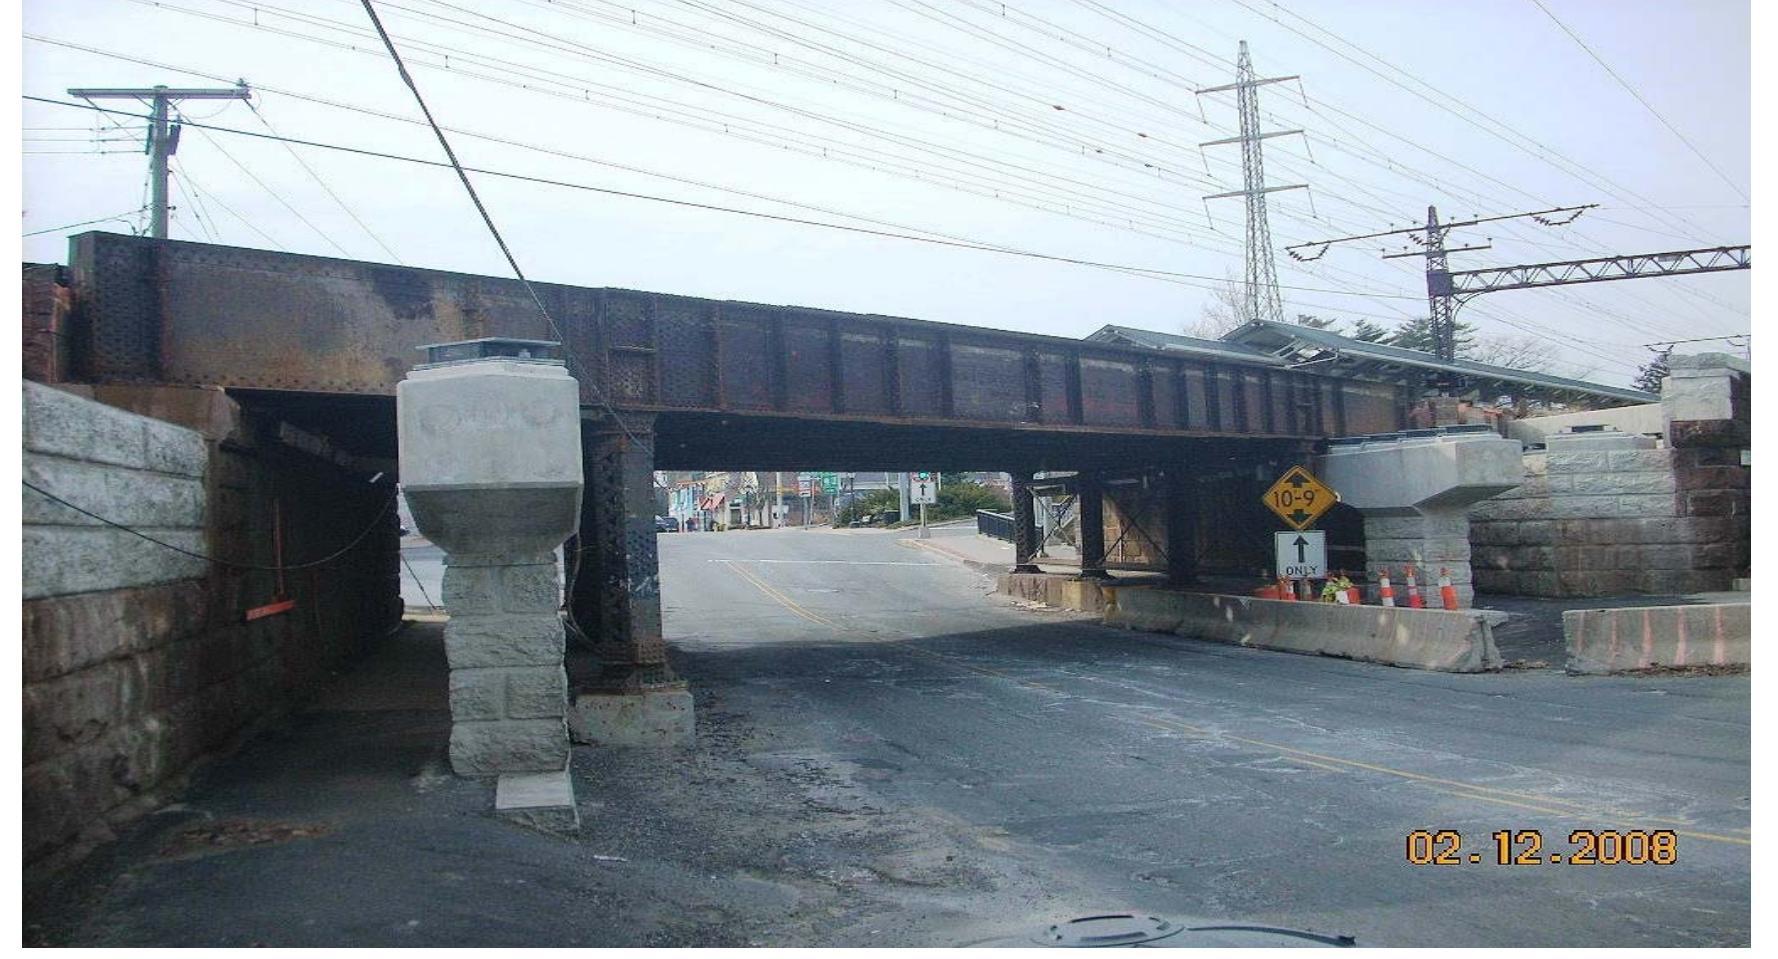
BRIDGE NO. 00316R – BOSTON POST RD. (US RTE 1) MP 37.82, DARIEN

NEW BRIDGE UNDER CONSTRUCTION REQUIRING ROADWAY UNDERCUTTING DUE TO LOW VEHICLE UNDERCLEARANCE DURING CONSTRUCTION. ROADWAY WAS ALSO WIDENED.

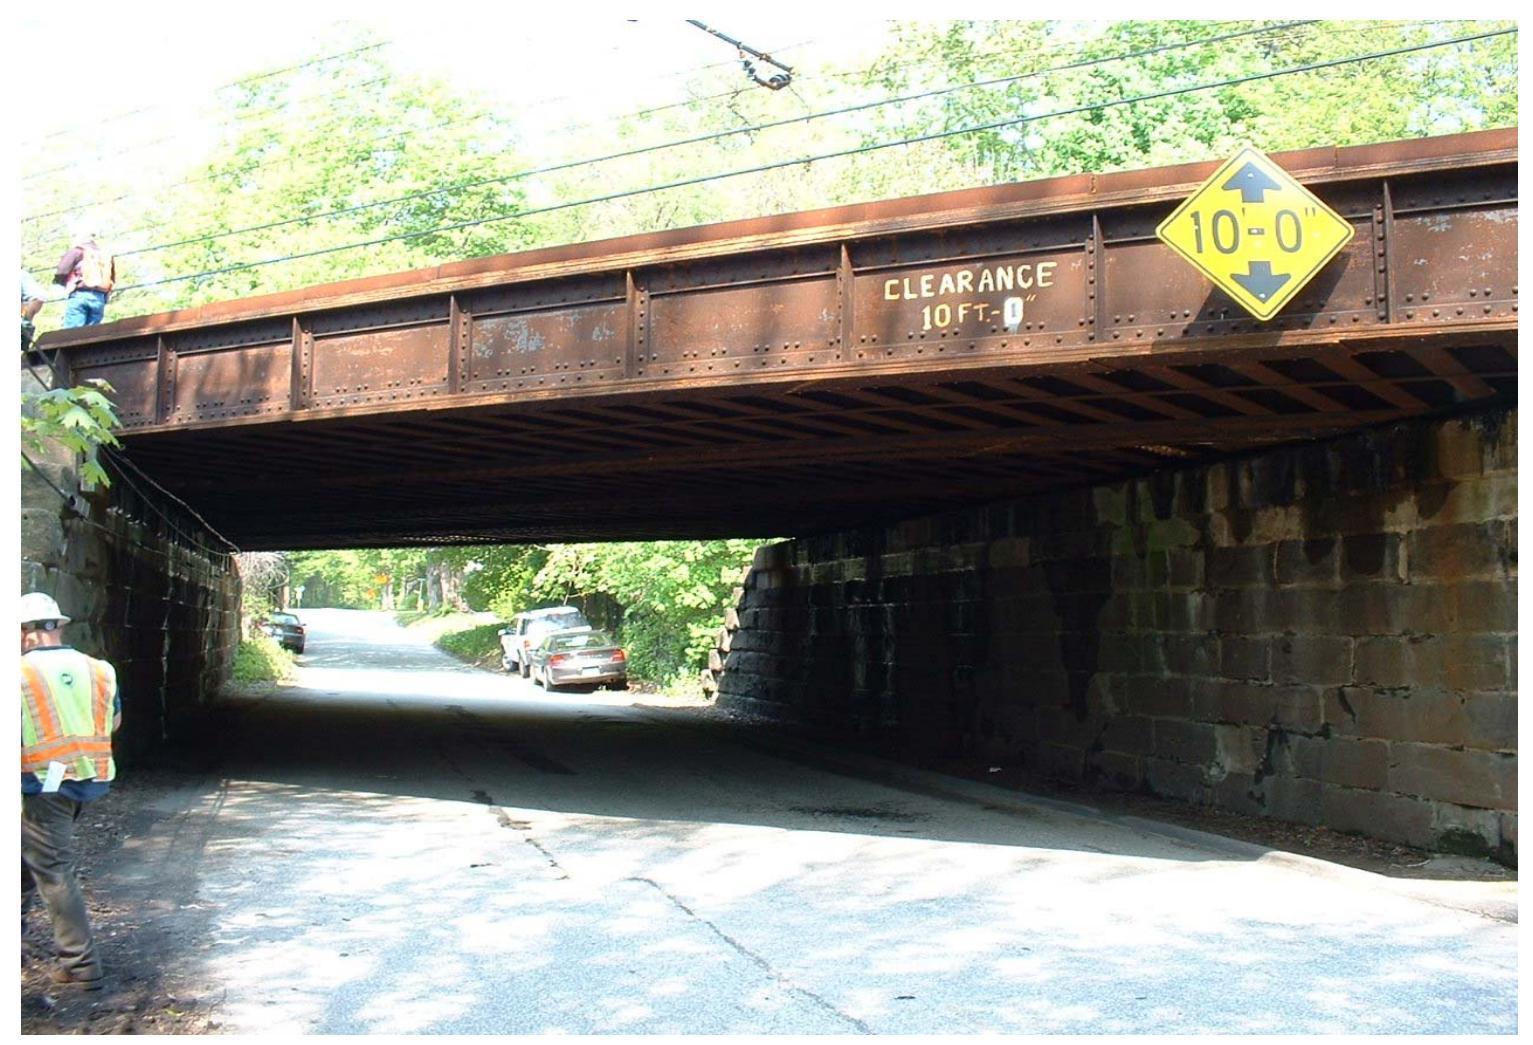
BRIDGE NO. 08039R – WESTWAY ROAD, M.P. 48.65, FAIRFIELD

View before removal of first two tracks.

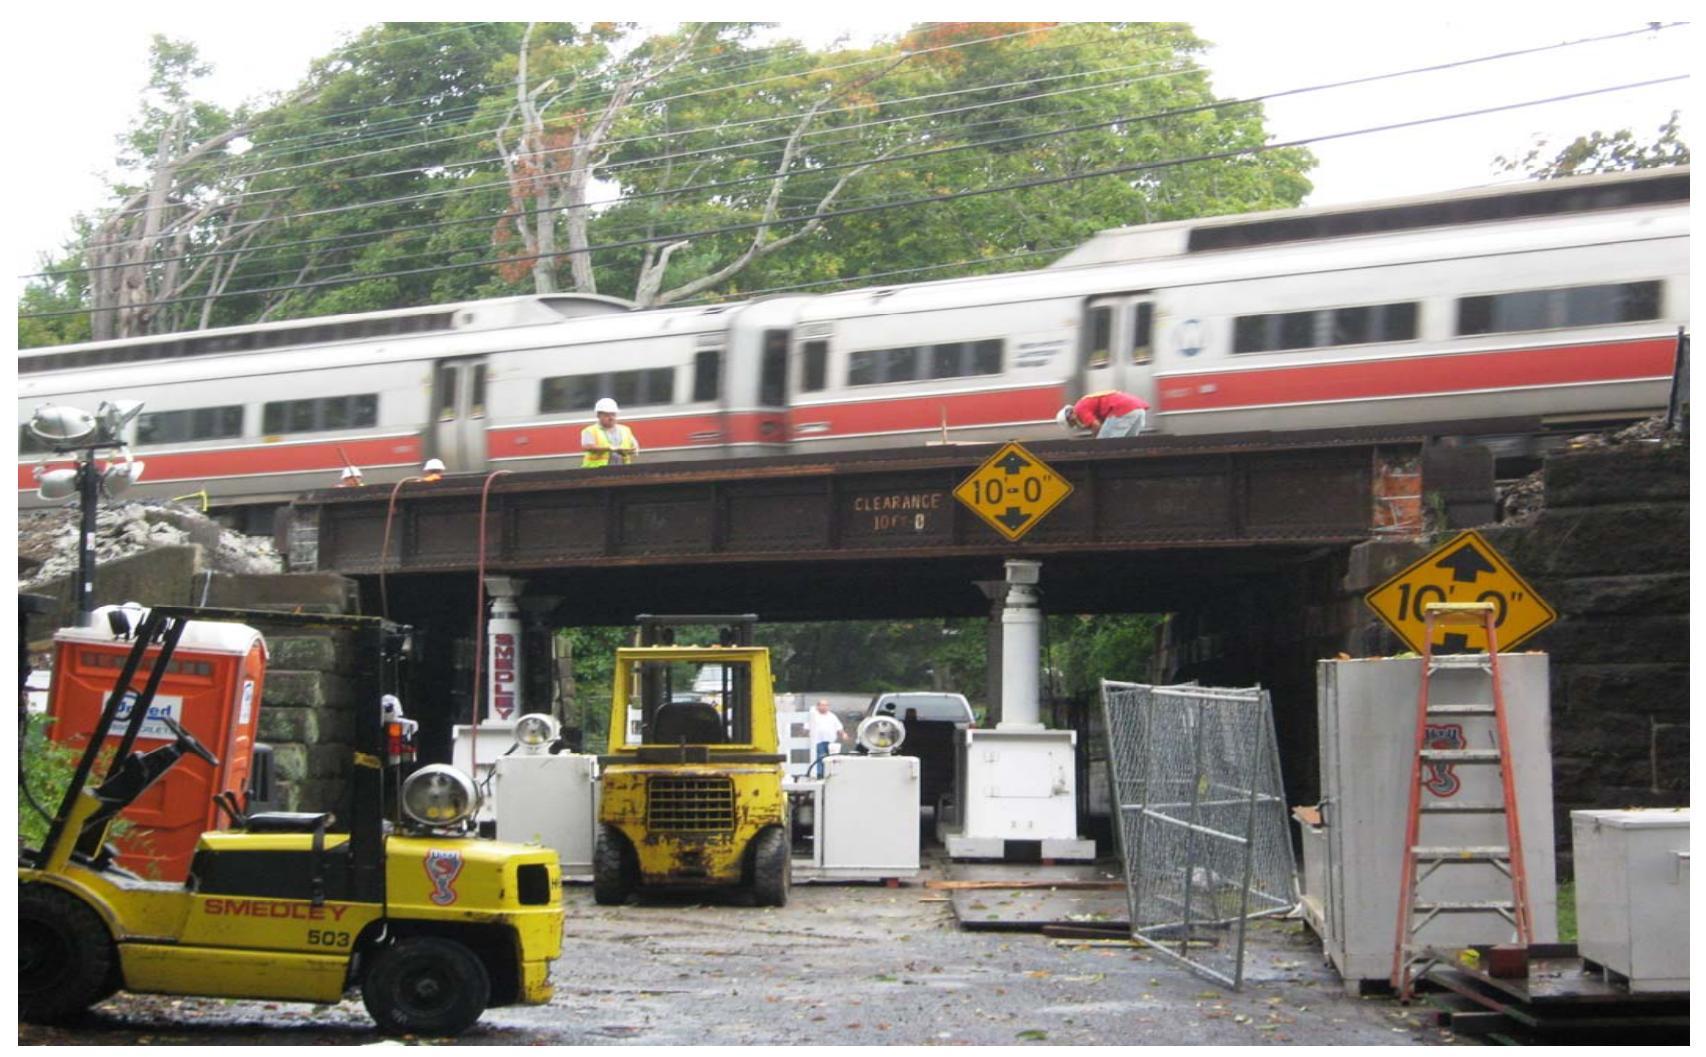
Setting up of the four hydraulic jacks leading up to the removal of first of two tracks. 55

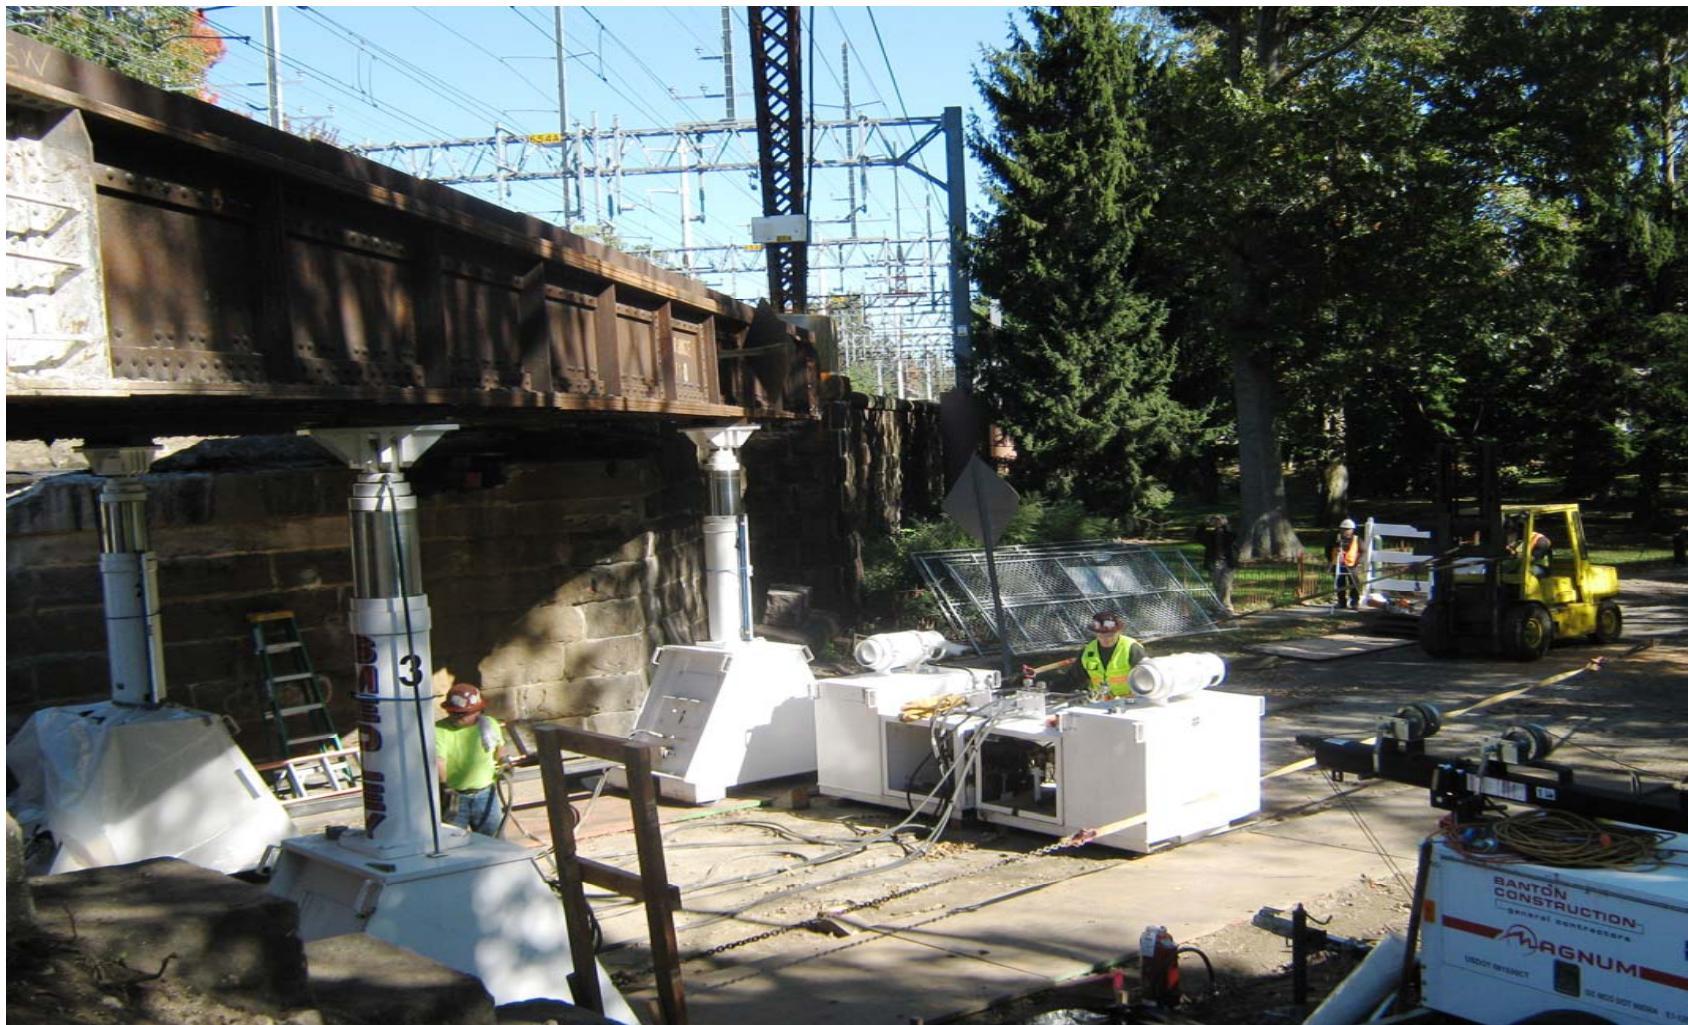
BRIDGE NO. 08039R – WESTWAY ROAD, M.P. 48.65, FAIRFIELD

The four bridge jacks are linked by the command station allowing them to work together to raise the bridge off its abutments and walk it up the street.

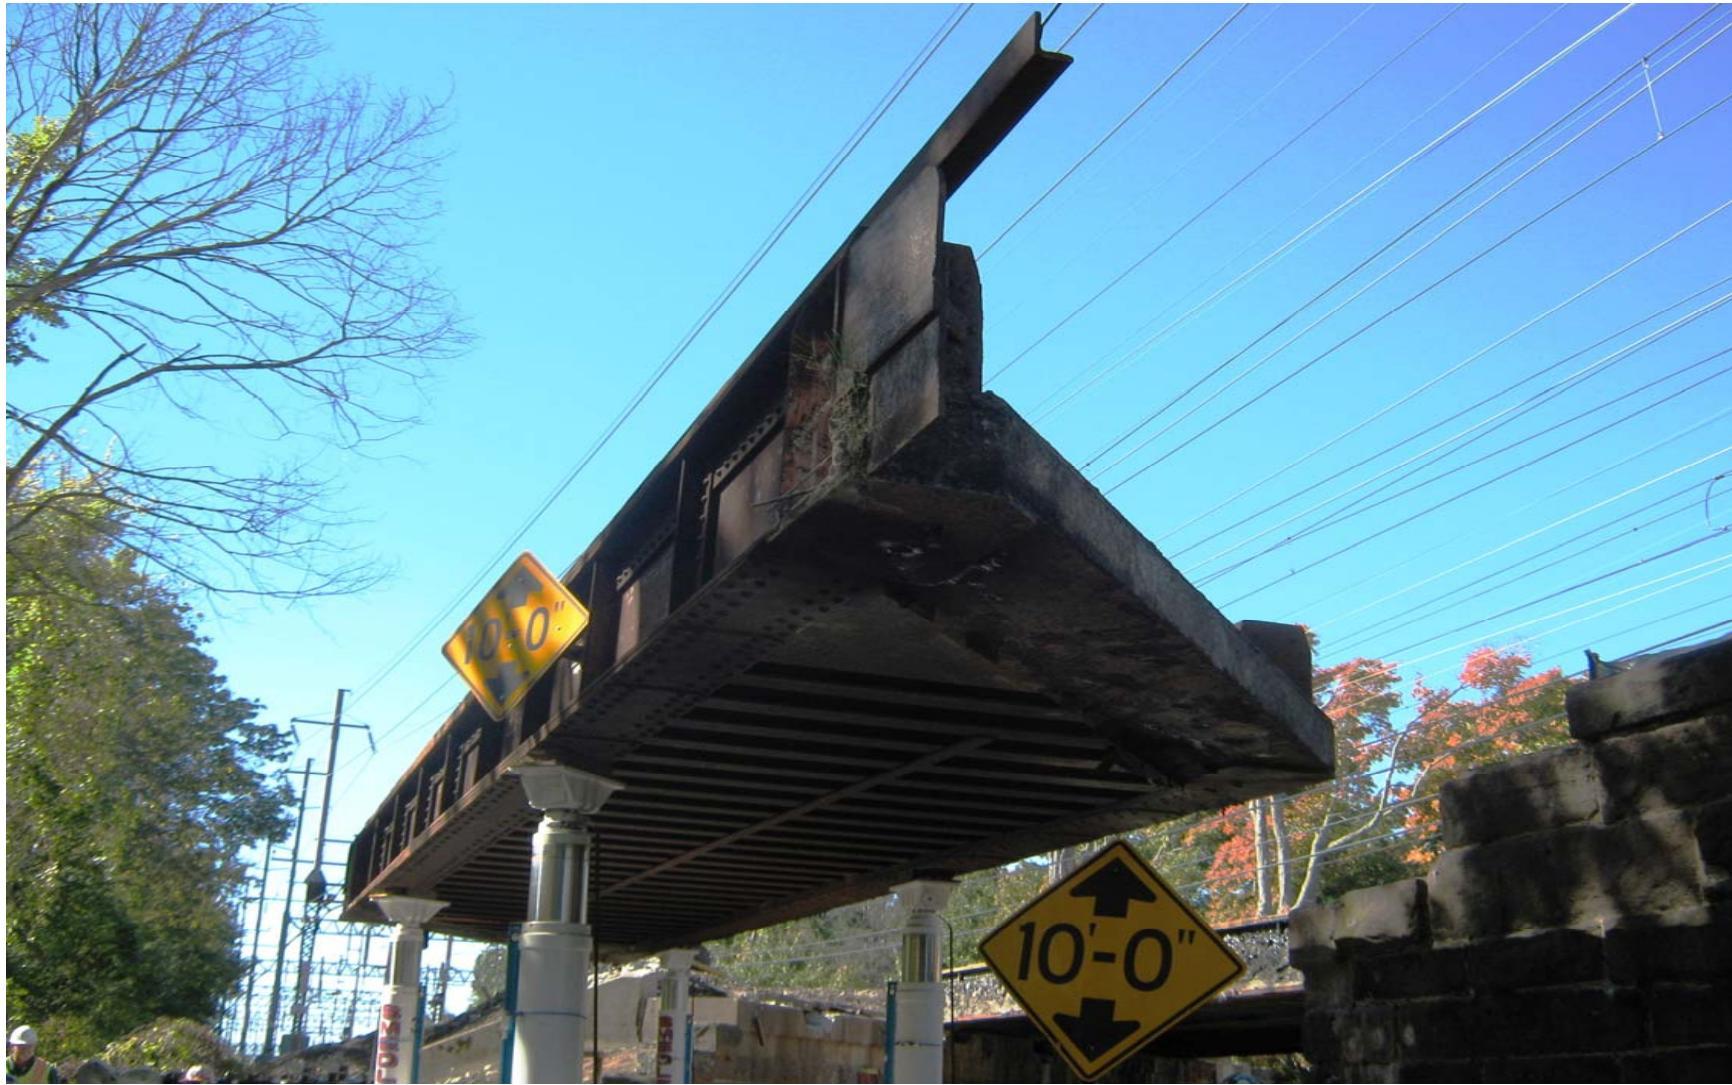
View of the removal of first two tracks.

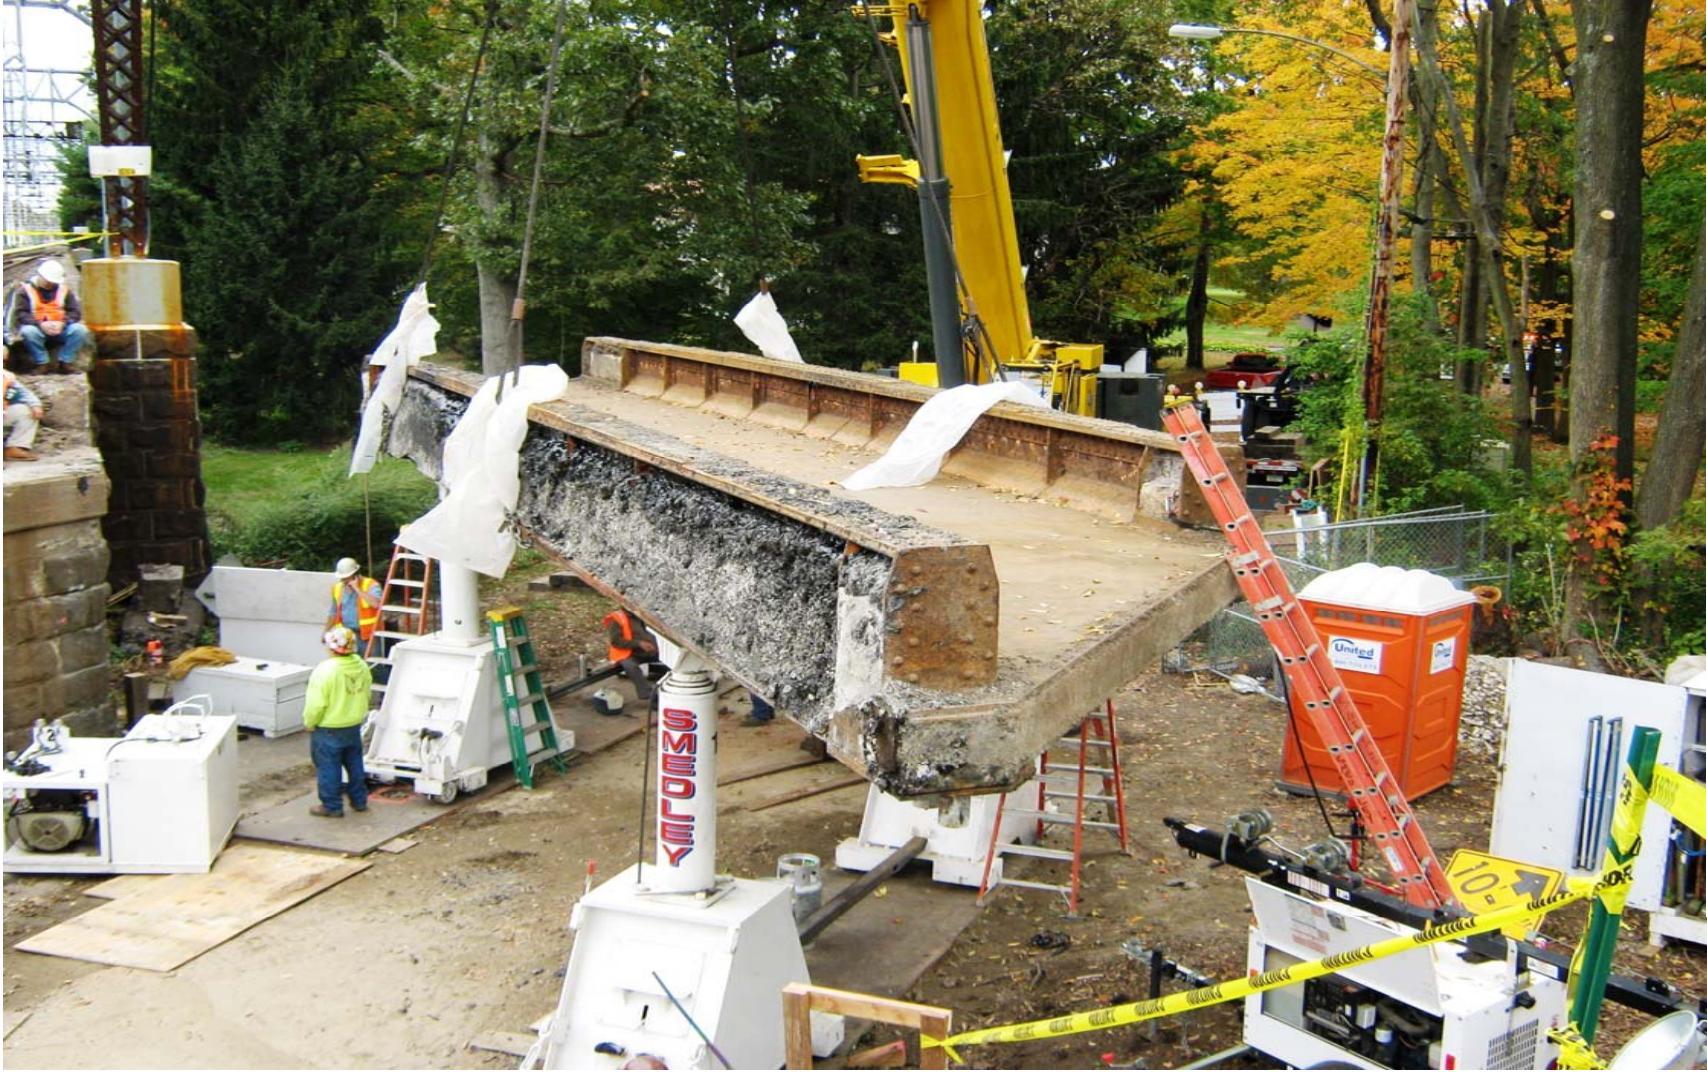
Final stage of bridge removal, now that there is overhead clearance the crane can be used to load the old bridge on a trailer to be hauled of site.
