PRESENTATION OVERVIEW

- Historical
- Selected Catenary & Bridge Replacement

In Connecticut, there are approximately 200 track miles of mainline overhead catenary powering our trains.

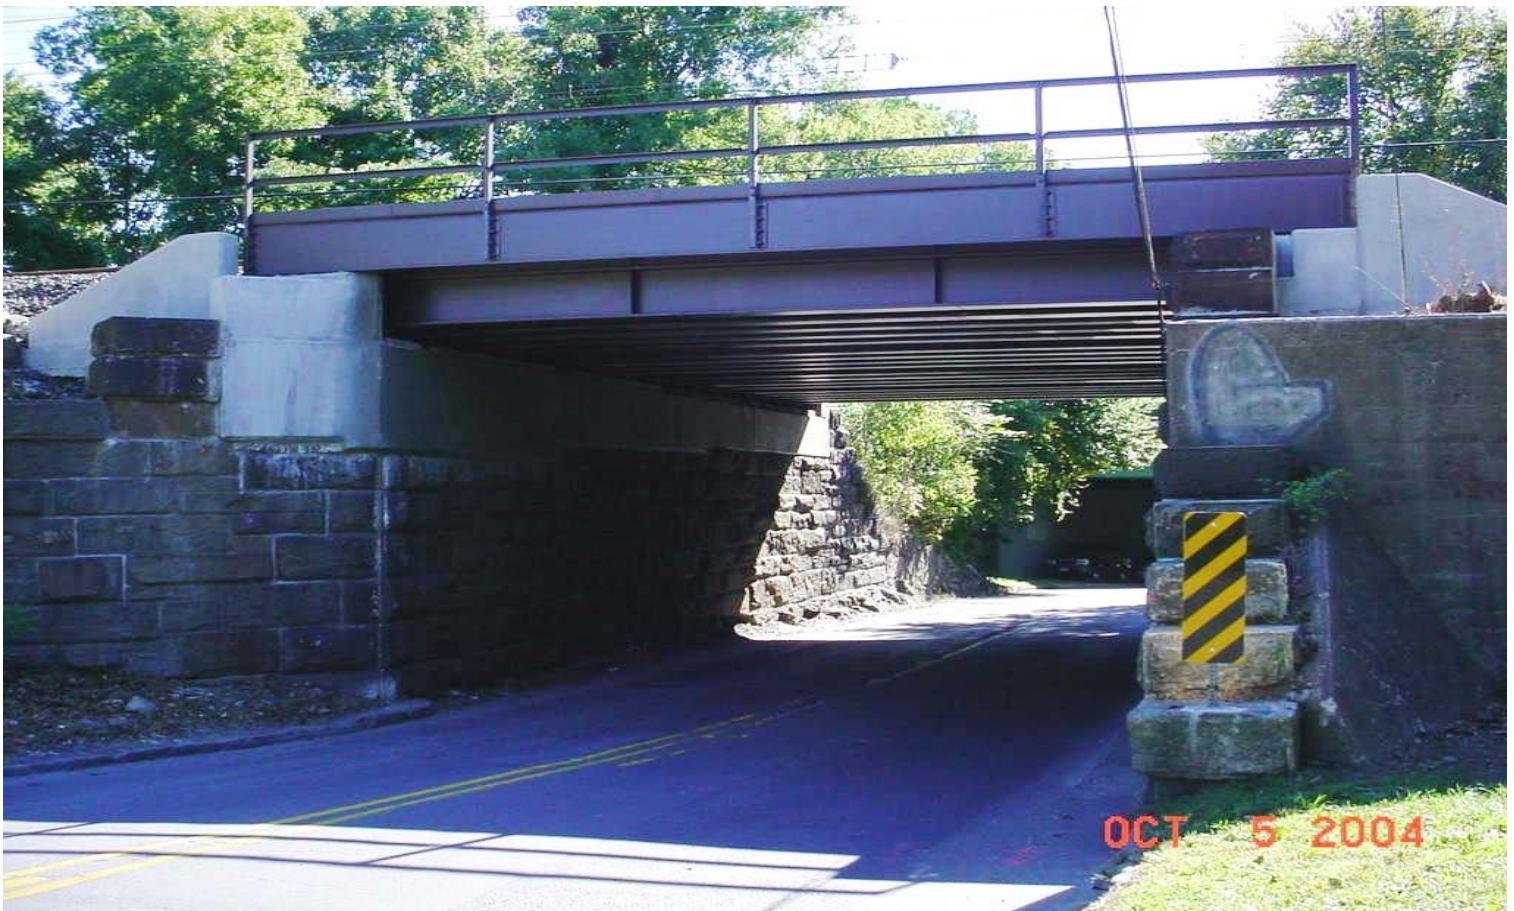
BRIDGE NO. 03945R – HAMILTON AVENUE MP 26.79, GREENWICH

ORIGINALLY BUILT: 1893
 BRIDGE TYPE: STEEL THROUGH GIRDER
 TYPICAL ABUTMENT CONFIGURATION
 NEW CONCRETE BRIDGE SEAT

✤ CONSTRUCTION COMPLETED: 2004

✤ BRIDGE TYPE: MULTI BEAM DECK GIRDER

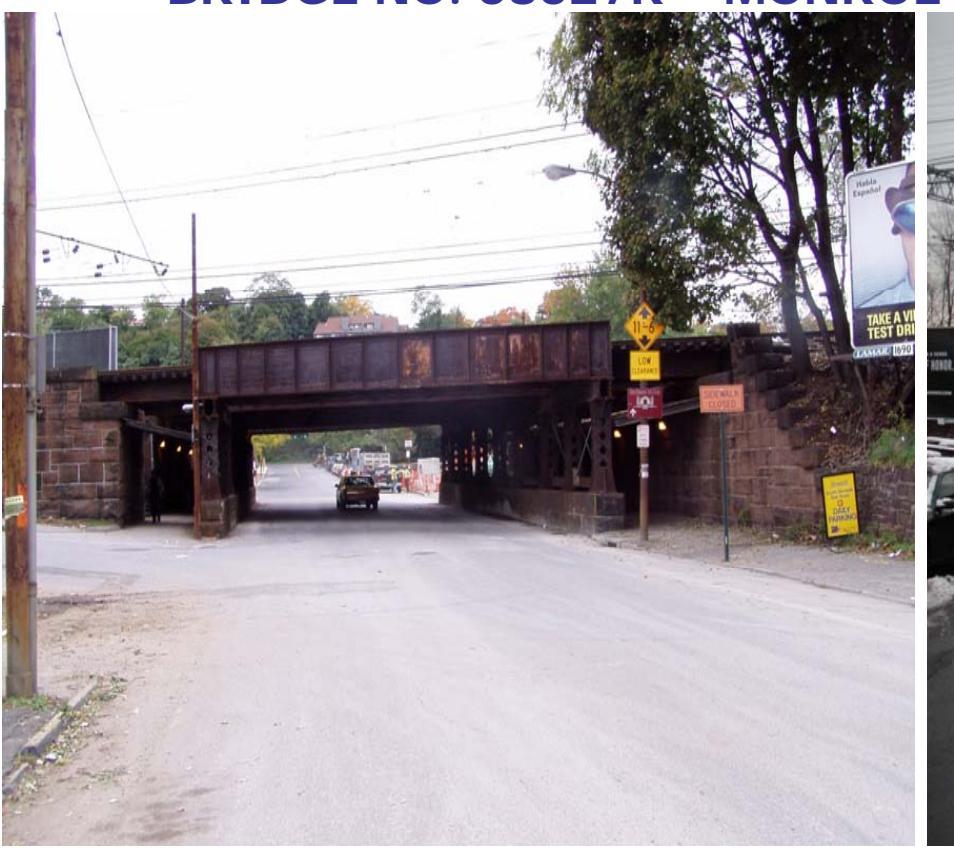
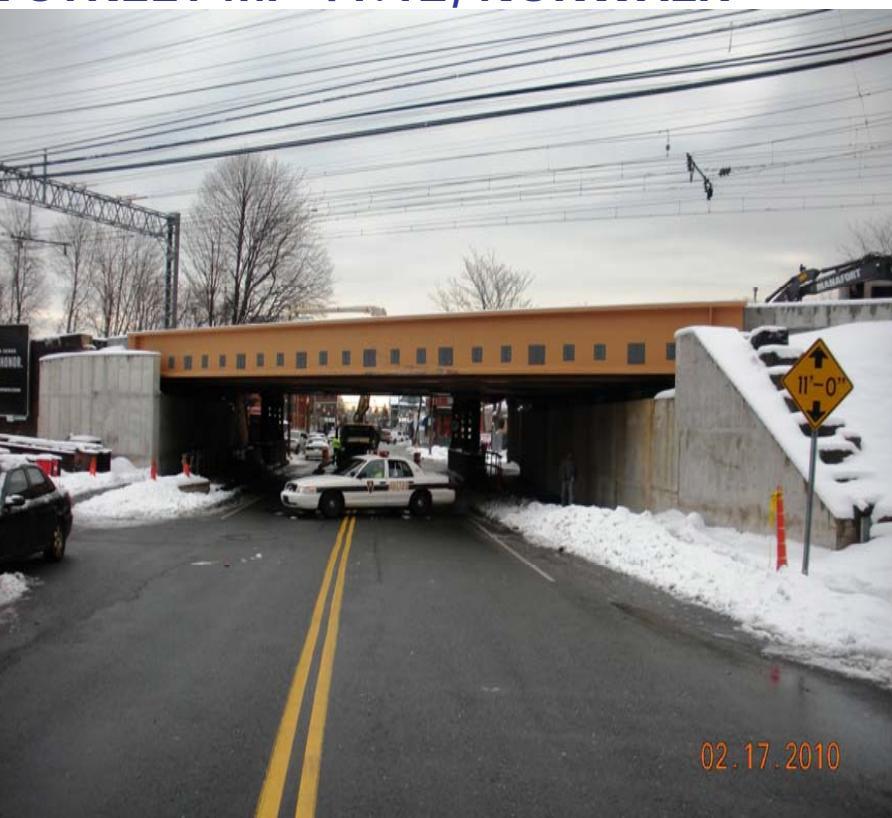
BRIDGE NO. 08027R – MONROE STREET MP 41.12, NORWALK

BEFORE CONSTRUCTION – 3 SPAN, OPEN DECK BRIDGE.

ORIGINALLY BUILT: 1895
BRIDGE TYPE: STEEL THROUGH GIRDER

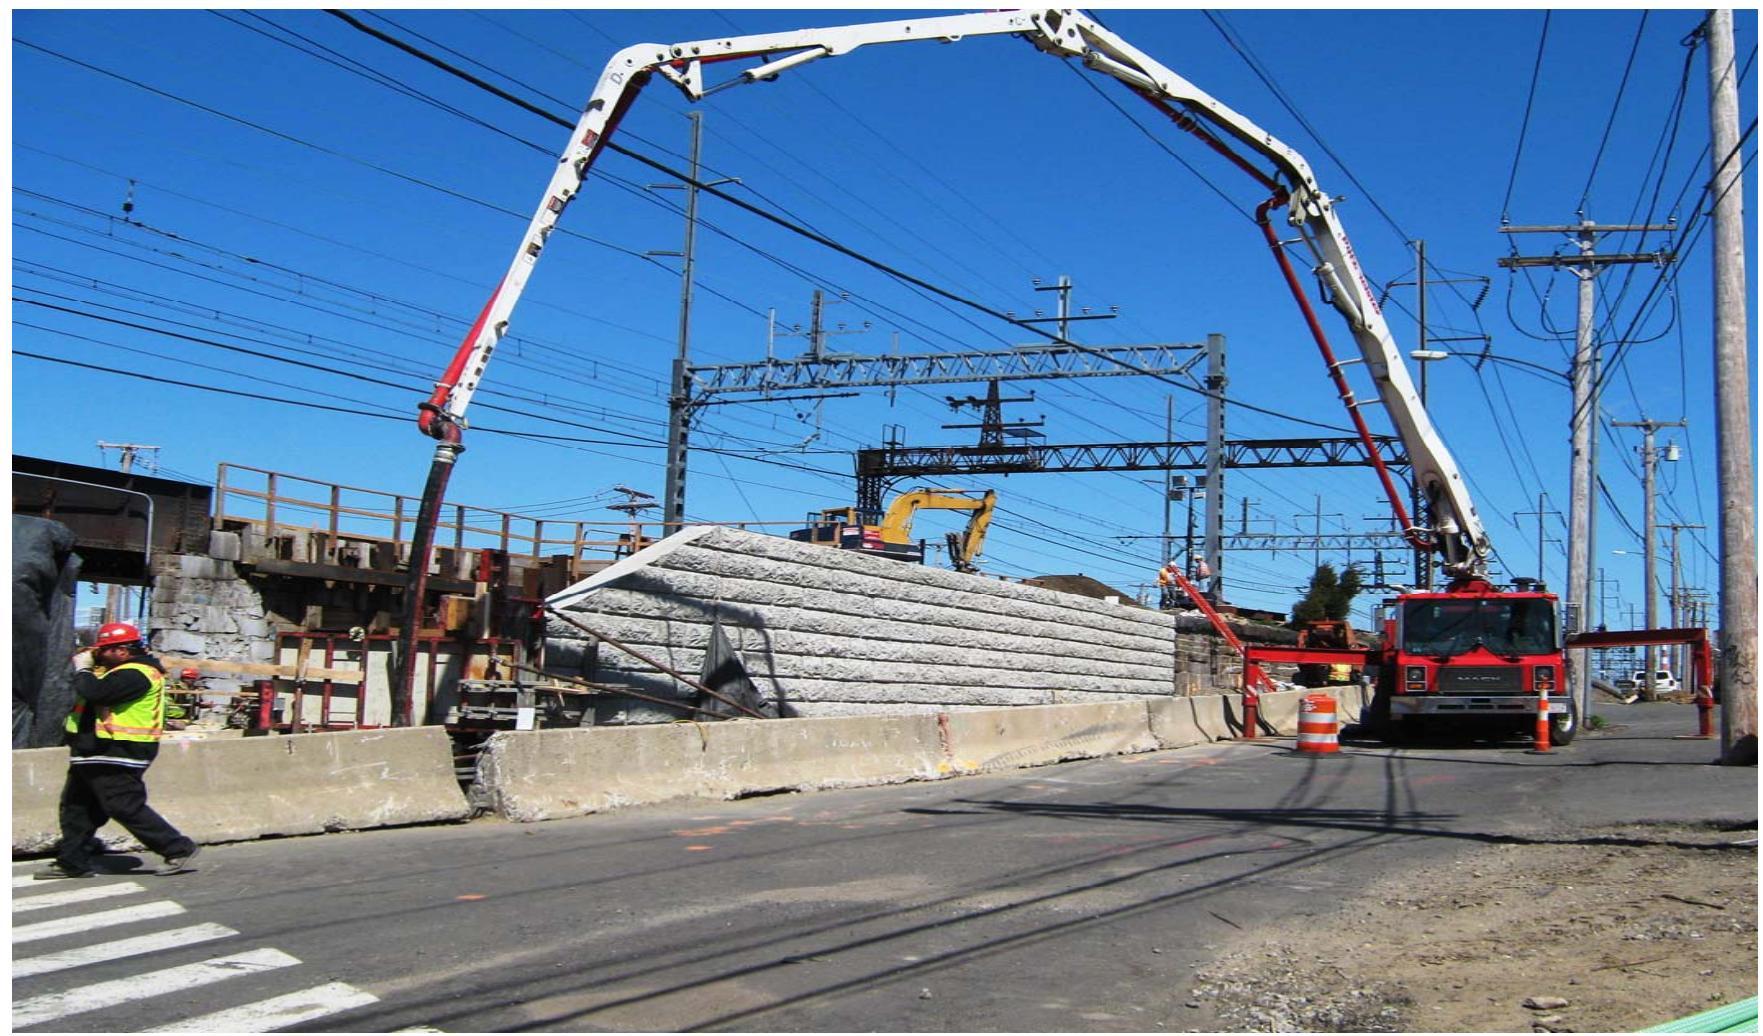
FAIRFIELD AVENUE, BRIDGEPORT

Use of a Crane-Concrete Pumper Truck to place concrete for the new abutment foundations.

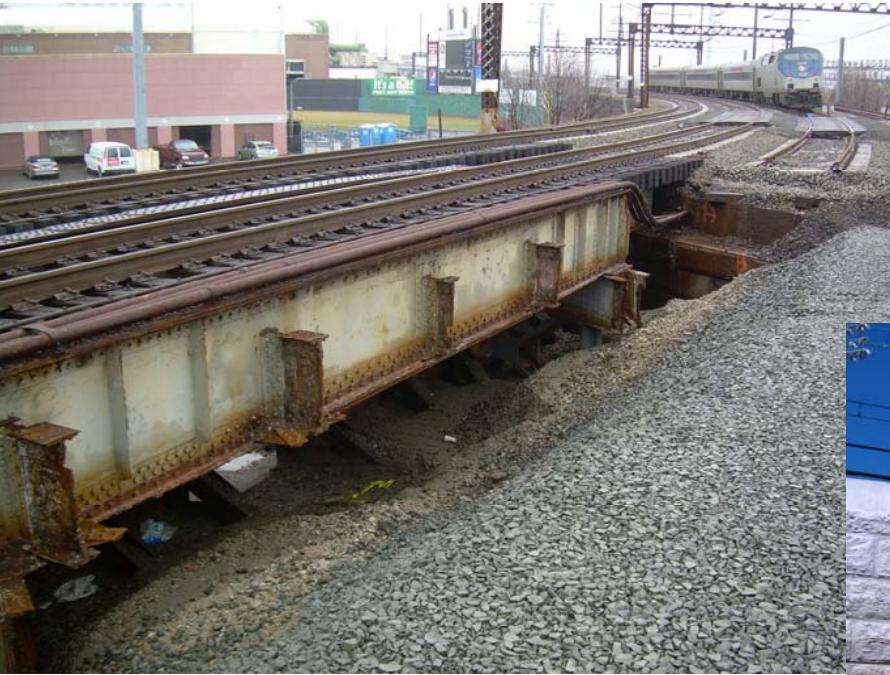
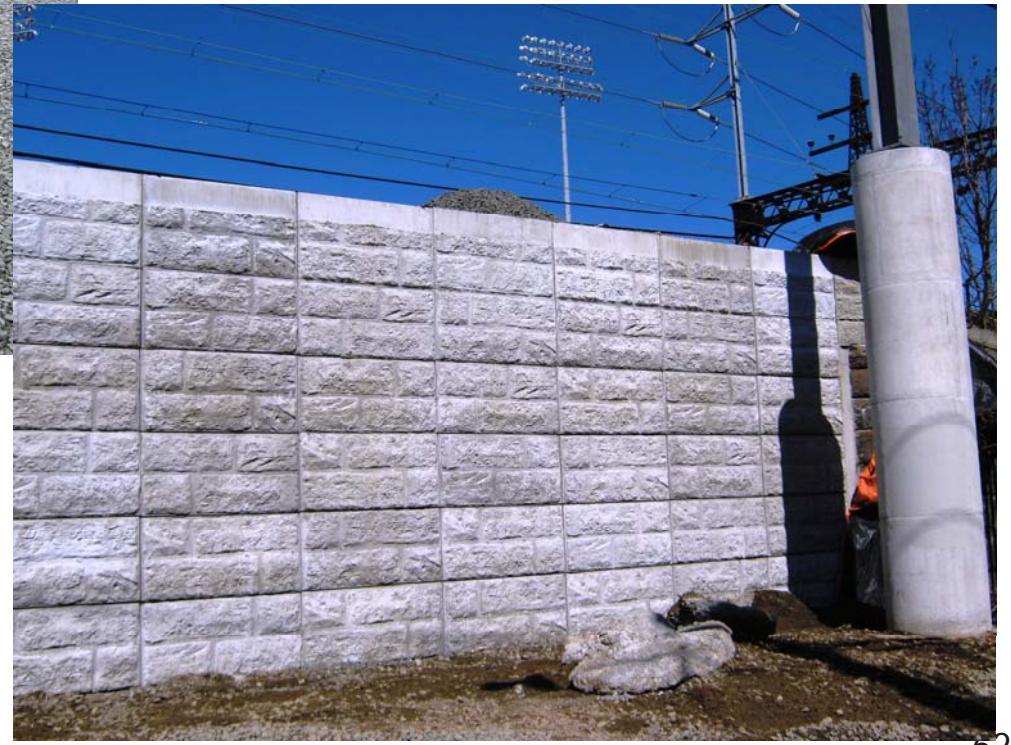
BRIDGE NO. 08058R – MAIN STREET #1 MP 54.98, BRIDGEPORT

OLD STRUCTURE ORIGINALLY BUILT 1900.

Above is the view of half of it removed and filled in.

At right are simulated brownstone faced precast retaining wall units to be stained brown to match the look of the adjacent walls. Below is a view from the former roadway abandoned by the City, that made the elimination of this bridge possible. It's removal now allows the railroad the ability to make improvements to the geometry of Jenkin's curve, shown at right.

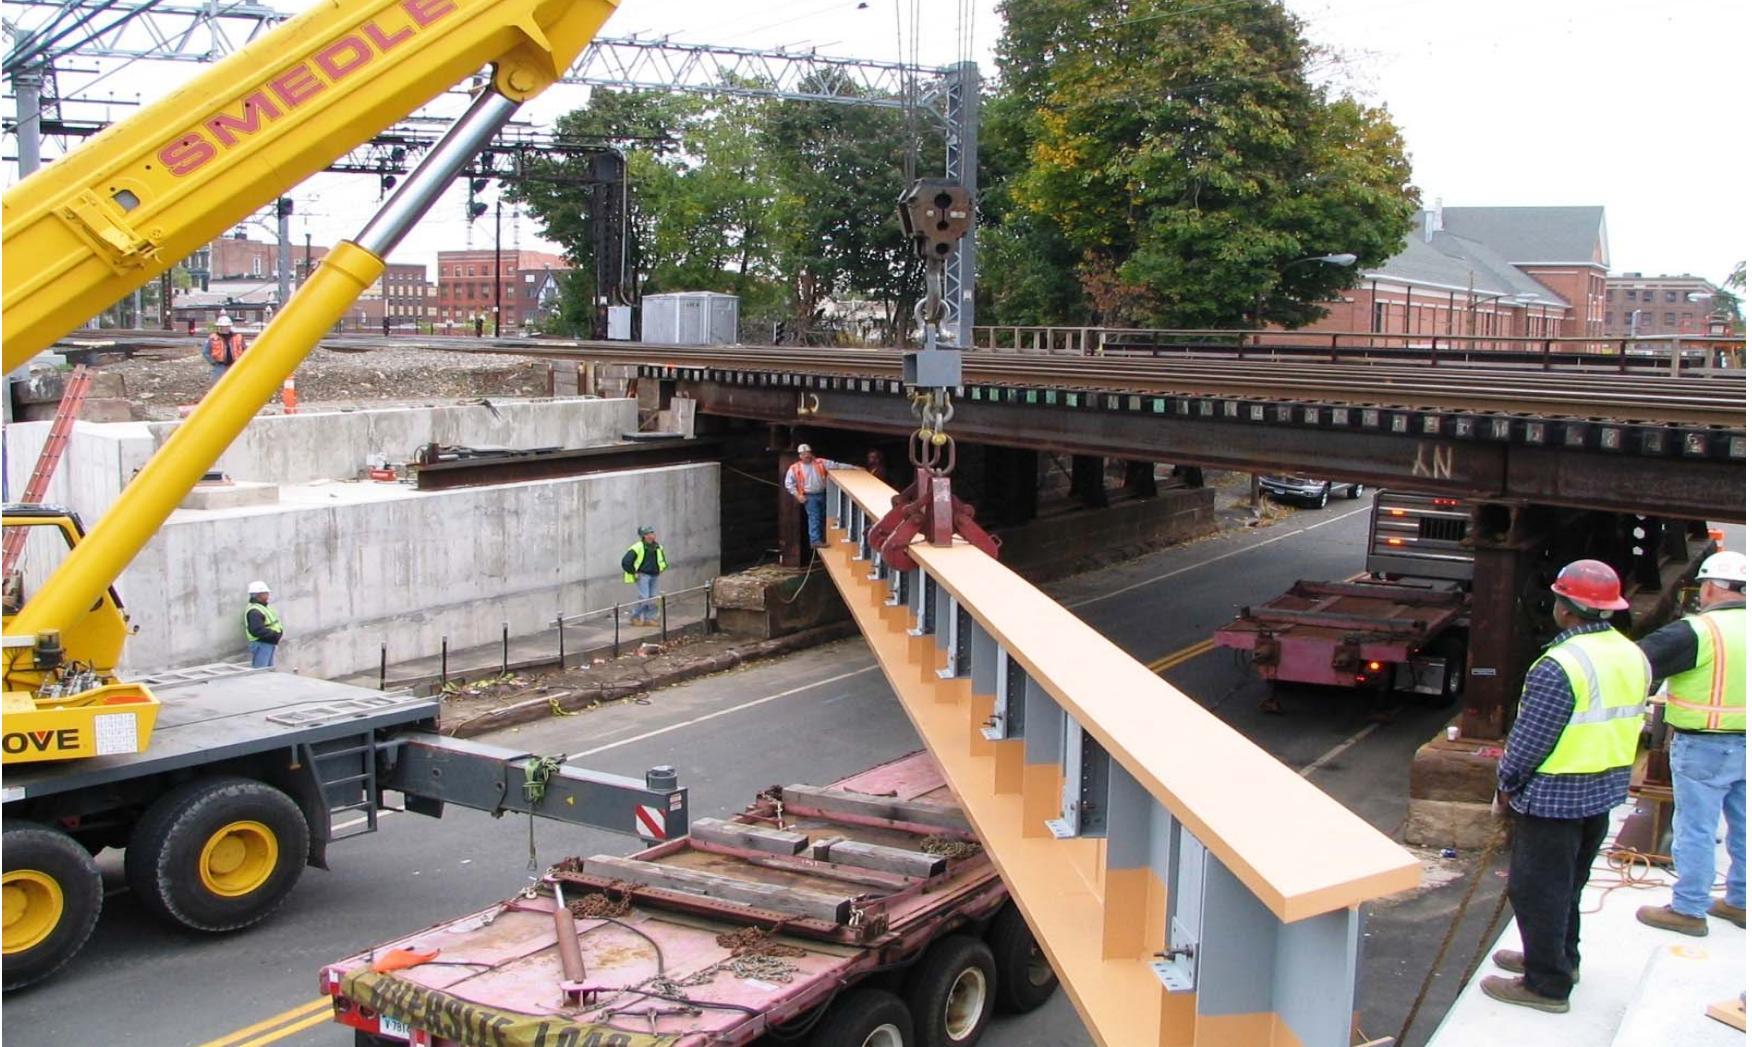
SETTING NEW BRIDGE STEEL

At Monroe Street, new bridge girder is delivered by semi-trailer, with a complete road closure, the crane lifts the new girder up onto the new abutments.

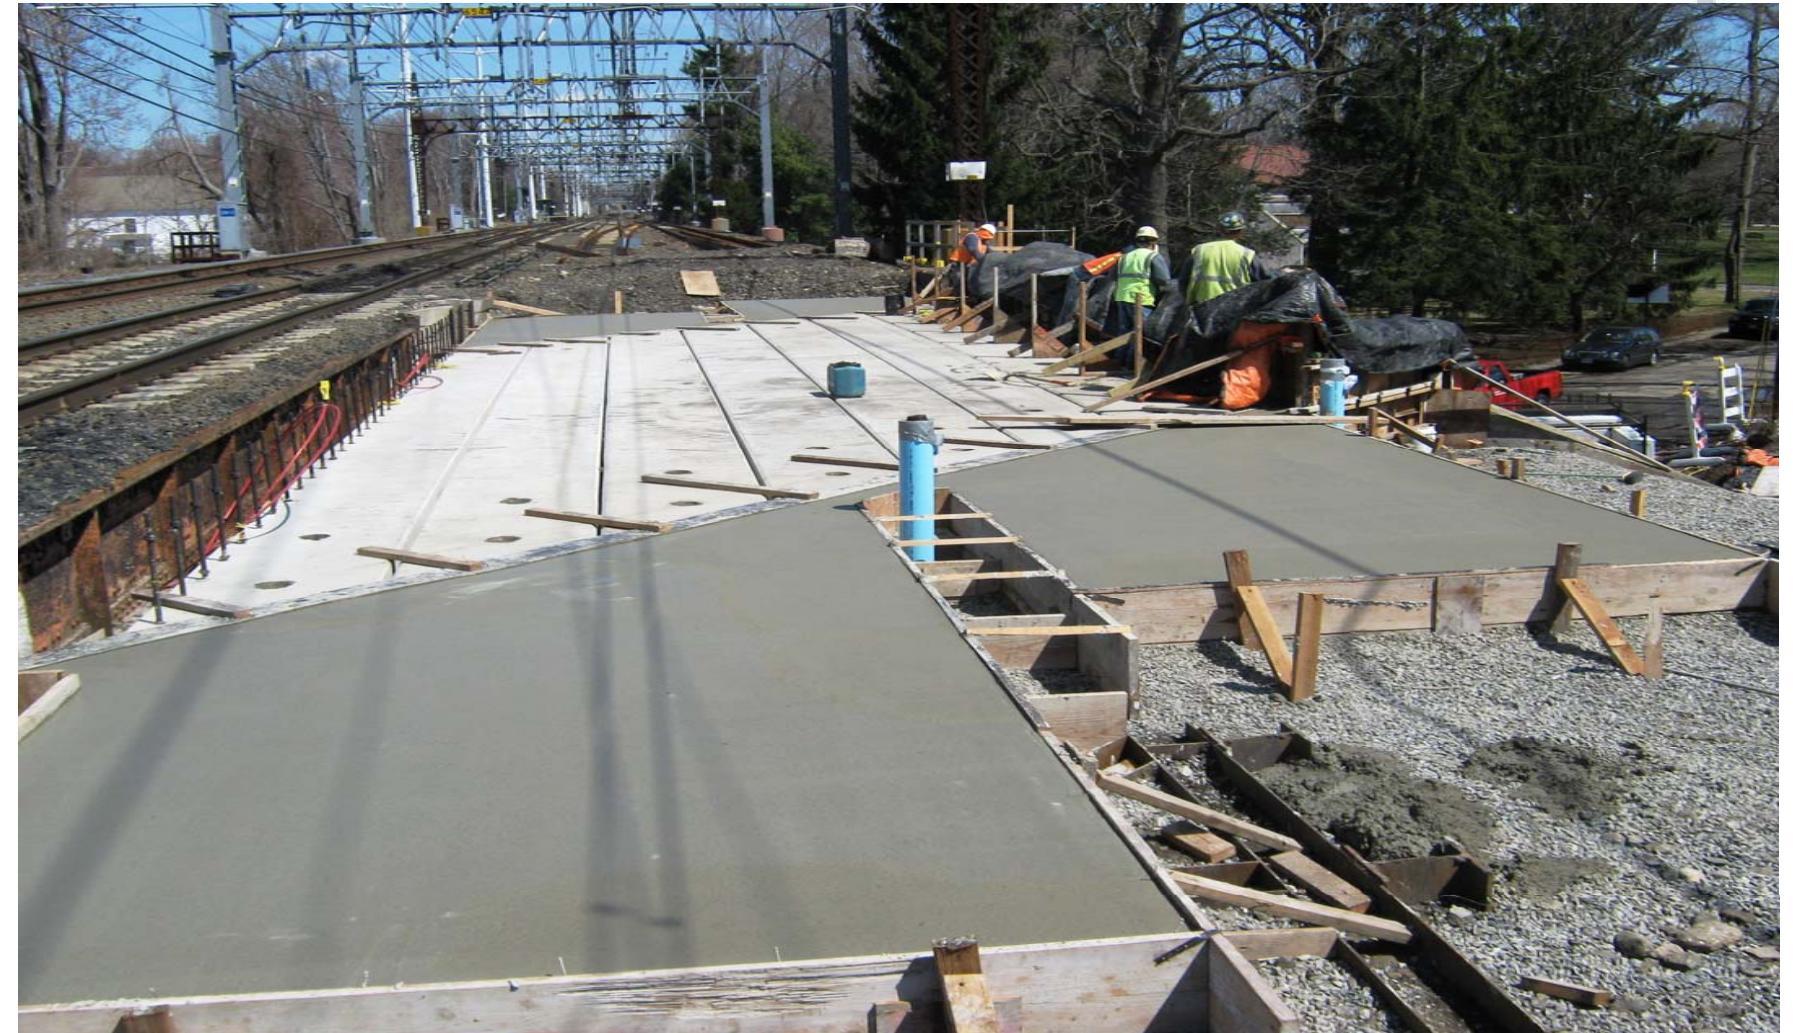
APPROACH SLABS

Over time, the constant impact from passing trains would force the abutment backwalls forward and pinch the girders inhibiting normal expansion. The idea to incorporate approach slabs at railroad bridges was taken from highway bridge design. ⁶⁴

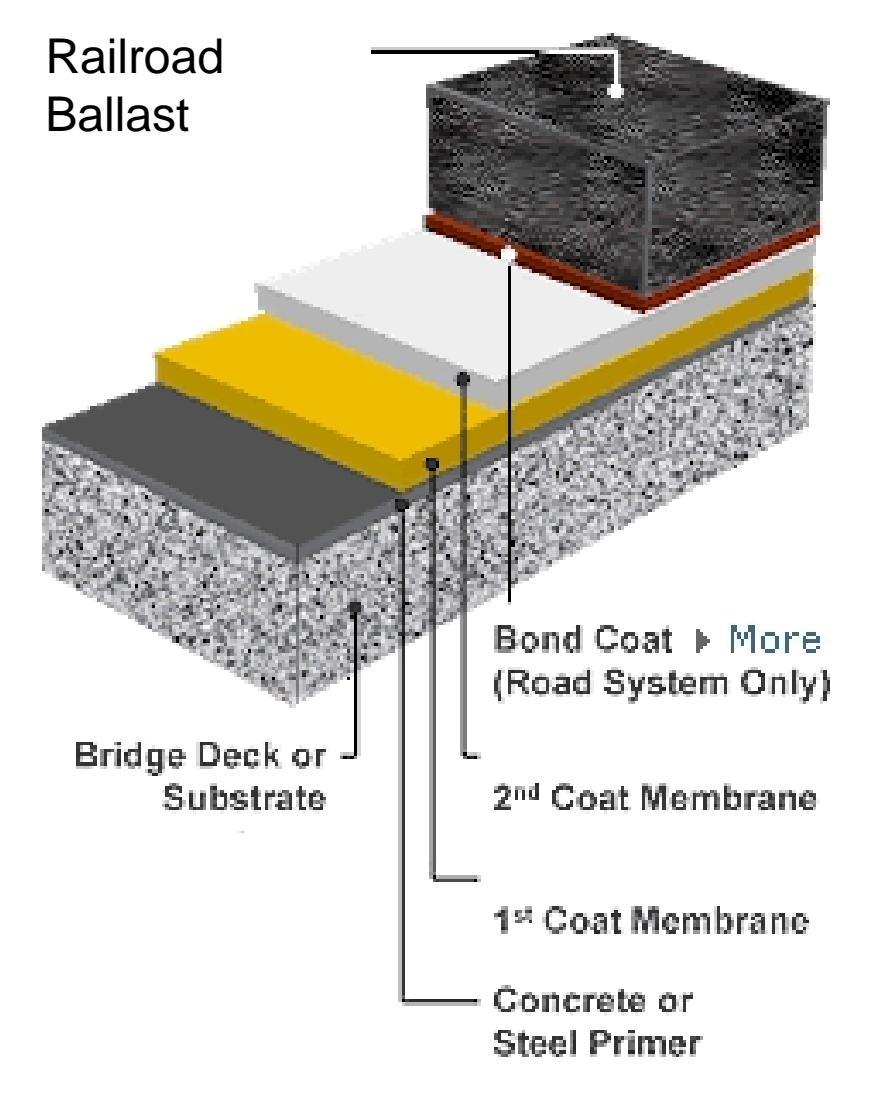
BRIDGE DECK WATERPROOFING

Another item updated with the times and taken from highway construction to meet the needs of the railroads.

Some of our earlier bridge projects, used woven glass fabric and liquid asphalt, however, that combination required the use of a protection board to keep the stone ballast from puncturing it.

Prior to either of these products, railroads used coal tar to coat their bridge decks, and a lot of it.

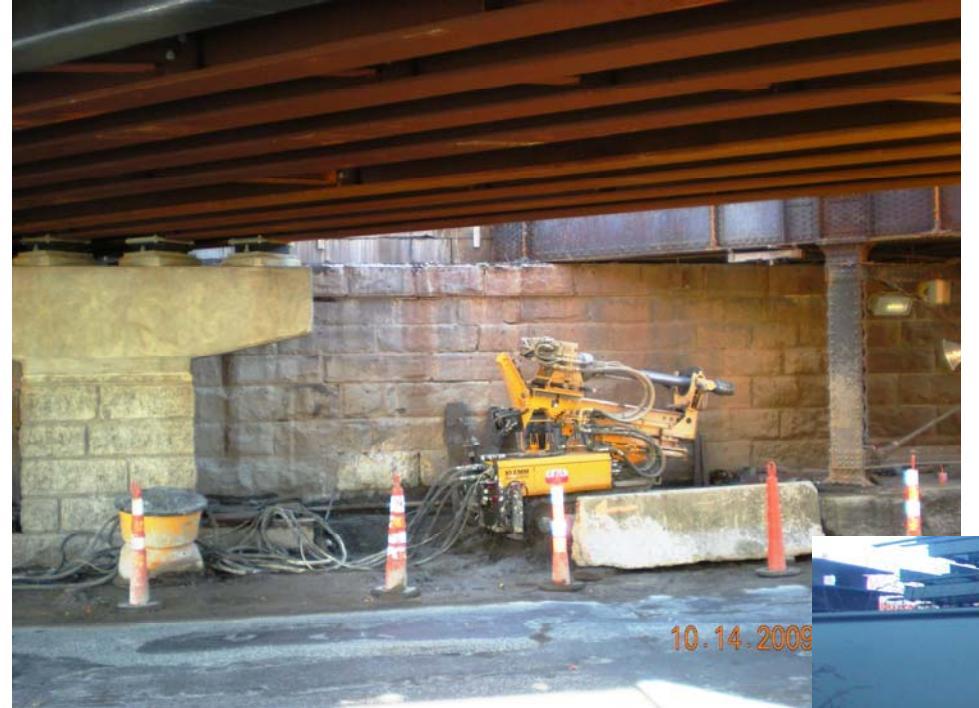
FOUNDATION TECHNOLOGY

Left: Photo of micropile drilling rig showing limited overhead clearance available to allow installation of the piles.

Right: Photo of typical micropile pipe fitted with drilling teeth. Pipe comes in short lengths to allow installation with low overhead clearance.

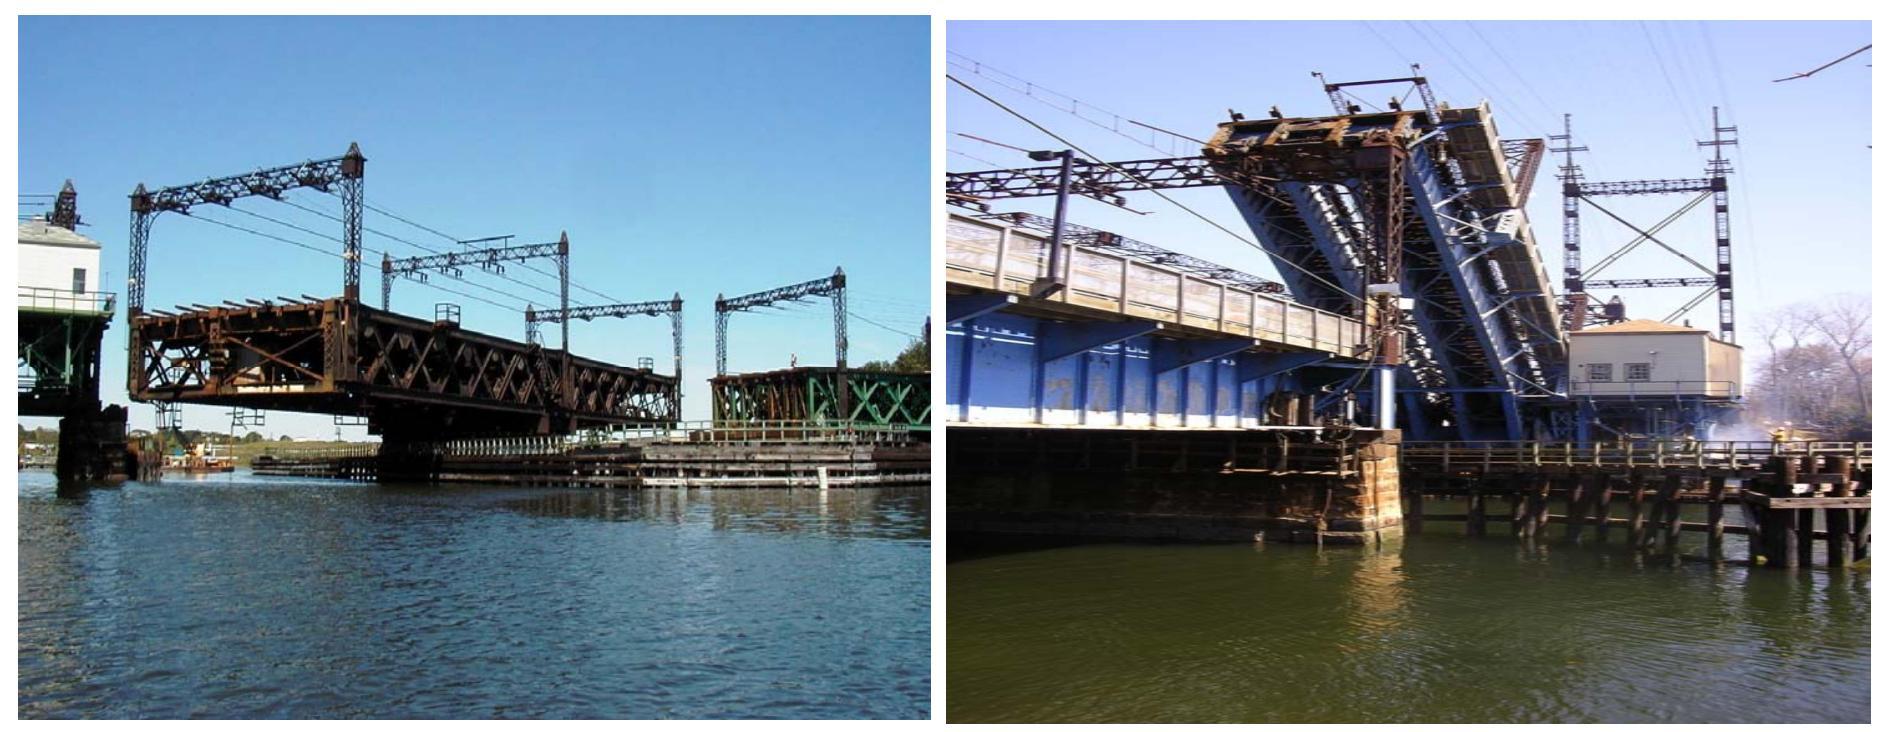
NORWALK (WALK) MOVABLE SWING BRIDGE

SAGAUTUCK (SAGA) MOVABLE LIFT BRIDGE

- Rehabilitation/Replacement of movable bridges while maintaining marine and railroad traffic.
- Working on these movable bridges will necessitate two track outages that will negatively impact railroad operational flexibility.
