Petition No. 1222 Interrogatories Set Three May 25, 2016 Windham Solar LLC (WS) Responses June 24, 2016

ECOS Energy, LLC Fisk Solar Garden Windham County, Connecticut

FISK ROAD SOLAR HARTFORD TURNPIKE & FISK ROAD HAMPTON, CONNECTICUT

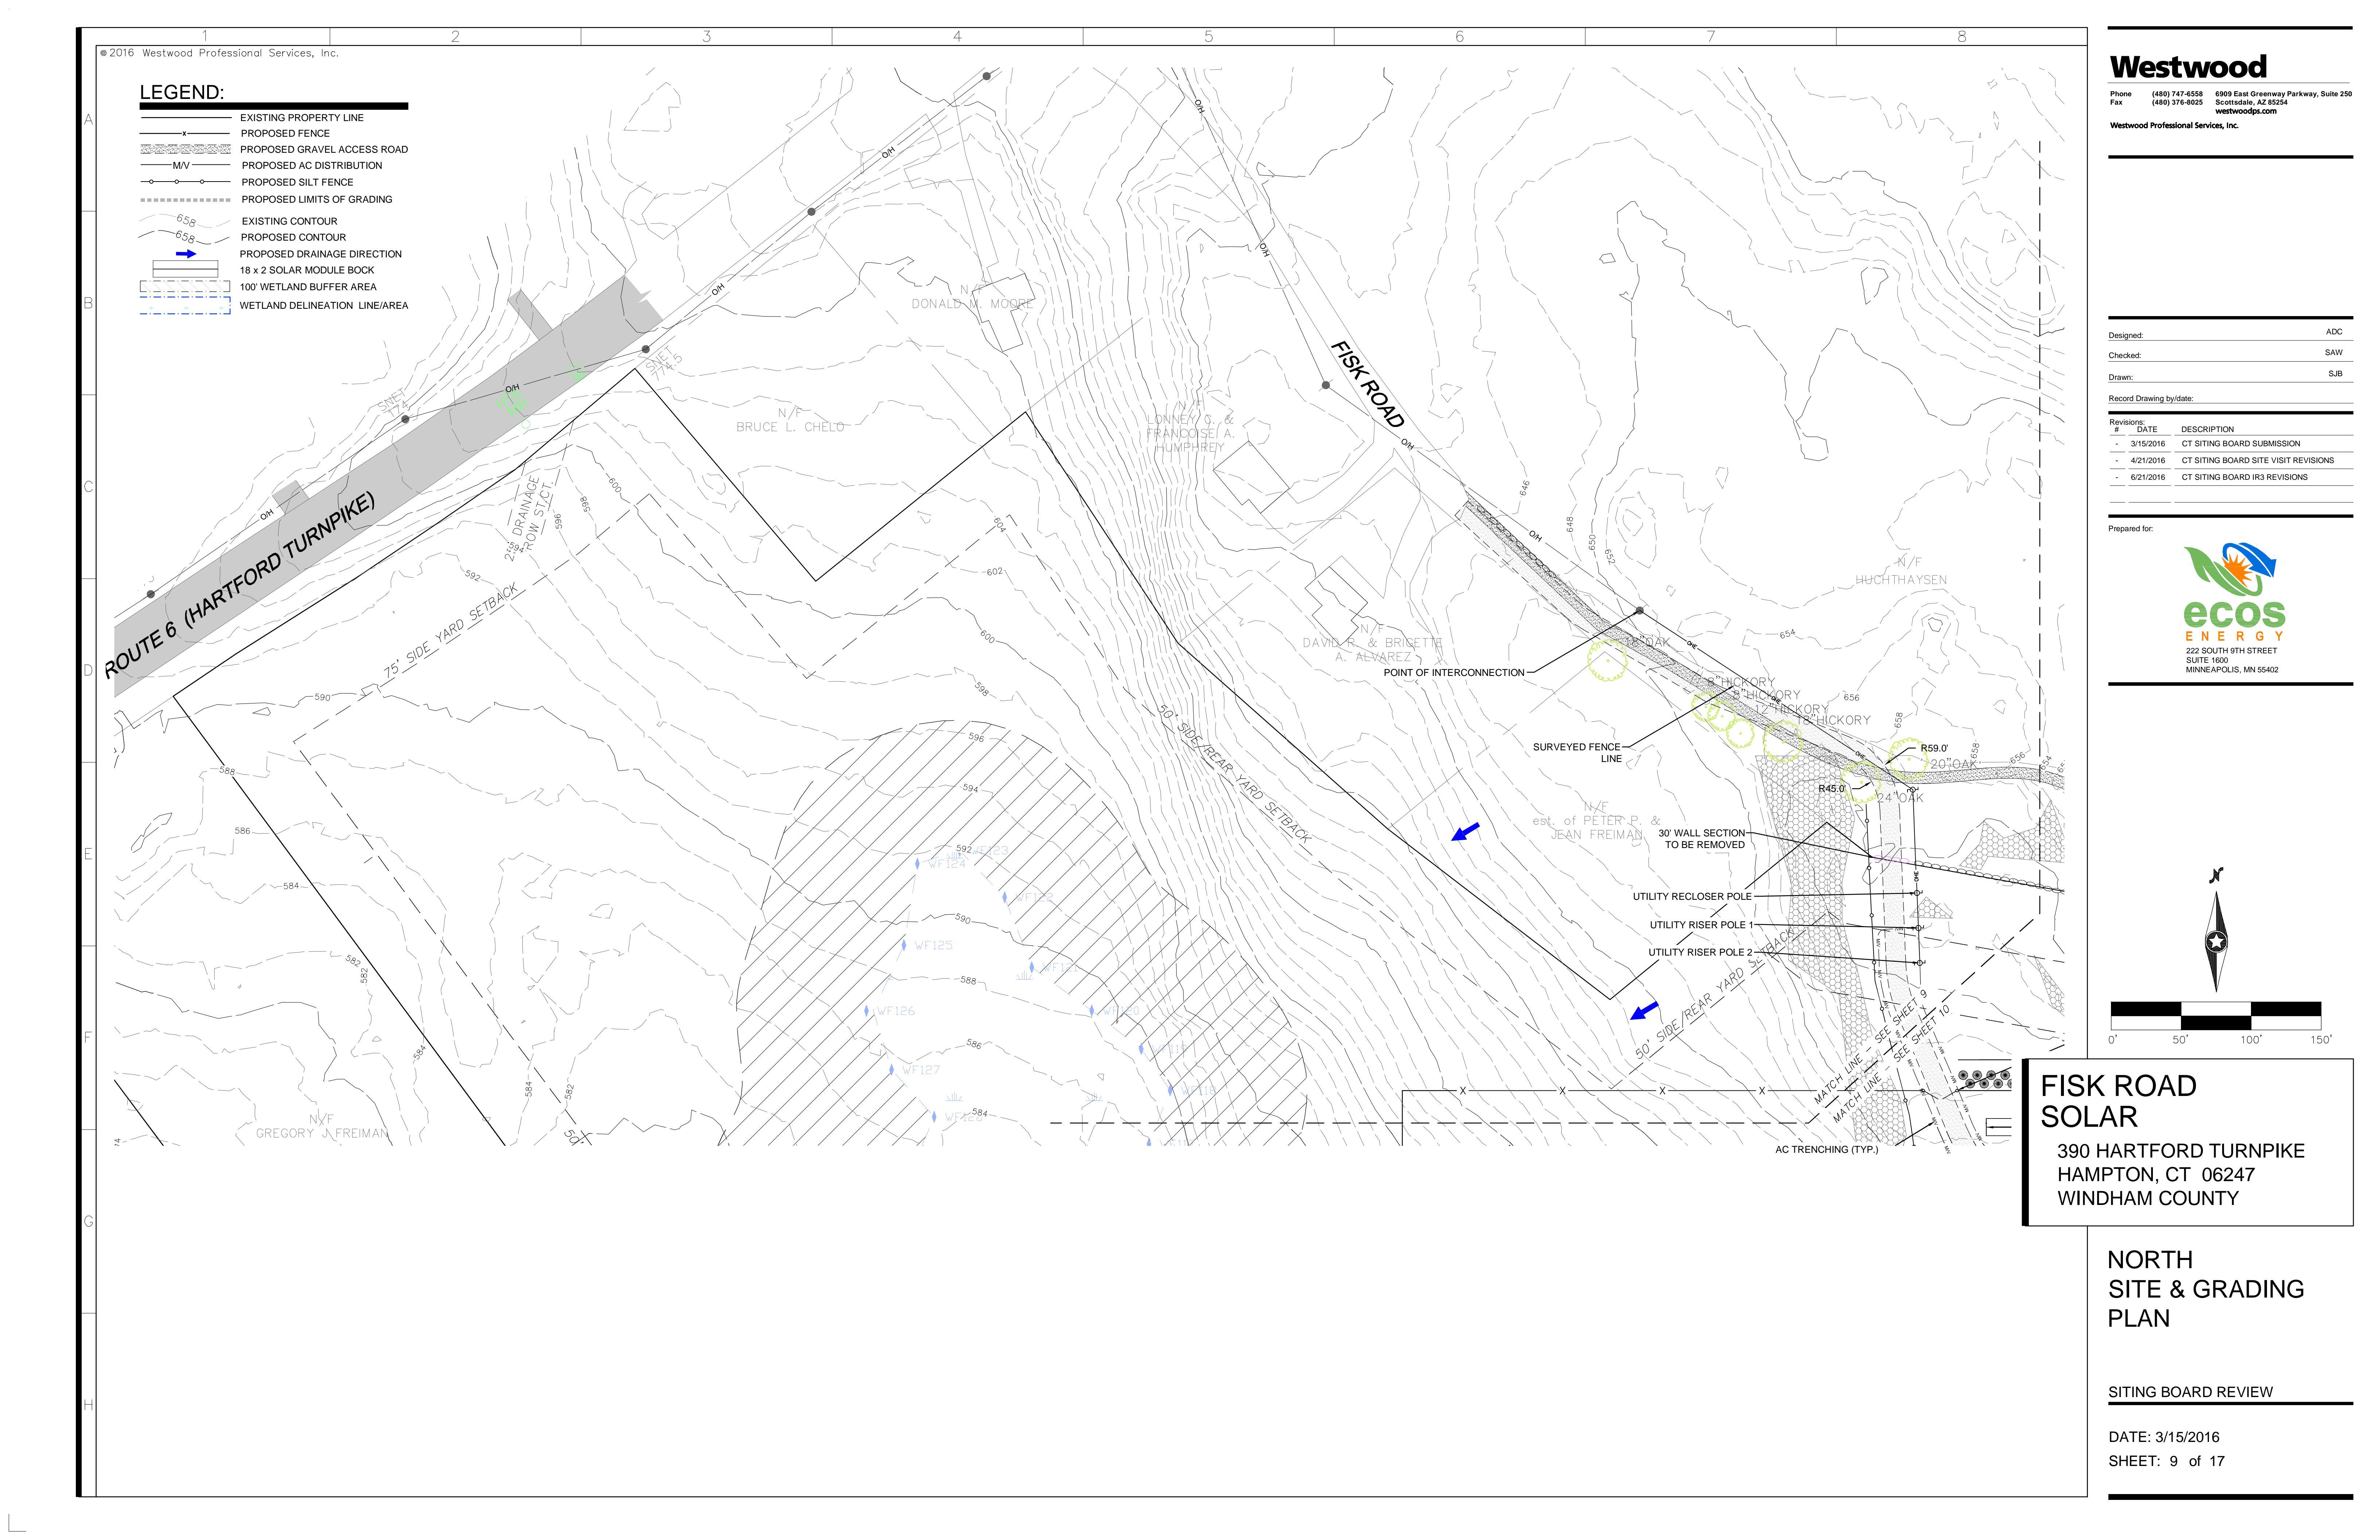
EROSION CONTROL

A final erosion and sediment control document, stormwater pollution prevention plan ("SWPPP") and an application to CTDEEP for a construction general permit will be made for the project prior to groundbreaking. A preliminary grading, erosion and sediment control plan has been prepared for the first phase of construction and the revised footprint and is attached - Exhibit D.
