# Monitoring Report

## Invasive Aquatic Plants

Candlewood Lake  
Squantz Pond

*Bulletin 1065*

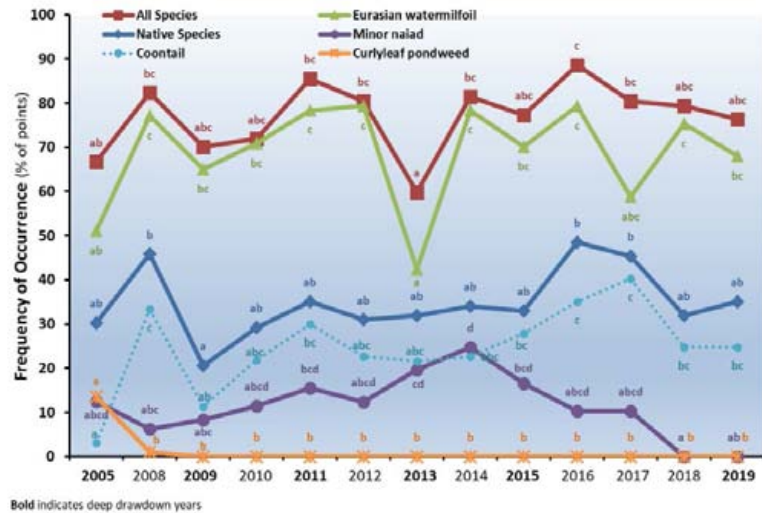
Figure 6. Yearly frequency of occurrence of aquatic vegetation on transects in Candlewood Lake. Points with the same letter within a species are not statistically different.

The frequency of occurrence (FO) of Eurasian watermilfoil on transects was 75% in 2018 and 68% in 2019 (Figure 6). These FO's are not statistically ( $p \leq 0.05$ ) less than any previous year. Yearly variability caused by the winter drawdowns will decrease the sensitivity of this measure when

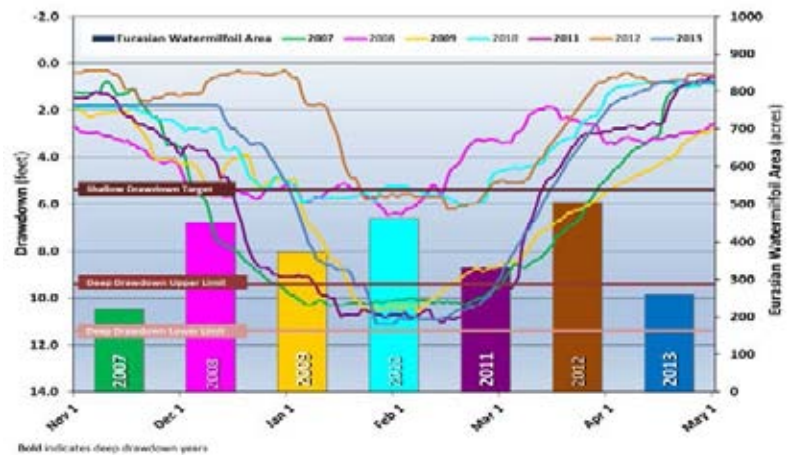
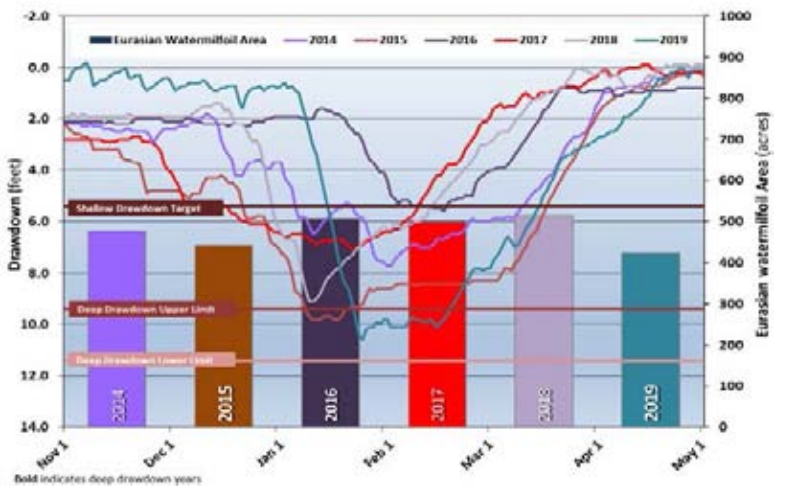
Figure 10. Candlewood Lake’s drawdown depths and duration and Eurasian watermilfoil coverage from 2007 - 2019. Bars with years in bold are deep drawdown years.

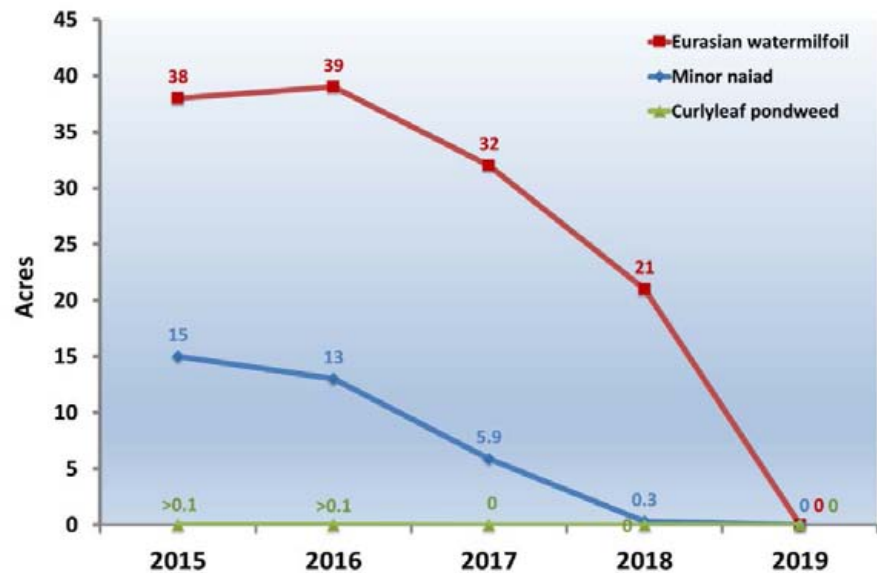
Figure 12. Yearly changes in in the acreage of invasive aquatic plants in Squantz Pond from 2015 – 2019.

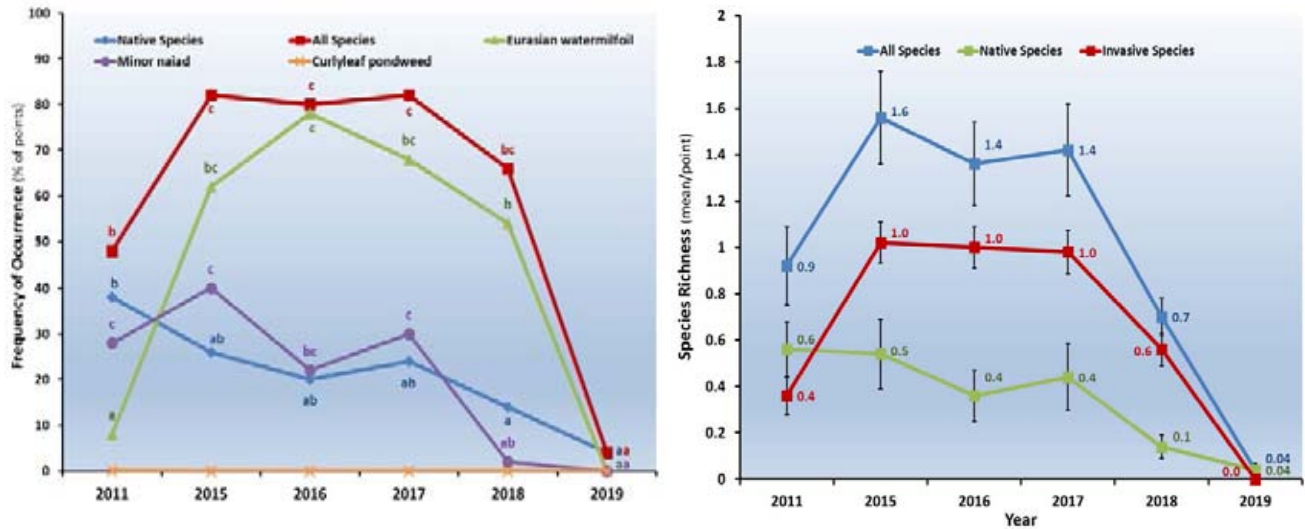
Figure 15. Yearly comparison of the frequency of occurrence of native and invasive species (left) and species richness (right) on transects in Squantz Pond from 2011 to 2019. Points with the same letter are not significantly different. Error bars +/- one standard error of the mean.

The 2018 frequency of occurrence (FO) of Eurasian watermilfoil on transects declined from a high of 78% in 2016 to zero in 2019 (Figure 15, left). Likewise, the FO of minor naiad declined from a high of 40% in 2015 to zero in 2019. No curlyleaf pondweed was found in any years on transects. The FO of all species (native + invasive) declined from highs near 80% from 2015 to 2017 to 4% in 2019 while native species FO declined from a high of 38% in 2011 to 4% in 2019. Vegetative species richness of all species, invasive species, and native species follow trends like FO with highs from 2015 – 2017 and a sharp decline to near zero in 2019 (Figure 15, right). These findings are consistent with the absence of all species except for native waterwort.

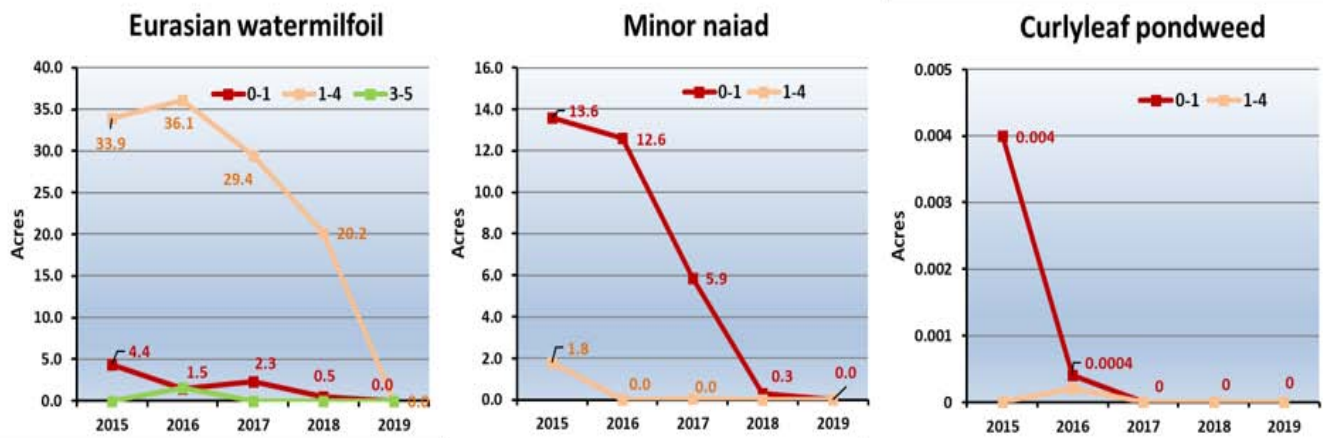
Figure 16. Depth preferences (meters) of invasive plants in Squantz Pond from 2015 - 2019.

Most Eurasian watermilfoil in Squantz Pond in 2018 (20 acres) was located at a depth of 1 – 4 m with a small amount at a depth of 0 - 1 m (<1 acres) (Figure 16). We found most minor naiad (0.3 acres) at a depth between 0 - 1 m in 2018. This showed little change from previous years.

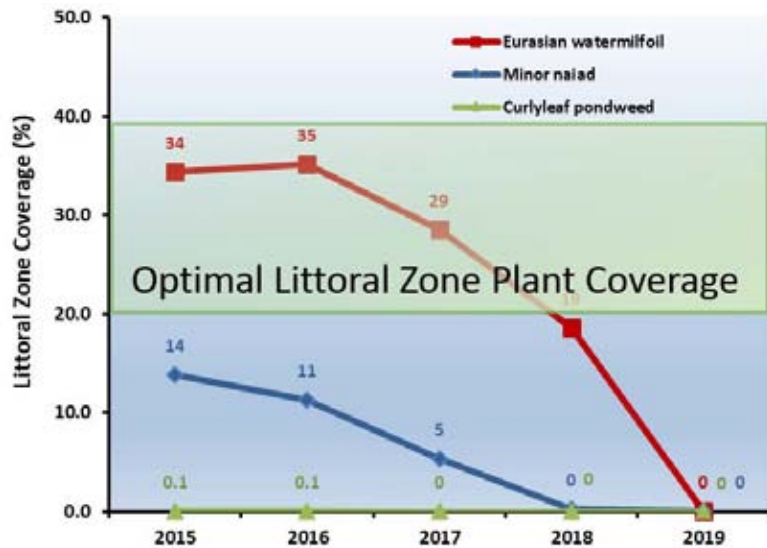
Figure 17. Littoral zone coverage of invasive aquatic plants in Squantz Pond from 2015 - 2019.

Squantz Pond has a littoral zone of 111 acres or 42% of its total area. Eurasian watermilfoil covered 19% of the littoral zone in 2018, a decrease from 29% coverage found in 2017 (Figure 17). Minor naiad littoral zone coverage decreased to <1% in 2018 from 5% in 2017. Curlyleaf pondweed was not found in 2018, so it did not impact littoral zone coverage.

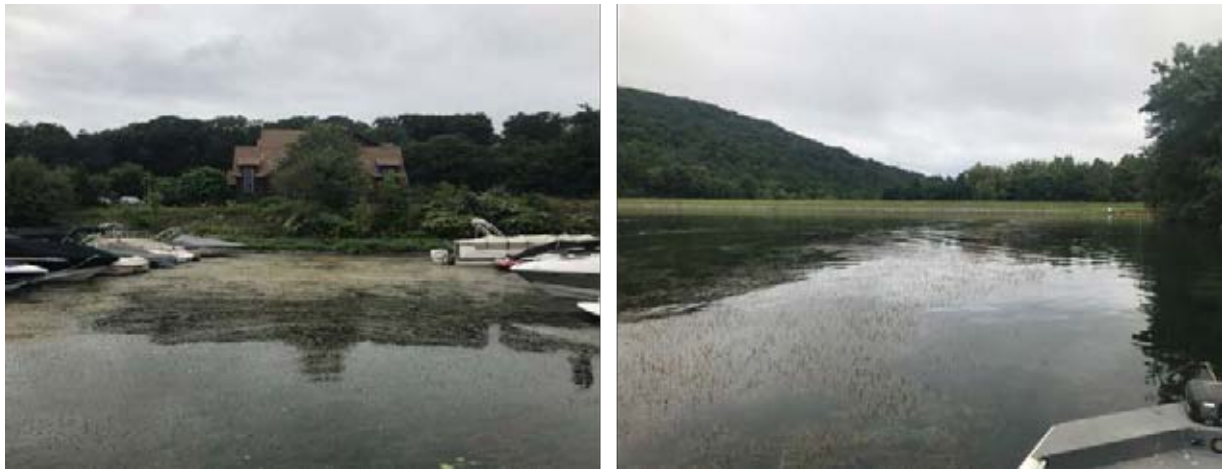
Figure 18. Surface Eurasian watermilfoil in 2018. Nina’s Marina, Danbury (left) and looking north from the New Milford Town Beach (right).

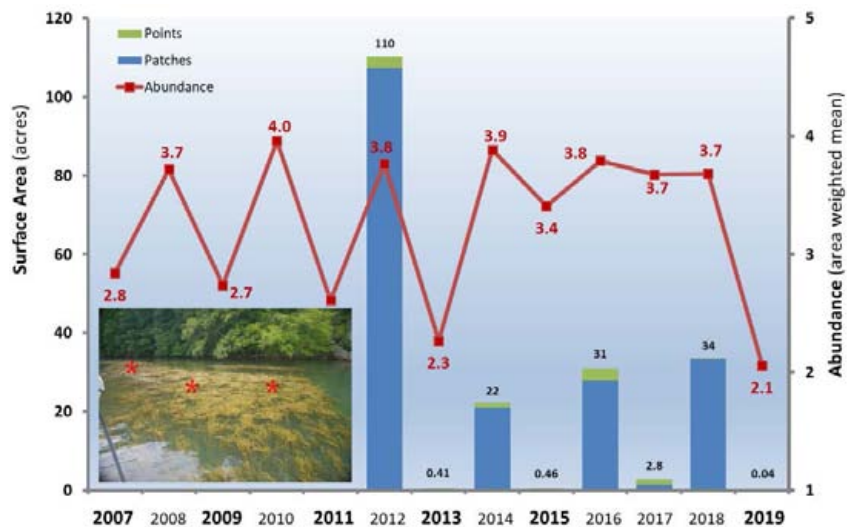
Figure 19. Number of points where Eurasian watermilfoil was flowering at the surface and area weighted abundance in Candlewood Lake. Insert shows how surface points were marked (\*). Deep draw-down years in bold.

The shallow draw-down years of 2012, 2014, 2016 and 2018 showed the highest acreage of surface patches and points with 110, 22, 31 and 34 acres respectively (Figure 19). The deep drawdown years of 2013, 2015, and 2019 featured only 0.4, 0.4, and 0.04 acres, respectively.

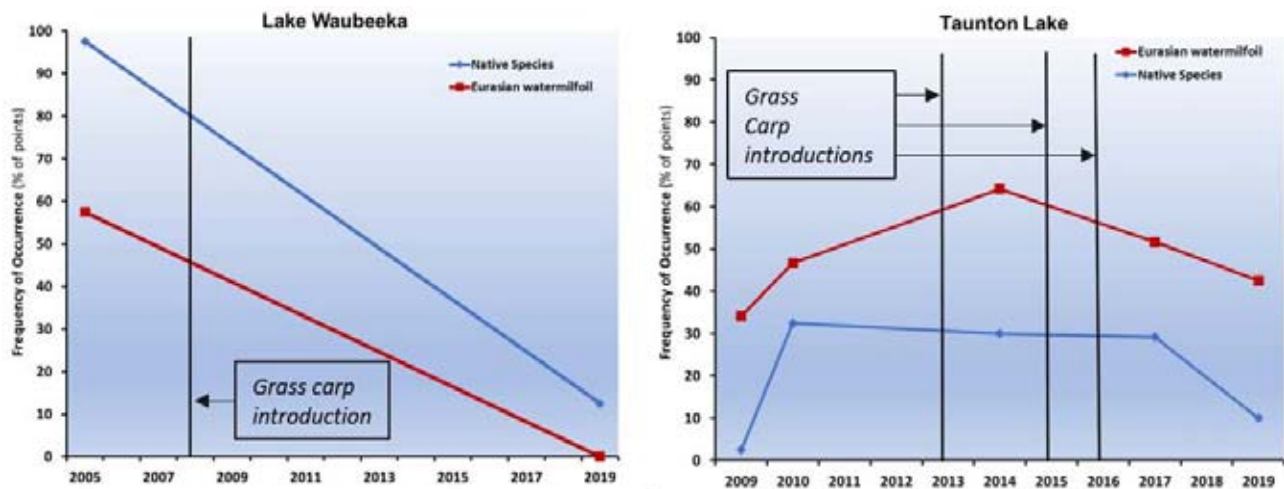
Figure 21. Comparisons of the effects grass carp introductions on Eurasian watermilfoil and native species in four Connecticut Lakes. Vertical lines indicate times of grass carp introductions.

It would be expected that as vegetation becomes scarce in Squantz Pond the grass carp will have to move back into Candlewood. Currently it appears that Squantz Pond may be experiencing a condition like nearby Waubeeka and Taunton Lakes where grass carp may have reduced vegetation to less than optimal levels (Figure 21).

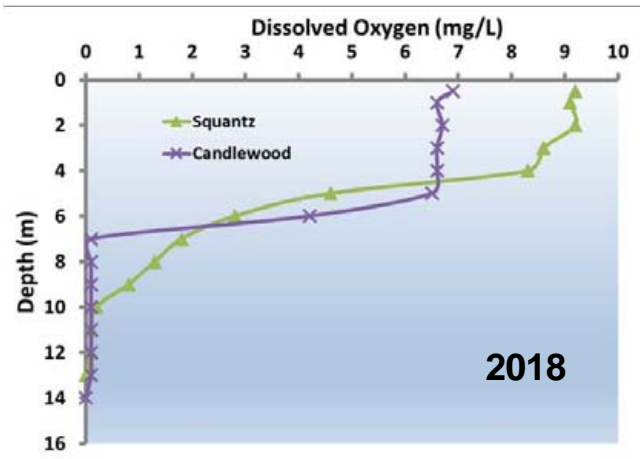
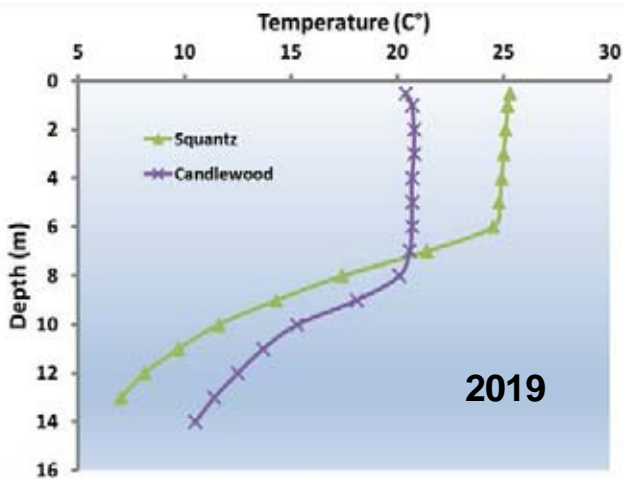
Figure 23. Temperature and dissolved oxygen profiles in lakes Candlewood and Squantz Pond in 2018 and 2019.

The 2018 and 2019 temperature and dissolved oxygen (DO) profiles differed in Candlewood Lake and Squantz Pond likely because the former lake's samples were taken nearly a month after the latter. Candlewood Lake's surface temperature was nearly 5°C warmer than Squantz Pond's. The thermocline began in both lakes at about eight meters in both years when bottom temperatures fell to about 14°C (Figure 23, left). DO profiles also differed between the lakes with surface DO higher in Candlewood Lake by about 2.5 mg/L in both years. Both waterbodies showed similar trends with well oxygenated conditions to a depth of approximately six meters followed by a decline to near zero near the bottom (Figure 23, right). In 2018 Candlewood Lake and Squantz Pond had occasional filamentous algal mats primarily in

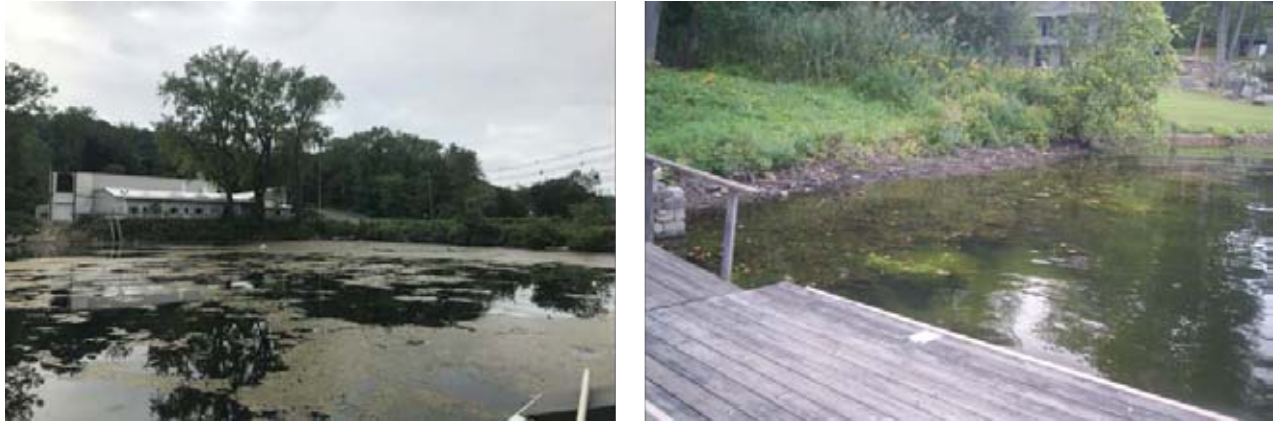
Figure 24. Filamentous algae on cove south of the causeway in New Milford in 2018 (left) and mixed with one of the few patches of surface Eurasian watermilfoil in a cove in the northern Sherman arm in 2019 (right).
