**The Connecticut
Agricultural
Experiment
Station**

*Bulletin 1089
June 2, 2023*

**Bashan Lake
East Haddam, CT
Aquatic Vegetation Survey
Water Chemistry
Aquatic Plant Management Options
2022**

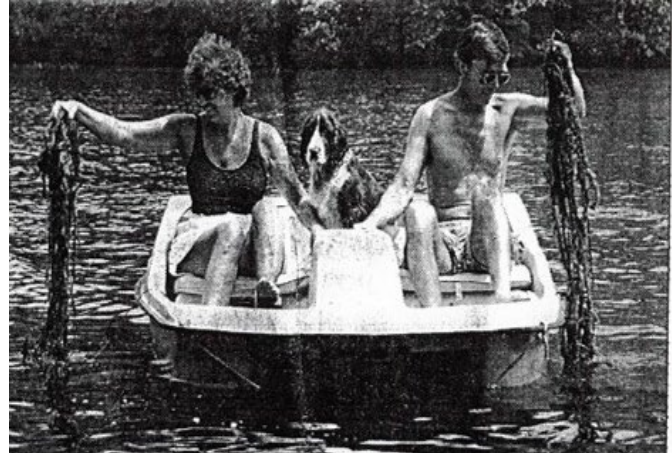
Figure 11. Treatment of Bashan Lake with Aquacide in 1999 caused variable watermilfoil to break away from the roots requiring hand removal. A switch to the Navigate formulation in the following years solved this problem. (John and Barbara Hoban with dog Abbey, Harold Press photo by Michelle McLoughlin)
