Public Information Session

Firefighting Foam Release to the

Farmington River

July 2, 2019

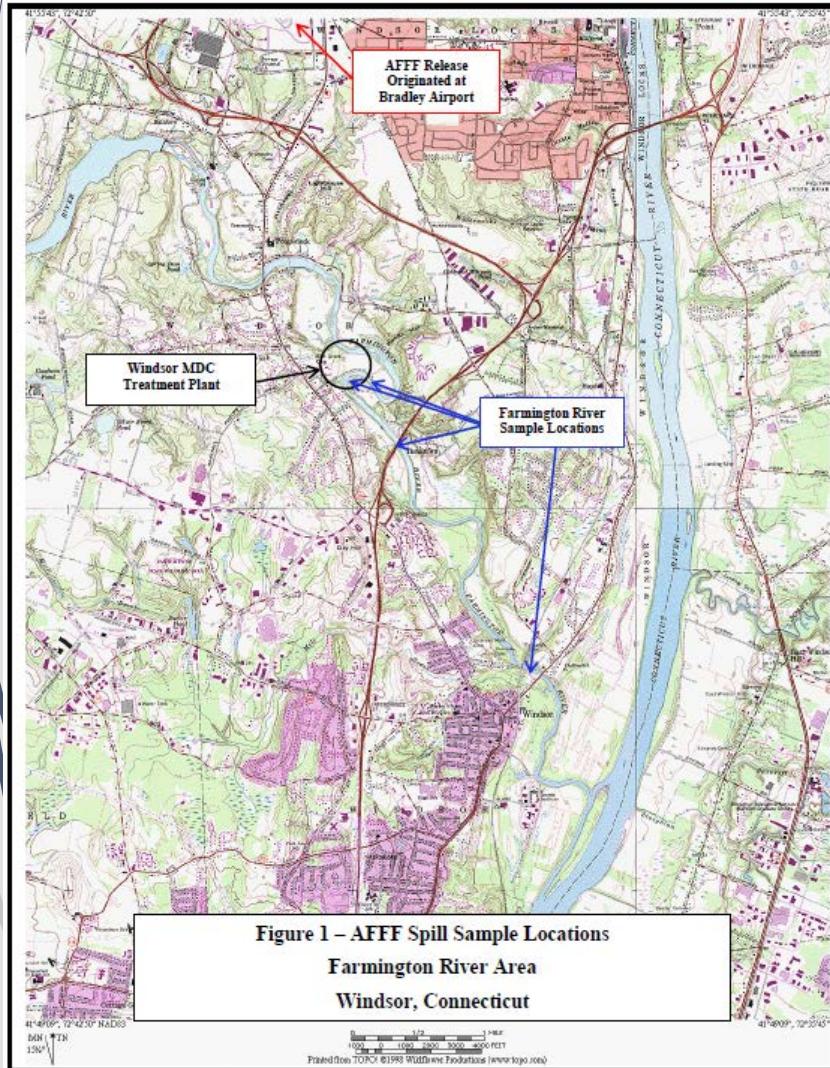
Timeline of Events: June 8th

- ▶ Approx. 2 pm, malfunctioning fire suppression system at a private hangar at Bradley Airport caused discharge of AFFF for 6 minutes
 - Total foam released: ~40,000 gallons
 - Total AFFF concentrate: ~1,500 gallons
- ▶ CT DEEP onsite within 45 minutes, Signature Flight immediately took responsibility
- ▶ Emergency Contractor onsite 40 minutes later
- ▶ ~15,000 gallons foam captured onsite

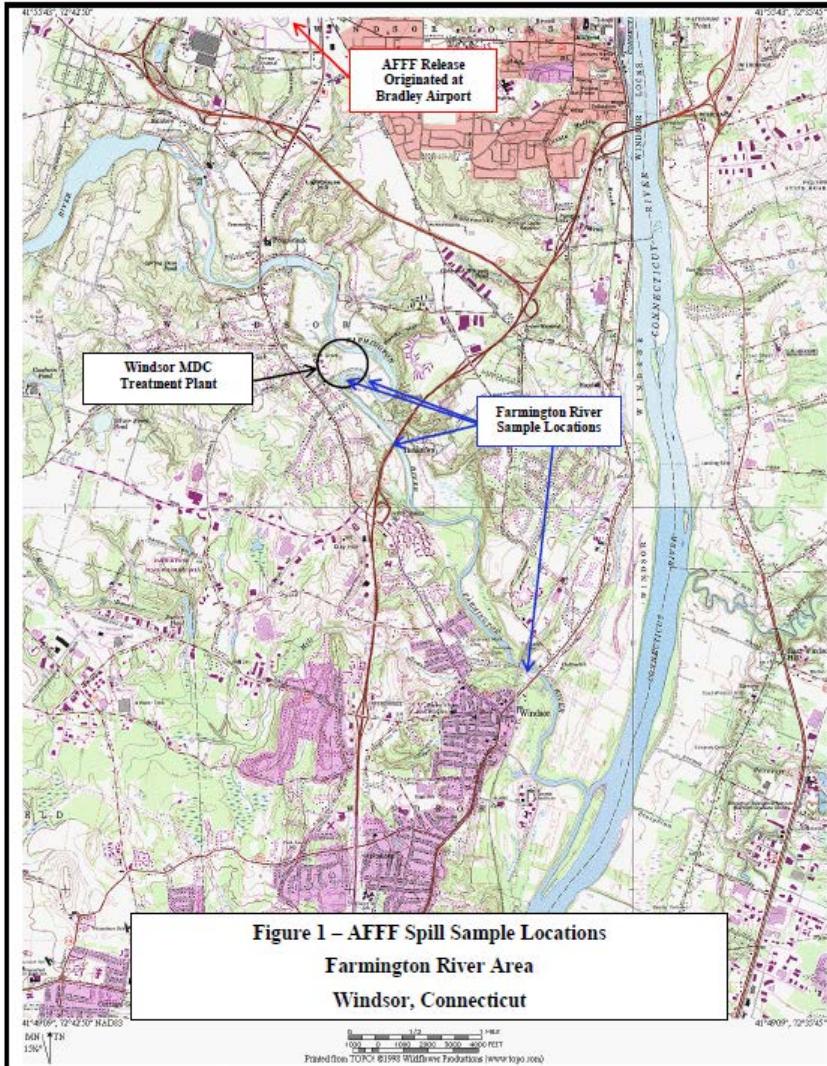
Timeline of Events: June 8th

- ▶ Path of remaining foam solution:
 - Floor Drain → Oil-Water Separator → Sewer System → MDC Wastewater Treatment Plant → Farmington River
- ▶ MDC notified of release
- ▶ Approx. 7:30 pm, foam observed exiting sewer manholes on Rainbow Road
- ▶ Emergency Contractor called to remove foam from 2 manholes

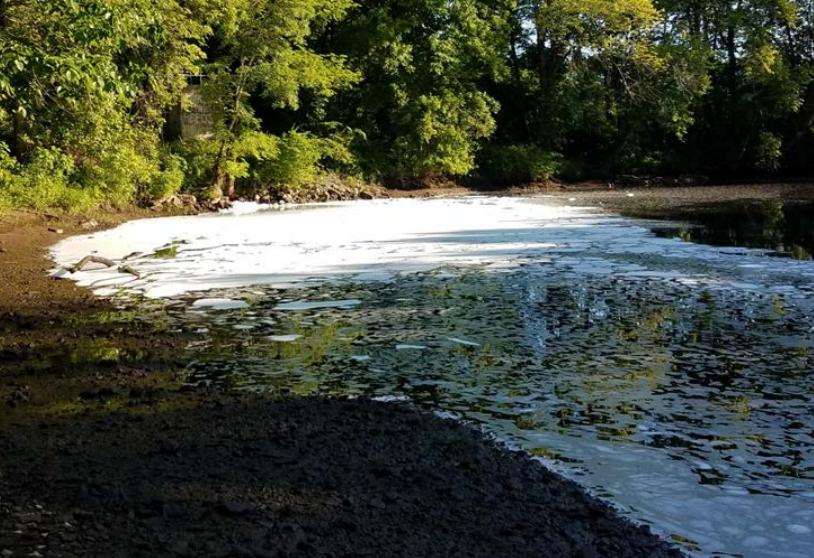
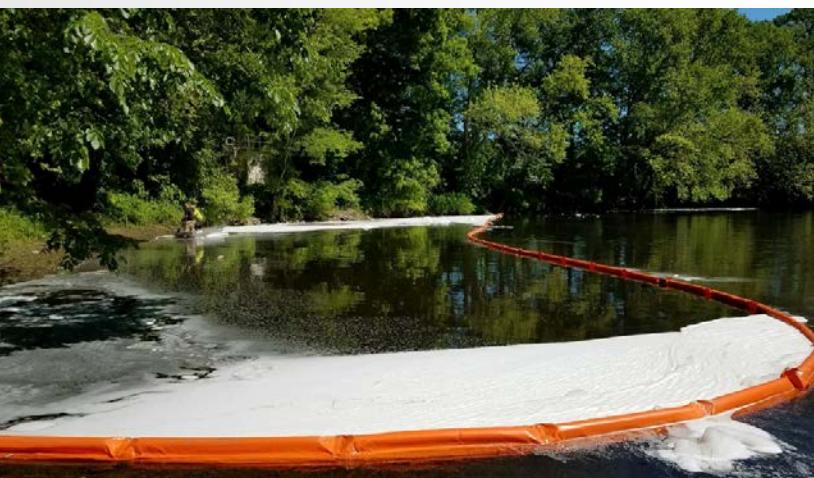
Timeline of Events: June 9th

- ▶ Foam entered MDC Plant and the Farmington River in the early morning (5:30-7:30 am)
- ▶ Booms deployed to contain as much foam as possible
- ▶ ~5,000 gallons of contained foam vacuum-pumped out of the river
- ▶ Surface water samples collected
- ▶ DPH advises no contact with foam/do not eat fish

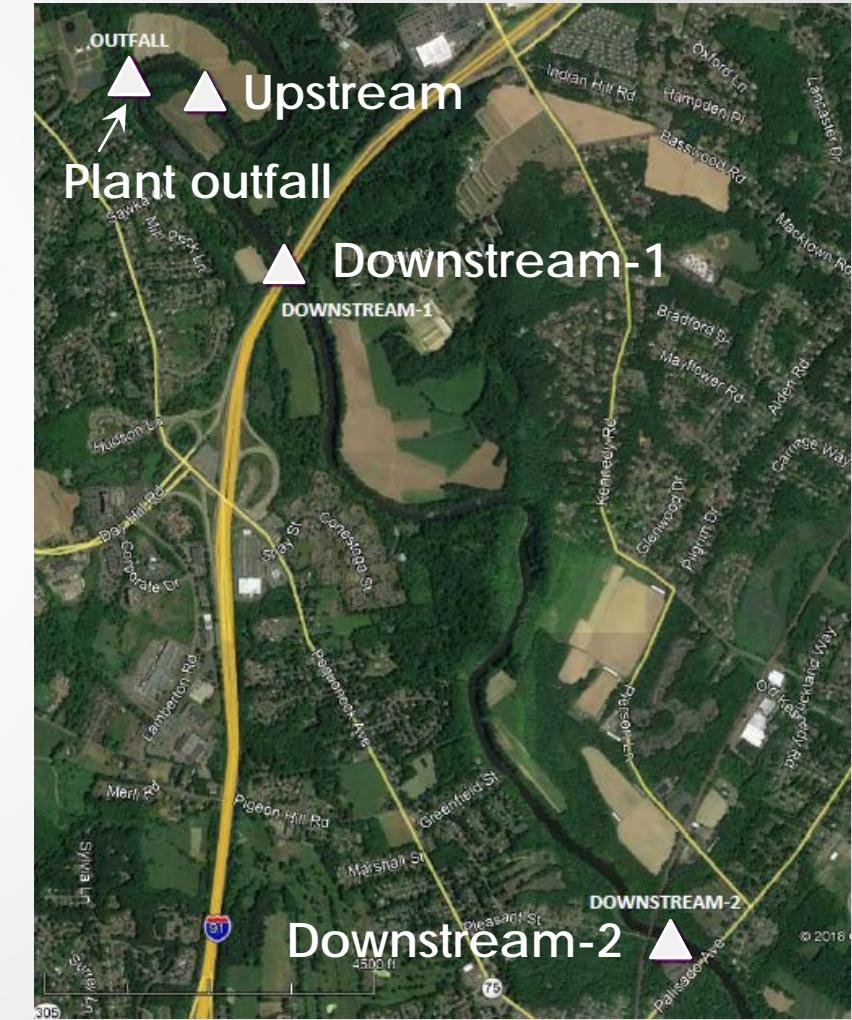
Surface Water Sampling

→ 3 sampling events

- June 9
- June 11 (outfall only)
- June 21

→ 4 locations

- Upstream
- Treatment plant outfall
- Downstream-1 at I-91(0.6 mi.)
- Downstream-2 at boat launch/Palisado Ave. (3 mi.)

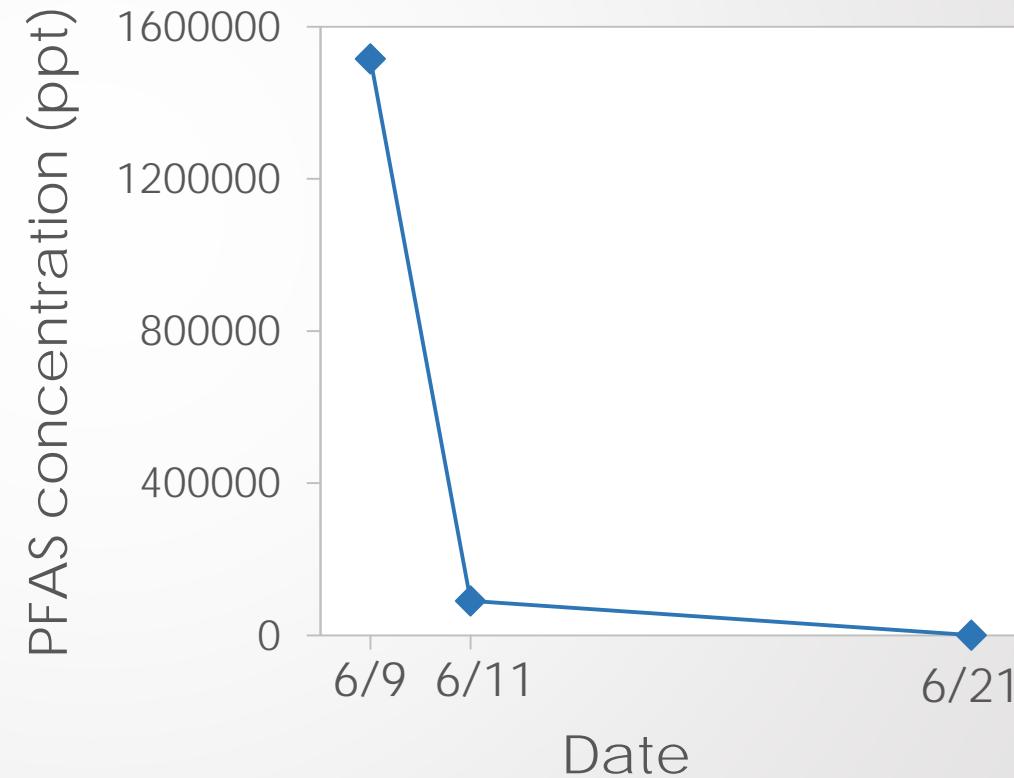
Concentration at Plant Outfall

- ▶ Total = sum of 18 individual PFAS
- ▶ Primary chemical is PFOS (1,300,000 ppt at outfall on 6/9, 86% of total PFAS)
- ▶ Total PFAS at the outfall decreased by more than 4,000 times over 12 days
