Tanning Salons and Other Improper Lamp Disposal Cases in Connecticut

February 27, 2018

Presented by: Michelle Gore, CT DEEP
Solid Waste Advisory Committee

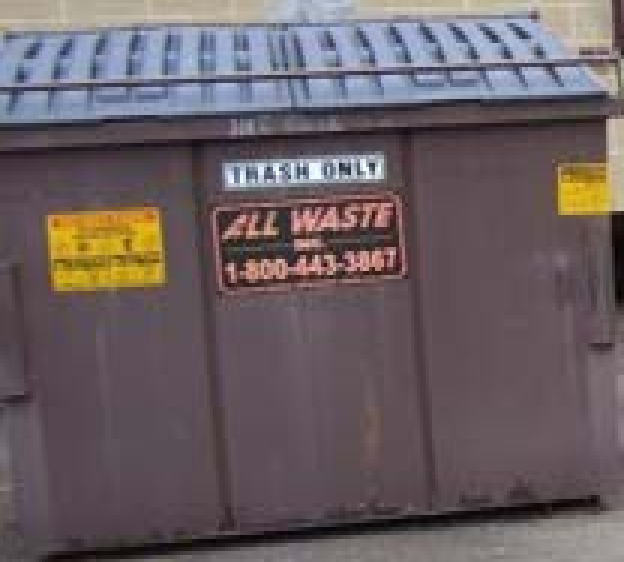
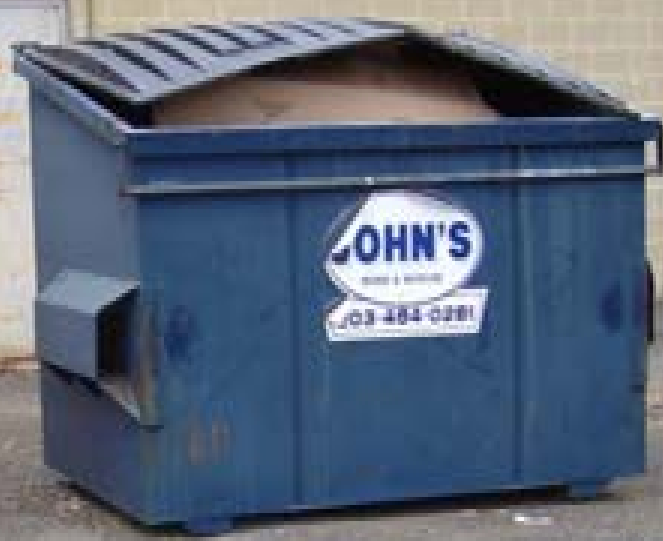
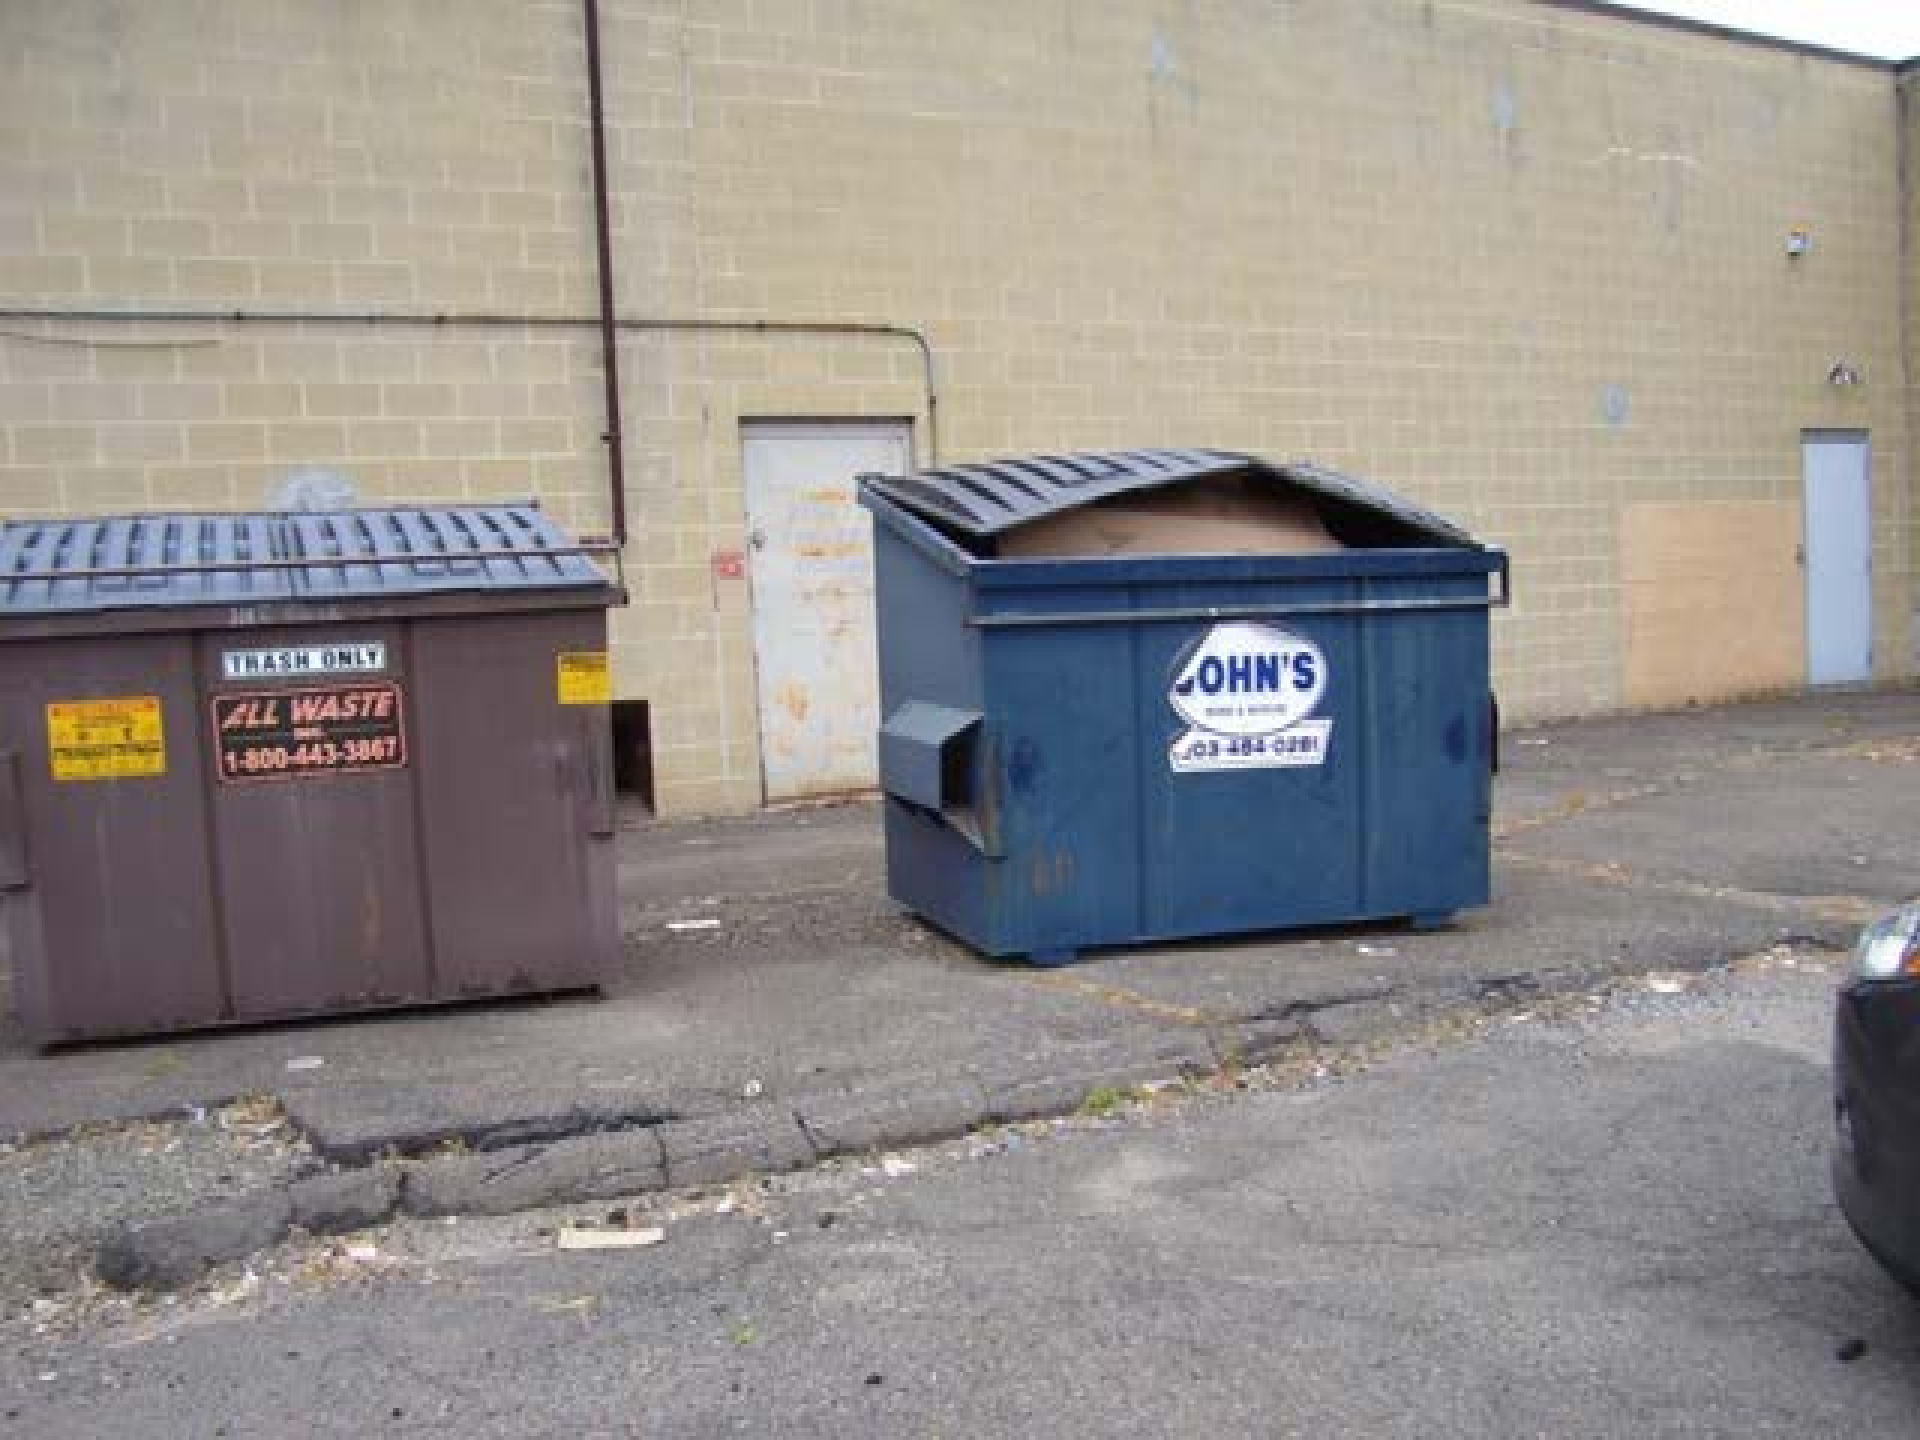
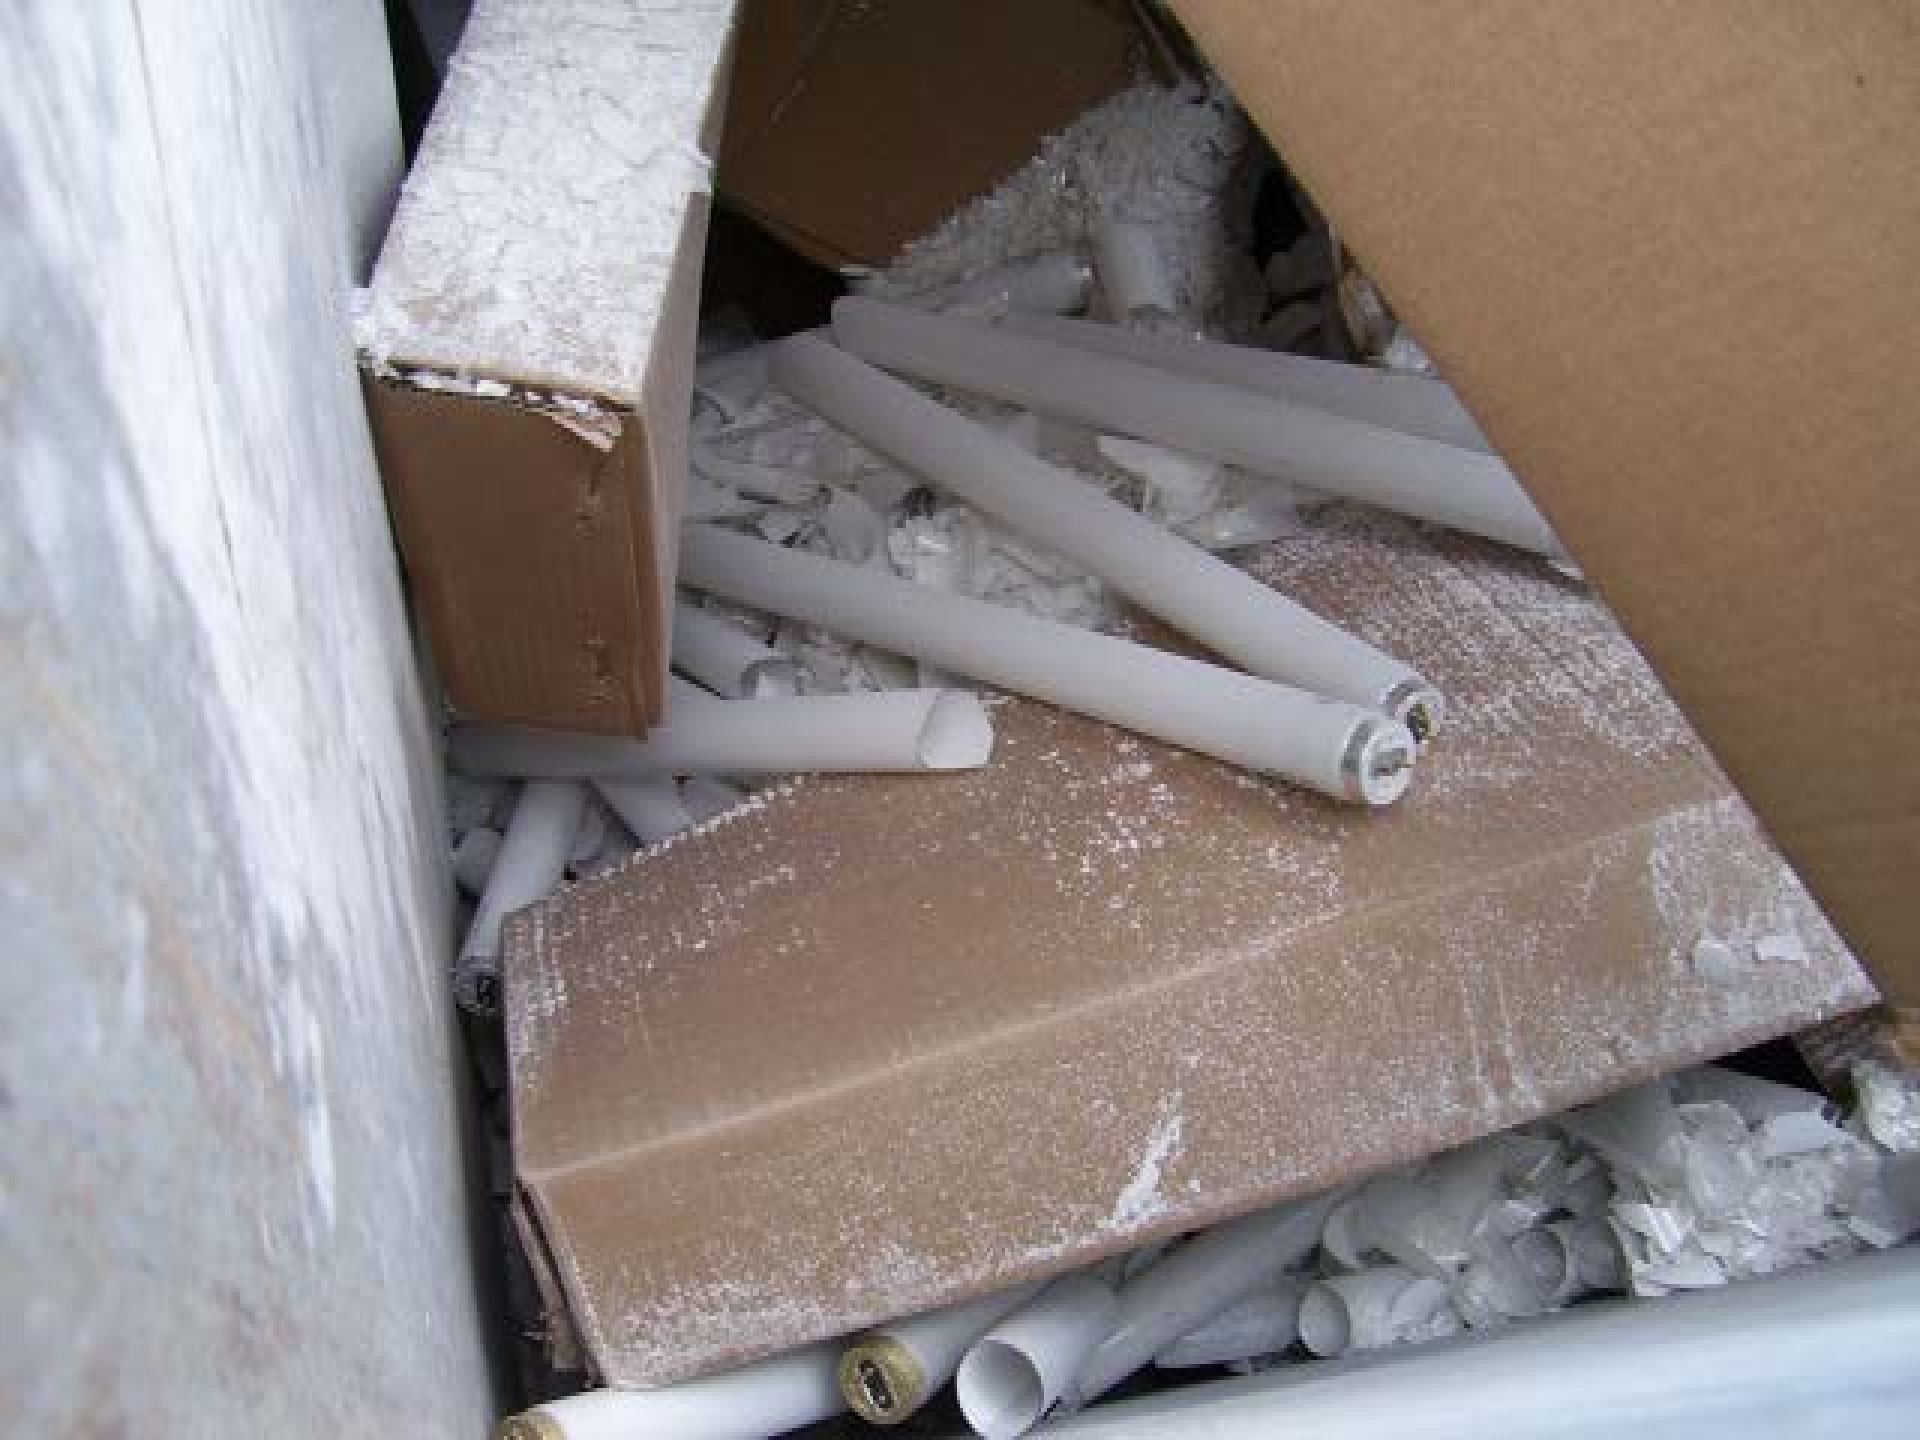
- Informed via anonymous complaint
 - Breaking tanning lamps and bulbs in the dumpster behind the building
- DEEP inspection found evidence of broken lamps in dumpster
 - On-going practice since salon's establishment
 - Dumpster leased, after mixing with MSW stream, incineration at CT trash to energy plant
 - Common aggregation point for 3,000 lamps/year

- Lamps tested, results for mercury < TCLP
- Dumpster decontaminated at cost of \$5,000 to company
- Consent Order
 - \$11,800 penalty
 - Lamp management plan (all locations)
 - Mercury investigation & cleanup
 - Business recycling profile (all locations)
- Compliance representative of this business sector?...
- Responsibilities of solid waste transporters?...
