Lake Waramaug Wave Impact Study

Final Report

Prepared for the Lake Waramaug Inter-Local Commission

November 15, 2024

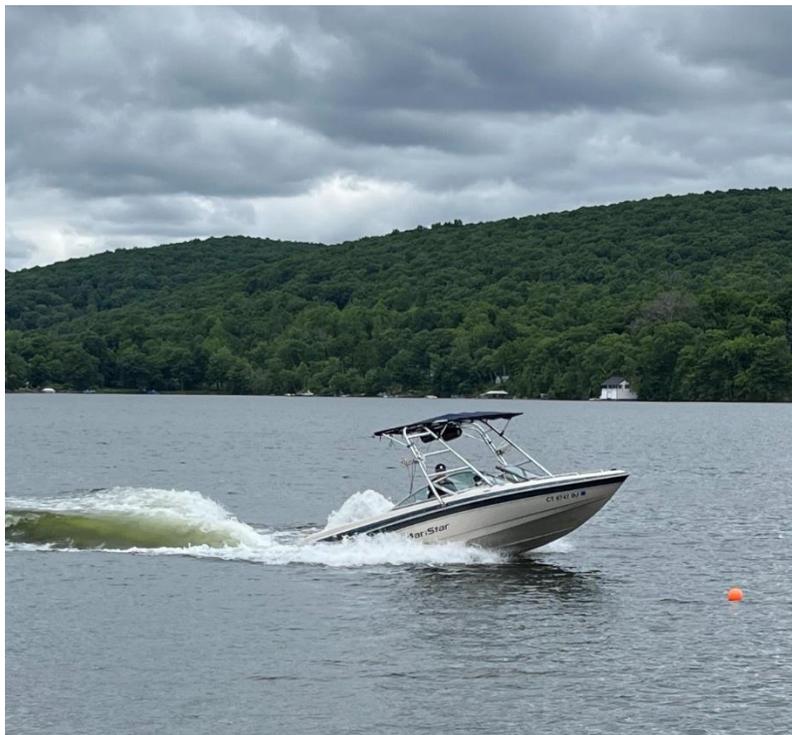
Figure 1 Wake Board Boat in Surf Mode

- 1) A powerful engine (350-500 hp)
- 2) Wave Enhancing (Shaping) Devices and ballasting systems
- 3) High bow angle, and low stern configuration (10-15 degree trim angle).

These vessels typically operate at 9-10 mph per hour to maximize large wave production. The spread of these recreational boats has been controversial, with increasing public concerns for wave impacts to other surface vessels, near shoreline, fish and waterfowl habitat and shoreline structures. These concerns have prompted scientific study which has produced a growing body of data supporting surface and subsurface wave and propeller downwash impacts. In particular, the studies reveal bottom re-deposition impacts from propeller downwash of wake board boats in surf mode. Nutrient release, bottom "scrubbing" damage, and related unseen impacts from powerful wave energy is reflected in this work. The bathymetric characteristic of a particular lake is a variable, with shallower lakes (less than 20 feet) showing more evidence of large wave impact.

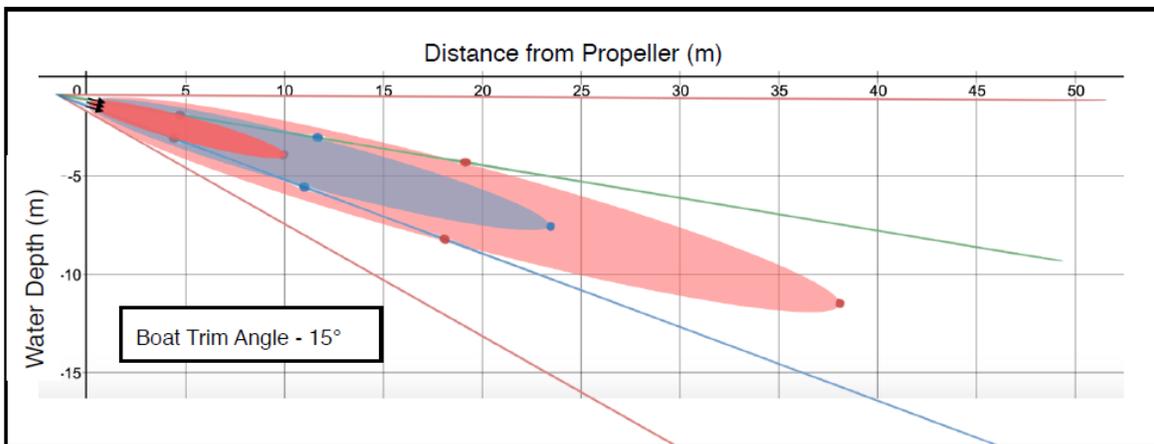
Figure 2 Slipstream Impacts Payette Lake. Ray (2021) Final Report, Payette Lake

**2019 Axis T-23**  
**Max Slipstream Velocity: 4.21m/s @ 10.2 mph, 2500 rpm at propeller**  
**(chart values in meters)**

- Slipstream Velocity > .25m/s = 25cm/s = 1ft/s
- Slipstream Velocity > .4m/s
- Slipstream Velocity > .9m/s

Alex Ray from Western Colorado University has completed a series of studies (2020-21) at Payette Lake, Idaho. This work has focused on the impact of propeller slipstreams (downwash) on lakebed sediments in Payette Lake. Based upon growing concern for nutrient load impacts to the waters of this large lake system, and specifically the risk of toxic blue green algae and other cyanobacterial blooms, the author studied non-buoyant jet streams produced by current model, powerful wake board boats in surf mode (ex: 2019 Axis T-23). Significant impacts from surf mode operations and their consequent slipstream bottom impacts on sediment redistribution were delineated in this work. See Figures 2 and 3.

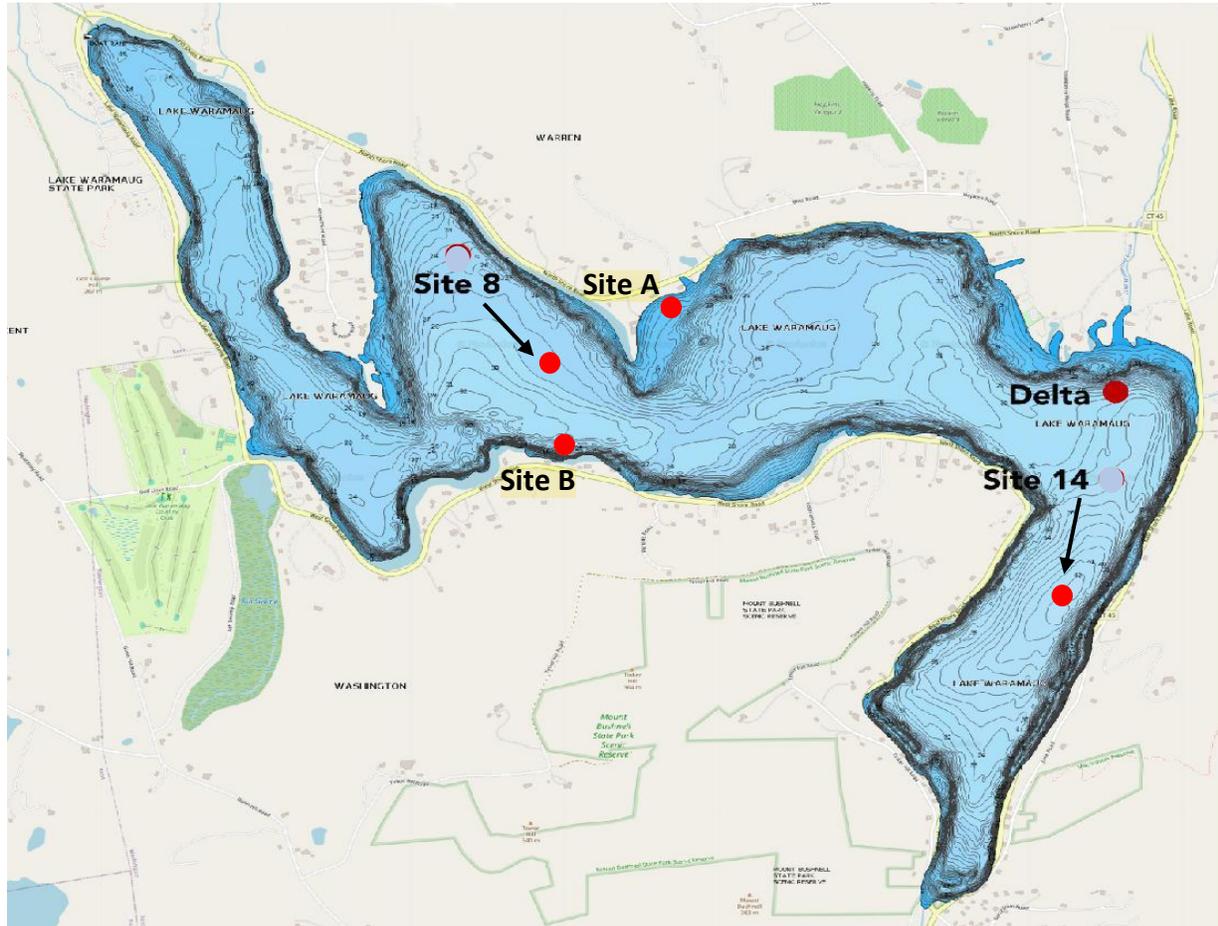
Figure 4 Bathymetric survey and study test site locations, Lake Waramaug, CT 2024.

Test sites A and B were chosen for wave propagation/attenuation distance comparisons with various vessels used on Lake Waramaug. Site A was chosen to measure near shore wave impacts due to shallow water depths near the shoreline. Site B was chosen to measure near shore wave impacts due to deep water depths (steep shoreline).

Site 8 was chosen as a location for propeller downwash measurements based upon a uniform depth of water at 26 feet where Wake Board Boats in surf mode typically operate. Site 14 was chosen for propeller downwash measurements based upon a deeper bottom area of approximately 36 feet.

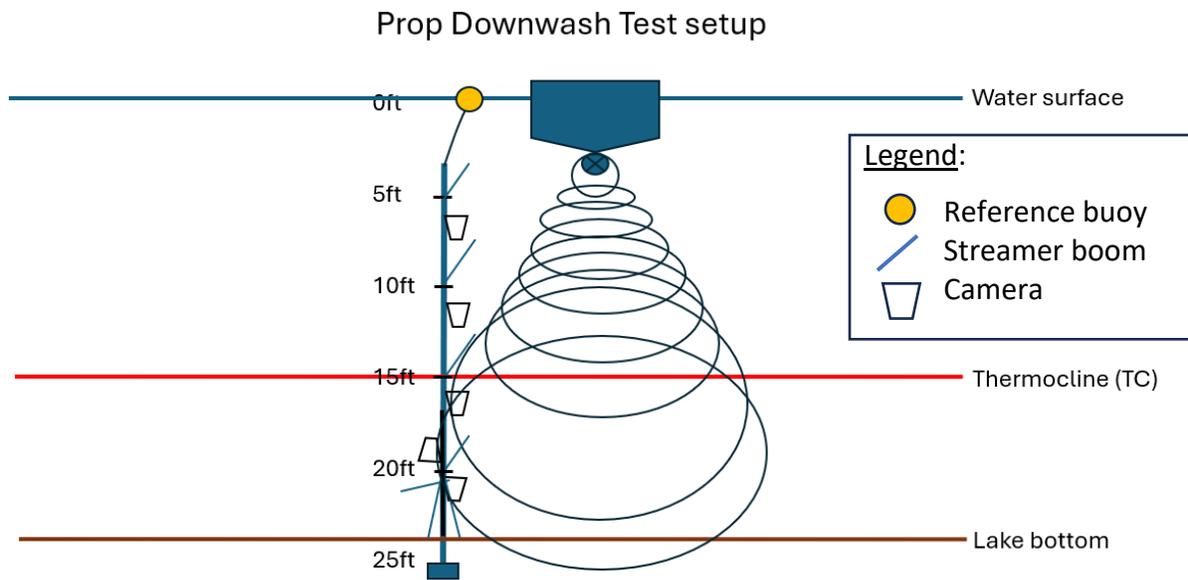
Figure 5 Subsurface Equipment and Hardware

The TVES engineered subsurface hardware is depicted in figure 5. A twenty-five-foot telescoping aluminum pole with anchor system was deployed at test site 8 and 14. The vertical pole had five, 36-inch extended fixtures attached at a 90-degree angle to the vertical pole. Each boom extension was affixed with a camera and color sensitive streamers to reflect dynamic water flow from propeller downwash energy. The boom extensions were affixed at 5, 10, 15, 20, 25 feet on the vertical pole. A camera with illumination was placed near the bottom of the vertical pole to record bottom sediment disruptions and re-distribution. All video captured was date and time stamped.

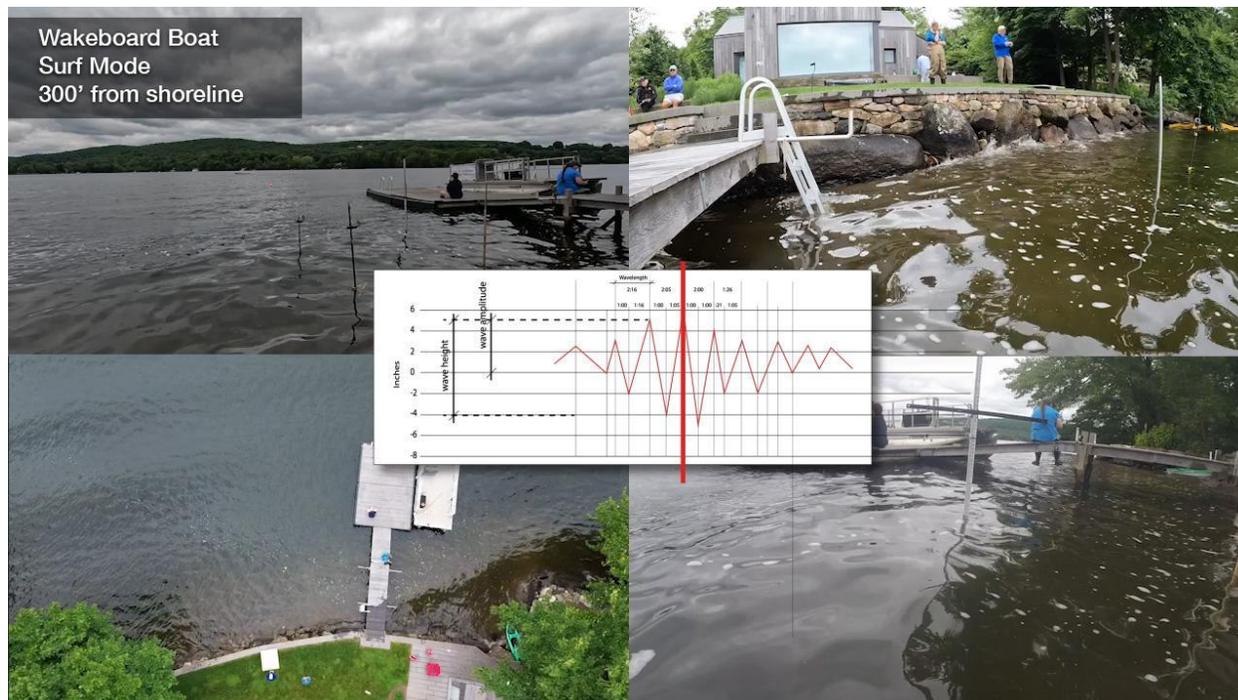
Figure 8: Four Quadrant view of Wakeboard Boat in Surf Mode at 300 feet from shoreline

Buoy markers were placed at staggered distances from the shoreline at Sites A and B allowing for a professional driver, operating a Wake Board Boat in Surf Mode, and a typical water ski boat to make multiple individual passes at 100 feet, 300 feet and 500 feet from the shoreline. Multiple aerial, surface, and subsurface cameras recorded each pass with pause intervals allowing wave activity to dissipate fully between passes. See Figure 8 of a four-quadrant image from the various time synchronized cameras. Post-processing of the videos provided measurements of wave crest and wave trough amplitudes, wave heights, and wave lengths in a repeated measures design as depicted by the insert on Figure 8. These measurements provide graphical representation of wave height versus time as shown in Figure 9. Wave energy was also derived from these measurements. See the results section for a data summary and graphical display of these comparative data sets. Video clips of wave propagation will be presented at scheduled town meetings and made available thorough Hyperlinks.

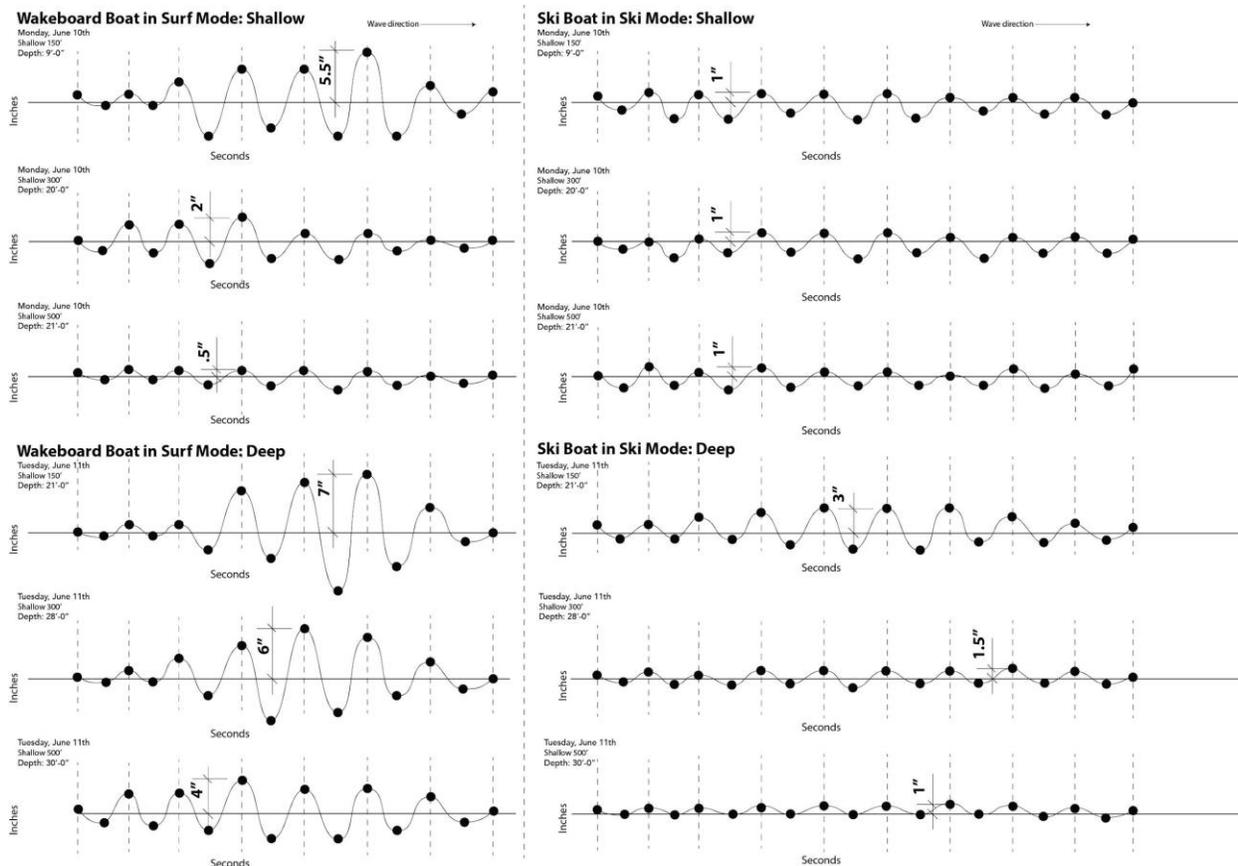
Figure 9 Wave Propagation Impacts at 100', 300', 500' from Shore in Shallow and Deep Test Sites A and B at Lake Waramaug, 2024.

Near shore wave characteristics including wave heights, wave trough depth, and wave amplitude are depicted in Figure 9 with waves generated at 100 feet, 300 feet and 500 foot distances from the shoreline. These wave characteristics are shown at both shallow and deep water testing sites A and B respectively. Wake board boats in surf mode produce significantly higher waves, significantly deeper trough depths, and a significantly higher wave energy than a water ski boat at all staggered distances tested. A separate calculation of wave energy is also shown in Table 1. The wave features of the Wake Board Boat operating in surf mode are demonstrably different from the ski boat comparative data. These data are consistent with other studies referenced in the literature review. Wake Board Boats operating in surf mode create a very different wave phenomenon, with a larger, faster, and more penetrating energy dimension under these test conditions.

The wave height data captured at Site B with the steep shoreline has limited distance for wave interaction with the lake bottom. The wave height data captured at Site A with a shallow lake bottom approaching the shoreline reveals that the waves propagating towards shore were scrubbing the lake bottom, thereby reducing the wave height and dissipating wave energy, but also causing sediment redistribution and nutrient release into the water column. See Appendix B Relationship Between Water Depth and Wave Behavior.

Note: Test site A has a shallow lake bottom near shore, so the 100' buoy was actually located 150' from shore to have a water depth of 9 feet to safely operate the wake board boat in surf mode without hitting the lake bottom.

Wave Heights on average were at least 200% (i.e. 2X) as high for Wake Board Boats in Surf Mode compared to Ski Boats at the same distances from shore. This results in Wave Energy from a Wake Board Boat in Surf Mode that is 400% (i.e. 4X) the amount of Wave Energy from a ski boat at the same distance. To dissipate the Wake Board Boat in Surf Mode wave to the same height and energy as a Ski Boat at 100 ft requires increasing the distance from shore to over 500 feet. This is depicted by the green highlighted bars in Table 1. This corresponds with results from other studies including: Marr et al, WEC, TVES-NLMD.

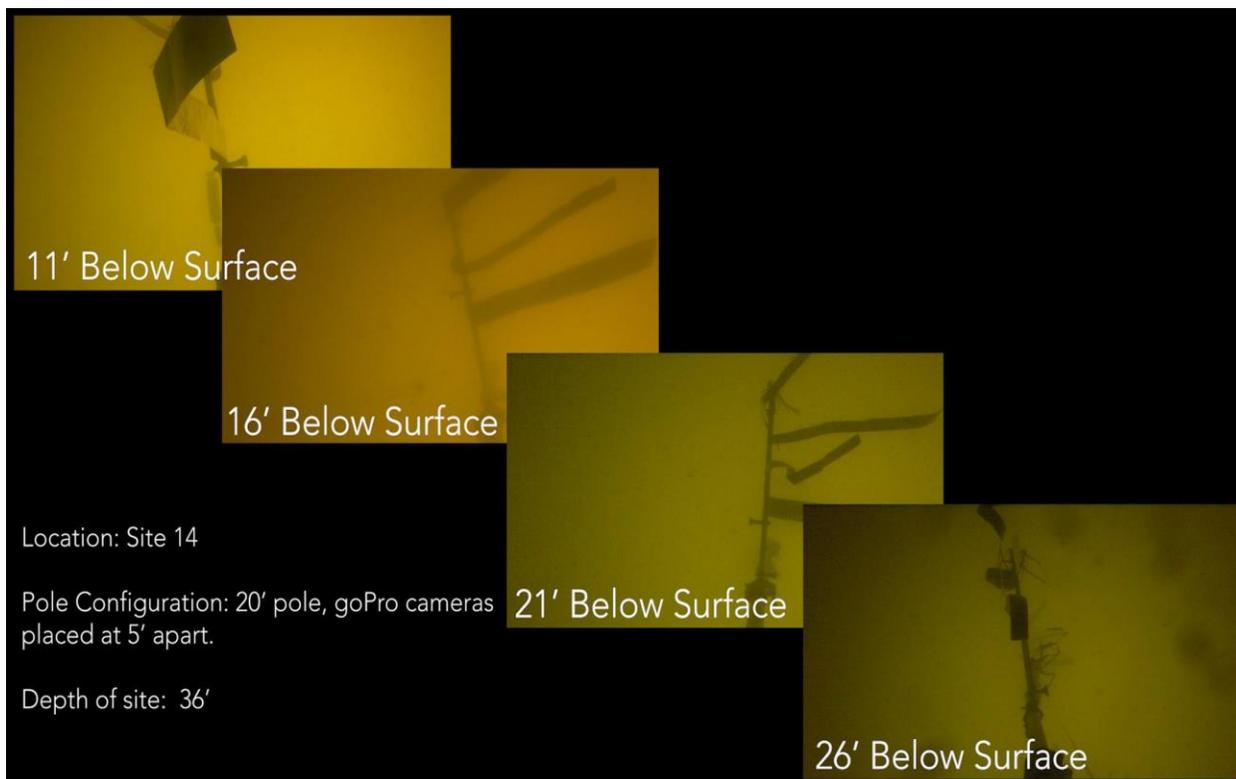
Figure 10 Propeller Downwash Impacts of at least 26 feet Depth by Wake Board Boat in Surf Mode. (Test Site 14) Lake Waramaug, 2024

Propeller downwash depths were measured under repeated startup and buoy pass testing conditions and reveal deep fluid kinetic energy activity for wake board boats in surf mode compared to minimal impacts by a water ski boat under identical testing conditions. Subsurface imagery as depicted in Figure 10 reveals propeller downwash impacts occurring at depths of at least 26 feet for a wake board boat in surf mode.

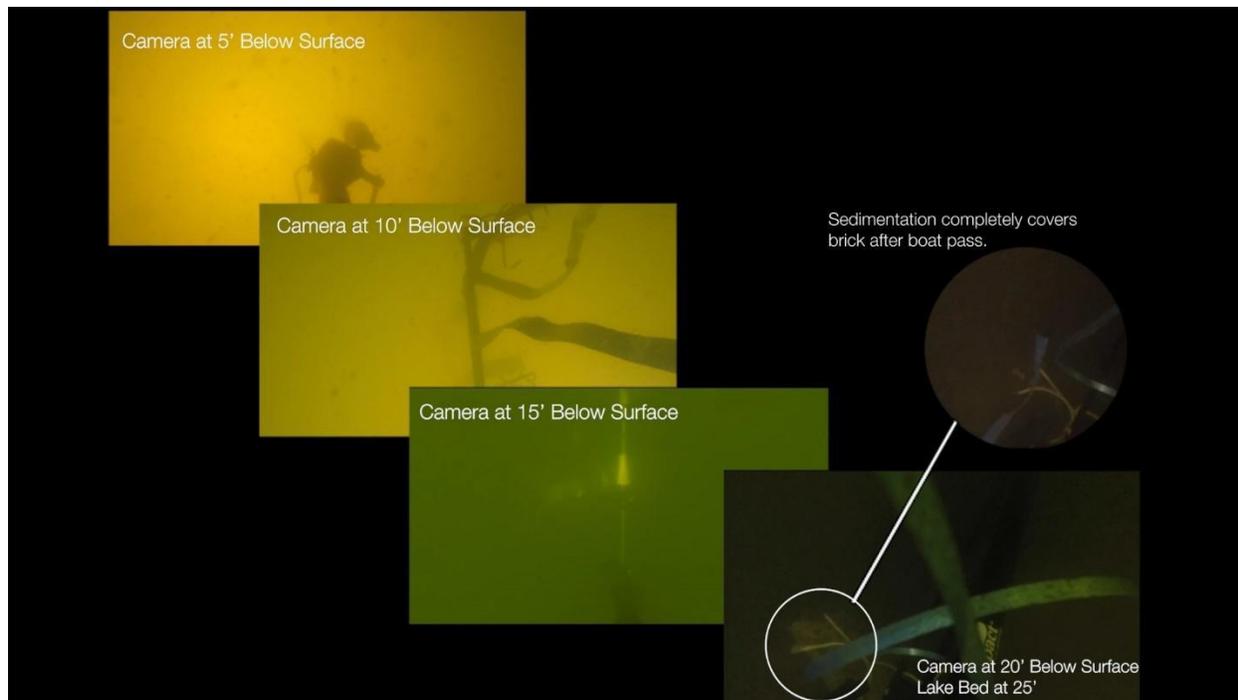
Figure 11 Images at Site 8 of Propeller Downwash and Sediment Re-distribution

Imagery was gathered at deep water test site 8. Cameras placed at the base of vertical poles in 26 feet of water depth revealed propeller downwash impacts including sediment re-distribution due to wake board boat propeller downwash in wake surf mode. See Figure 11.

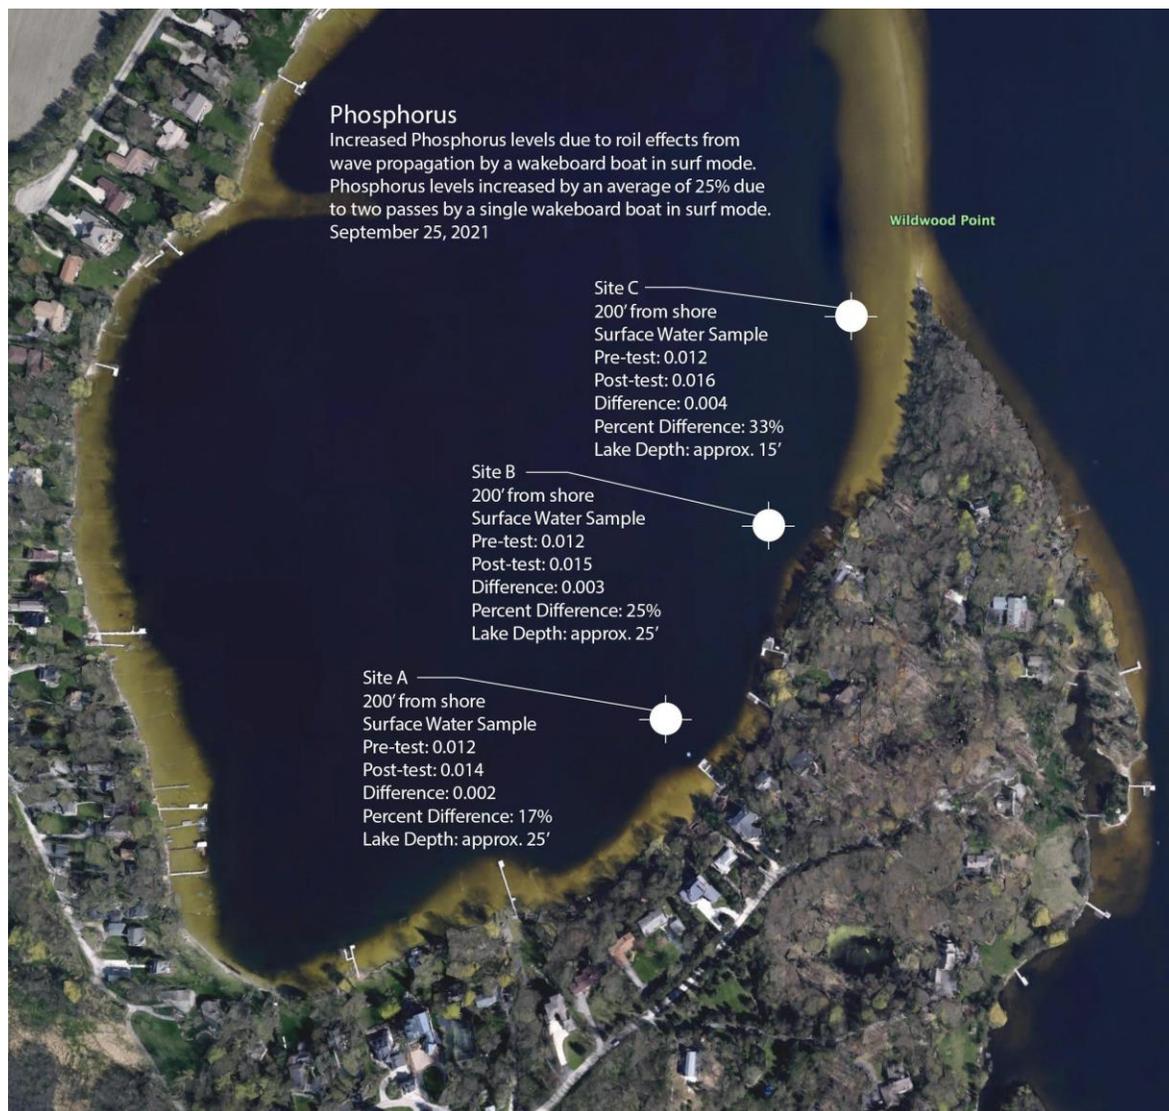
Figure 12 Increased Phosphorous Release Events Following Wake Board Boat in Surf Mode Operations, North Lake, Wisconsin Study (2021).

This nutrient release data is similar to previous study by the TVES group in North Lake, Wisconsin. In 2021, TVES designed a pre-post sampling procedure of phosphorous release events on a controlled, 800-meter course in 15’ to 25’ of depth with a wake board boat in surf mode. After two boat passes, measurements of 25% to 30% percent increases in Total phosphorus levels (dip sampling) were demonstrated in the near shore in that study. See Figure 12.

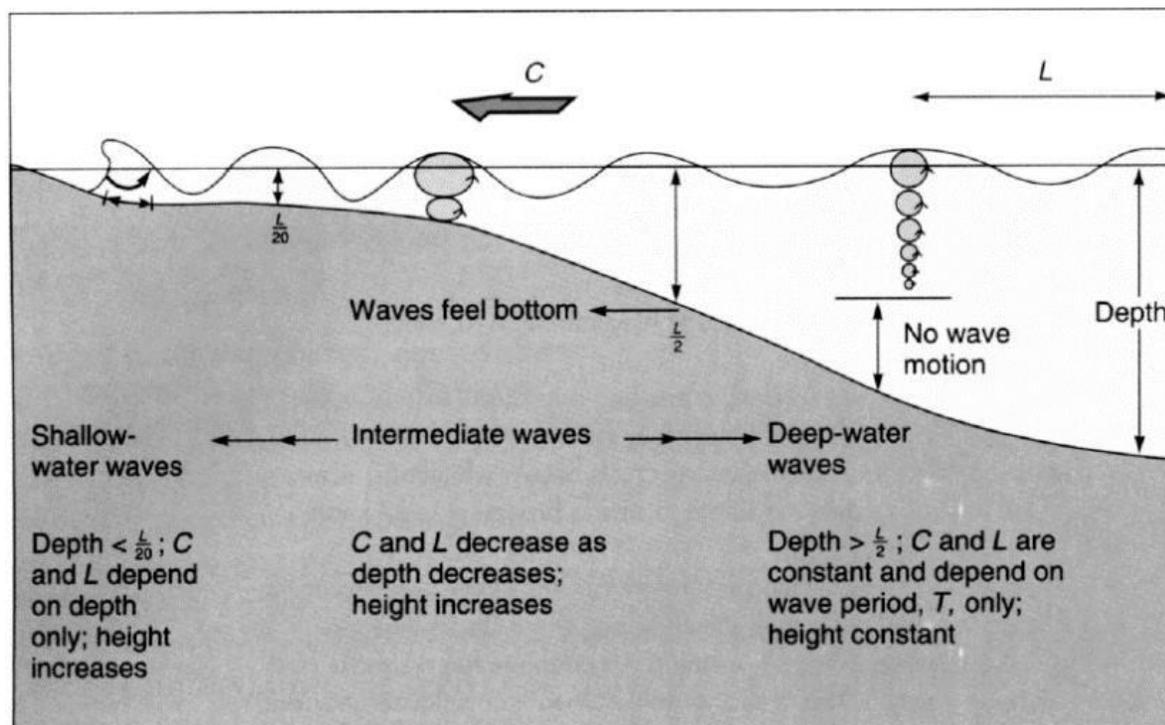
Relationship Between Water Depth and Wave Behavior

It is important to provide some background on general characteristics of waves, how they move through the water, and what affects them. The figure below shows the relationship between water depth and wave behavior. In deep water conditions (i.e., water depths greater than  $\frac{1}{2}$  wavelength of a wave) the speed ( $C$ ) and wavelength ( $L$ ) of a wave produced by a particular vessel type and operating mode are constant and are not influenced by the lake bottom and the water particles move in a circular motion. For example, a wave with a wavelength of 20 feet is considered a deep wave in depths of 10 feet or greater. Wavelength is defined as the distance between the top or crest of a wave to the next or adjacent crest. Although not illustrated on the diagram, wave amplitude is the difference in height between a wave crest and adjacent wave trough. Wave period ( $T$ ) is defined as the time for one wavelength to pass a fixed location.
