## WETLAND INSPECTION

APT Project No.: CT445170

**Site Name:** CT1225 Hamden 2

**Site Address:** 796 Woodin Street, Hamden, Connecticut

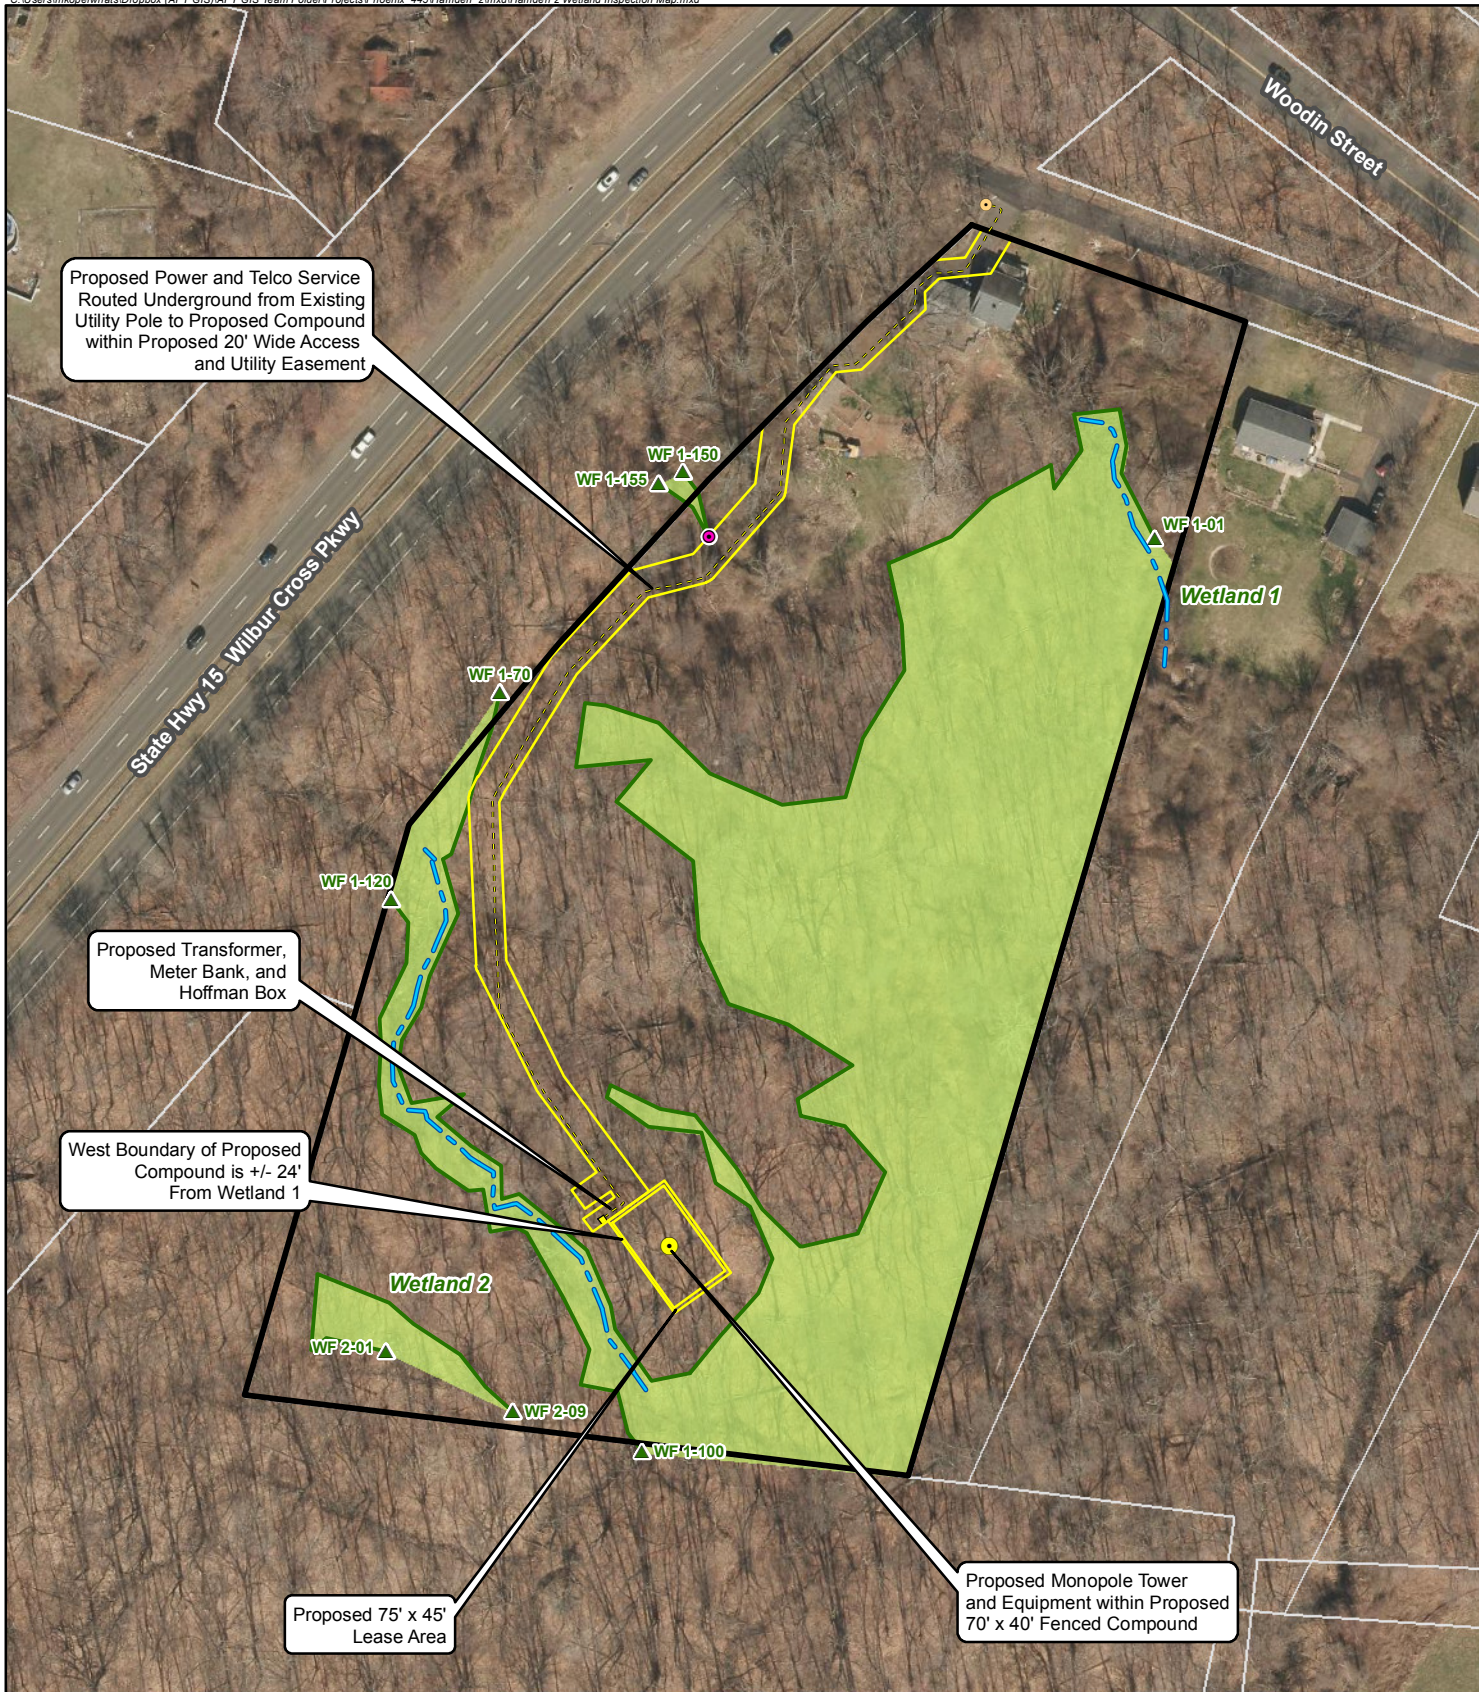
**Wetland Inspection Map**

Proposed Wireless Telecommunications Facility  
 Hamden CT Relo  
 796 Woodin Street  
 Hamden, Connecticut

**Map Notes:**  
 Base Map Source: 2016 Aerial Photograph (CTECO)  
 Map Scale: 1 inch = 125 feet  
 Map Date: May 2018
