RE: TS-T-Mobile-014-170208
T-Mobile Site Id CT11328F
50 Maple Street, Branford, CT
Notice of Construction Complete

Project: T-Mobile Marine Systems Smoke Stack CT11328F
50 Maple Street
Branford, CT 06405

FIELD VISIT REPORT

PROJECT NAME: Branford CT11328F

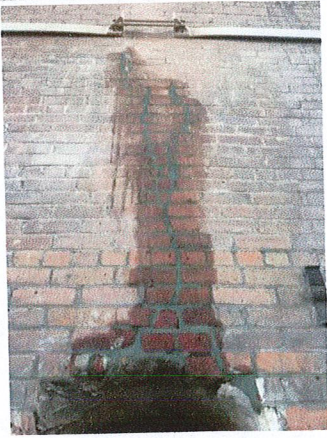
<p>092317. 4</p>	<p>See note (092317.3).</p>

092317. 1	Purpose of field visit was to conduct an overall assessment of the completed project for compliance with documents listed below. <ul style="list-style-type: none"> ▪ Atlantis Construction Drawings dated 09/27/16 ▪ International Chimney Corporations Chimney Analysis report dated 08/30/16 	
092317. 2	Weather conditions were clear with a temperature of 79°F.	
092317. 3	All stress cracks were repaired per the above listed documents.

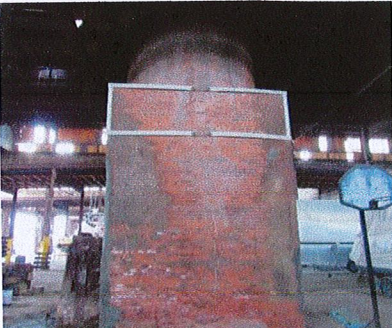
<p>092317. 7</p>	<p>See note (092317.6).</p>

<p>092317. 6</p>	<p>Metal strapping installed per the above listed documents. Visible gaps are due to the stack base not being exactly square.</p>

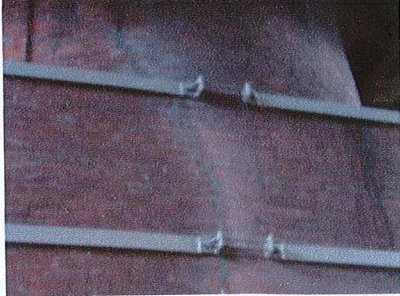
092317. 8	Hairline fractures received caulk (Refer to International Chimney Corp. letter dated 10/02/17).

This letter will serve as to what was done to the hairline vertical crack located in the upper elevation of the south west side of the chimney. Due to the size of the fracture it was determined that the best method to seal this crack would be to seal it with calking rather than disturb the masonry which appeared to be in good condition. The object was to prevent weather from entering the crack causing further damage. If you were to point a crack of this nature you would need to cut the crack and make it wide enough and deep enough to obtain a good bond. Doing this would have caused more damage to the area than was necessary. The crack was sealed with a calking material suitable for masonry repair.

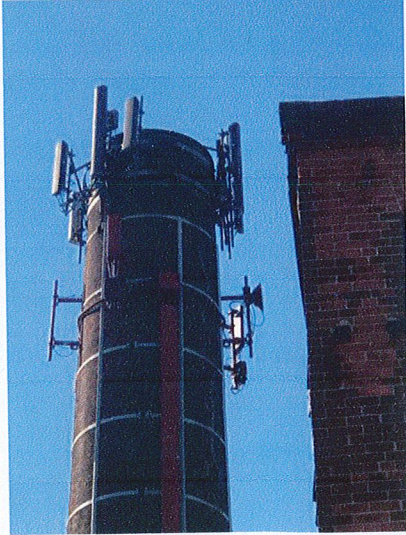
092317. 10	Project is confirmed as complete.
