Re: **Notice of Completion of Construction Activity**
EM-VER-051-100125 – 281 Woodhouse Road, Fairfield, Connecticut
EM-VER-057-100601 – 411 West Putnam Avenue, Greenwich, Connecticut
EM-VER-062-100202 – 265 Benham Street, Hamden, Connecticut
EM-VER-062-100127 – 890 Evergreen Avenue, Hamden, Connecticut
EM-VER-101-100107 – 117 Washington Avenue, North Haven, Connecticut
EM-VER-101-100119 – 15 Dwight Street, North Haven, Connecticut

Re: **EM-VER-062-100202– Cellco Partnership d/b/a Verizon Wireless**
265 Benham Street, Hamden, Connecticut

10. Recommendations

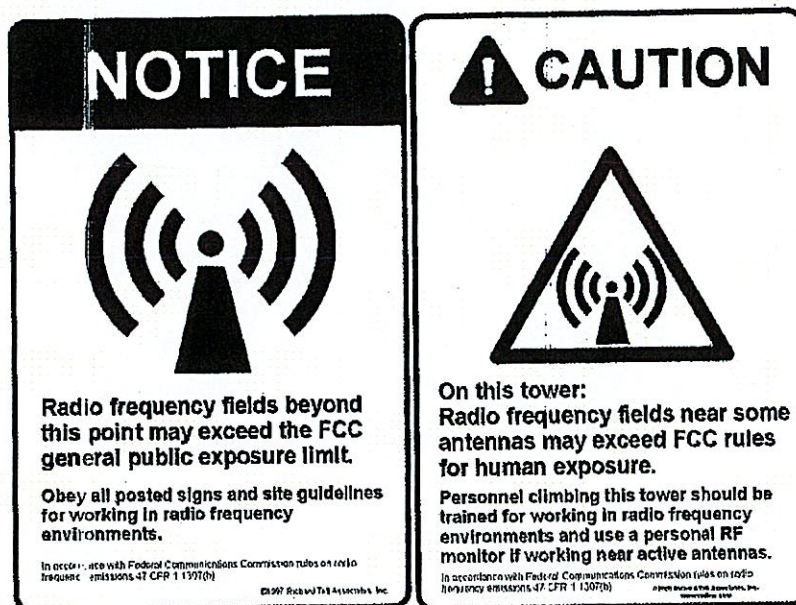
Figure 22: Signage Examples

- The site owner/manager should ensure that access to the rooftop is restricted to authorized personnel only at all times. Current access to the north rooftop is through a door with a dead bolt but no lock.
- A blue "Notice" sign should be posted at the point of access to the north rooftop as RF leaks or temporary spikes may occur but not exceed general population limits.
- A yellow RF "CAUTION" signage should be posted at the base of the tower located on the north rooftop to warn authorized personnel working on the tower of areas that may have RF emission levels that exceed the FCC General Population/ Uncontrolled standard. (Example signage is shown in 22 below.)

The following guidelines should be followed by all persons accessing the rooftop at 265 Benham St in Hamden, CT:

- All personnel accessing the rooftop must be authorized and have the necessary intellectual and physical tools to allow them to control or mitigate their exposure.
- Obey all posted signs
- Assume all antennas are active
- Do not stop in front of antennas
