PROJECT: **KEY CAPTURE ENERGY
CT 8 BATTERY STORAGE PROJECT
EAST HAMPTON, MIDDLESEX COUNTY, CT**

TITLE: **NRCS SOIL SURVEY**

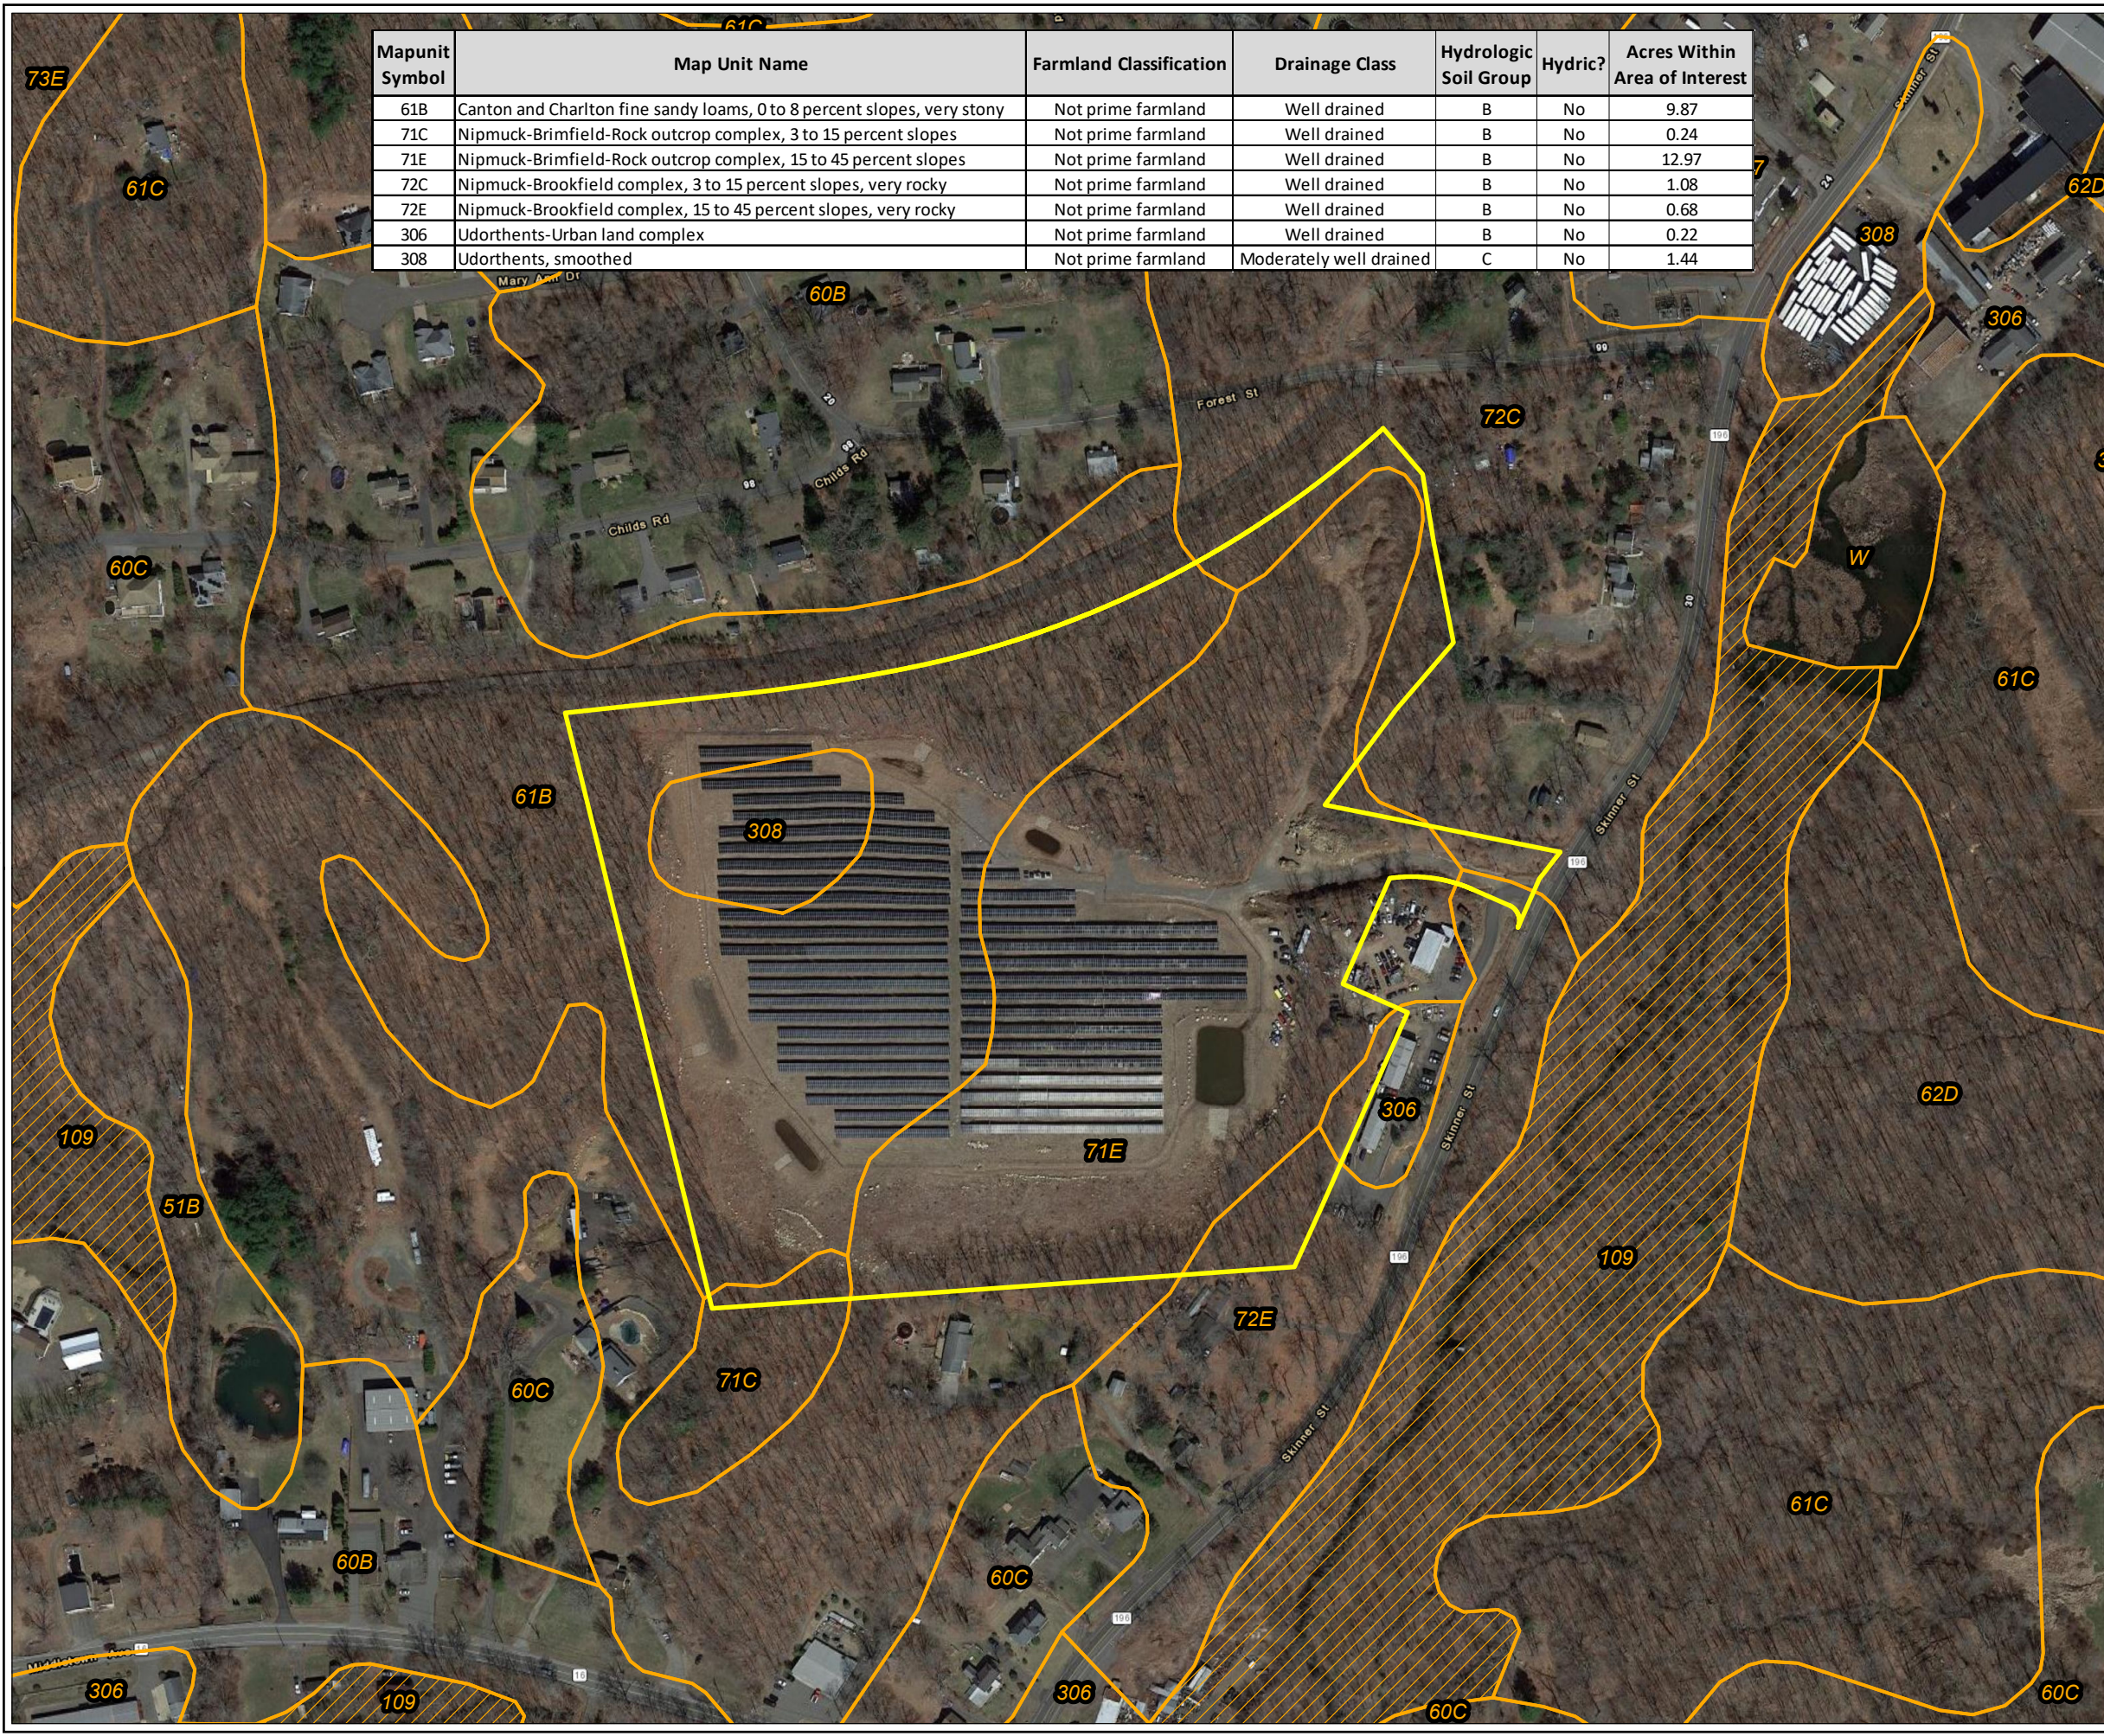
| Mapunit Symbol | Map Unit Name | Farmland Classification | Drainage Class | Hydrologic Soil Group | Hydric? | Acres Within Area of Interest |
| 61B | Canton and Charlton fine sandy loams, 0 to 8 percent slopes, very stony | Not prime farmland | Well drained | B | No | 9.87 |
| 71C | Nipmuck-Brimfield-Rock outcrop complex, 3 to 15 percent slopes | Not prime farmland | Well drained | B | No | 0.24 |
| 71E | Nipmuck-Brimfield-Rock outcrop complex, 15 to 45 percent slopes | Not prime farmland | Well drained | B | No | 12.97 |
| 72C | Nipmuck-Brookfield complex, 3 to 15 percent slopes, very rocky | Not prime farmland | Well drained | B | No | 1.08 |
| 72E | Nipmuck-Brookfield complex, 15 to 45 percent slopes, very rocky | Not prime farmland | Well drained | B | No | 0.68 |
| 306 | Udorthents-Urban land complex | Not prime farmland | Well drained | B | No | 0.22 |
| 308 | Udorthents, smoothed | Not prime farmland | Moderately well drained | C | No | 1.44 |

- HOST PARCEL
- NRCS SOIL BY DRAINAGE
- EXCESSIVELY DRAINED; MODERATELY WELL DRAINED; WELL DRAINED
- POORLY DRAINED; VERY POORLY
