Geotechnical Report BESS Installation CT5

Blair Road and Village Hill Road Willington, Connecticut

June 28, 2023 Project No. 2301203

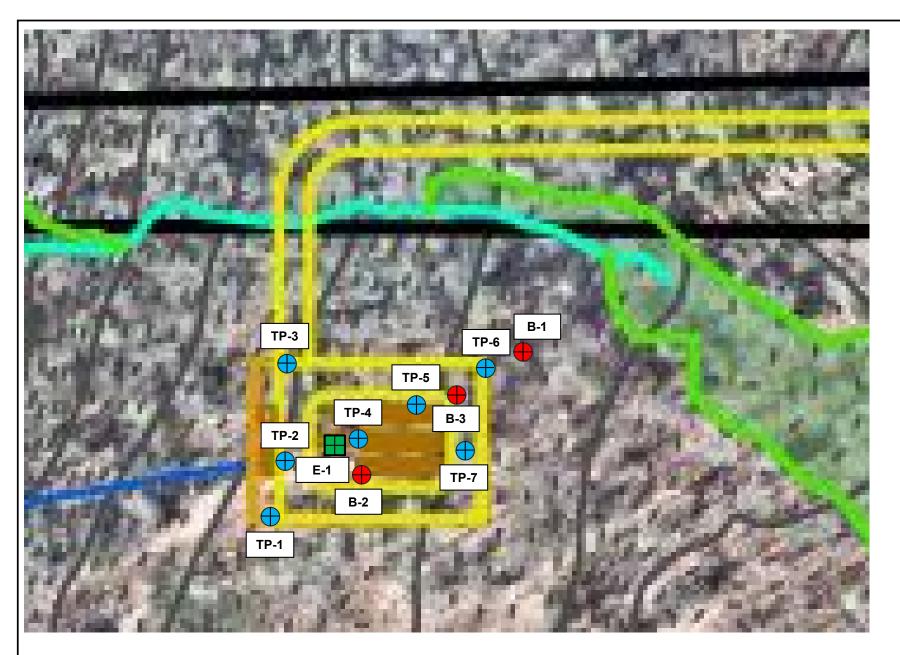
- APPROX. TEST PIT LOCATION
- APPROX. BORING LOCATION

In-situ hydraulic conductivity was measured using a Guelph permeameter within three (3) of the test pits, located within the property as shown on Figure 1. Constant-head test procedures generally followed ASTM D5126 and manufacturer recommendations.

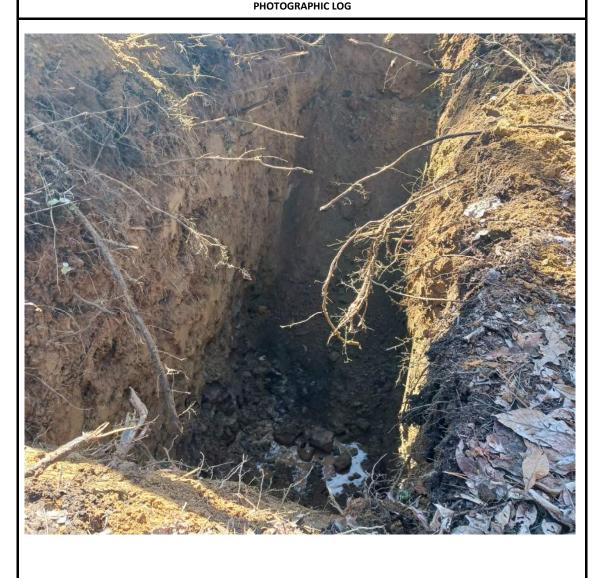
Bottom of test pit at 8.3 feet. Picture showing soil strata at Test Pit 2

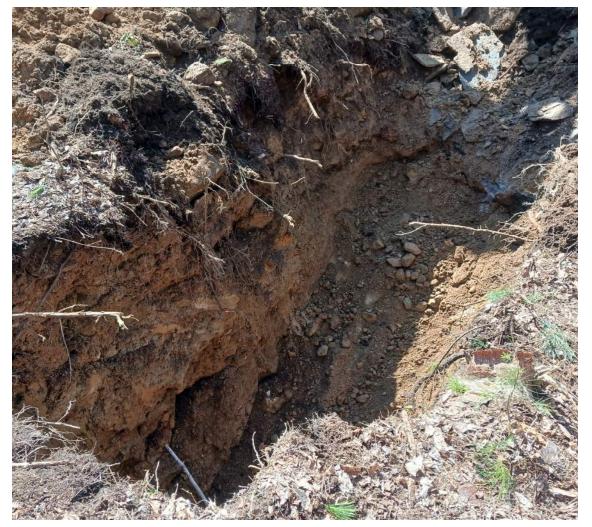
Bottom of test pit at 8.0 feet. Picture showing soil strata at Test Pit 5

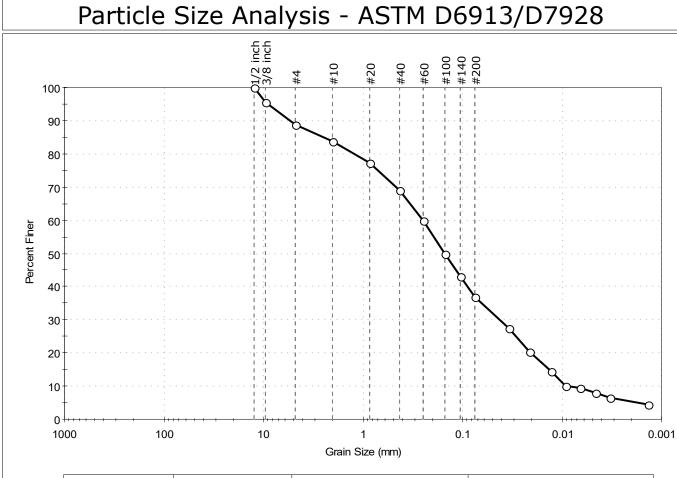
Client:	GEI Consu	ltants, Inc.				
	Project:	Key Captu	re Energy Batte	ery Storage			
ng	Location:	Windsor Lo	ocks, CT			Project No:	GTX-317151
9	Boring ID:	WI-TP-1		Sample Type:	bag	Tested By:	ckg
	Sample ID:	G-2		Test Date:	05/04/23	Checked By:	ank
	Depth :	2'		Test Id:	714048		
	Test Comm	ent:					
	Visual Desc	ription:	Moist, dark br	own silty sand			
	Sample Cor	nment:					
rticl	e Size	e Ana	lysis -	ASTM	D691	3/079	28

% Cobbl	le	% Gravel		% Sand		%8	Silt & Clay Size	
			11.3		51.8	36.9		36.9	
Sieve Name	Sieve Size, mm	Percent Finer	Spec. Percent	Complies	1		Coe	efficients	
						D ₈₅ =2.44	40 mm	D ₃₀ =0.0423 mm	
1/2 inch	12.50	100			1	D ₆₀ = 0.25	28 mm	D ₁₅ =0.0134 mm	
3/8 inch	9.50	95

#4	4.75	89				D ₅₀ = 0.15	16 mm	D ₁₀ =0.0086 mm	
#10	2.00	84				C _u =29.3	95	C _c =0.823	
#20	0.85	77							
#40	0.42	69				ACTM		sification	
#60	0.25	60				<u>ASTM</u>	N/A
