Docket No. 272 – Development and Management Plan Inspection

Segment 2a Inspection

Date: June 16, 2008

Location: Segment 2a – Beseck Switching Station to Cheshire/Hamden Town Line

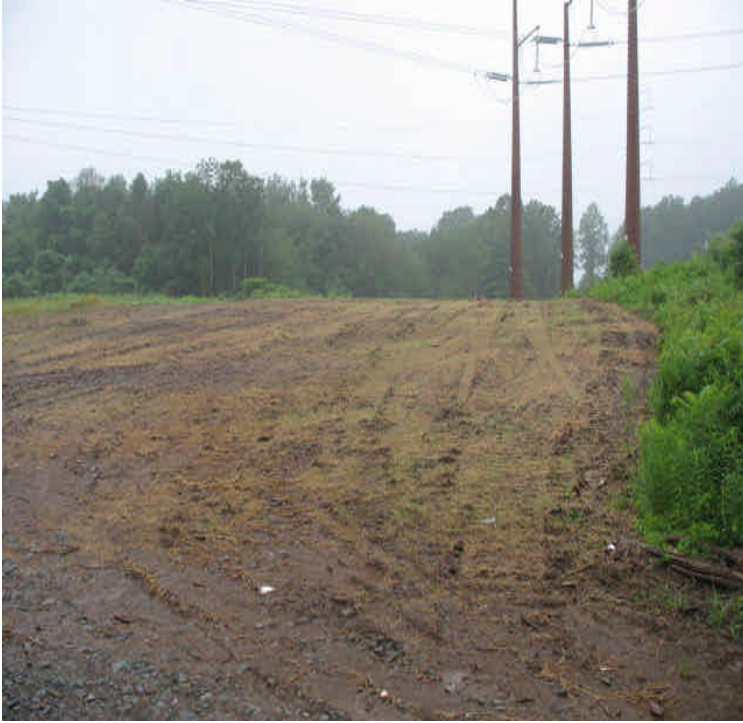
Carpenter Ln: Soil stockpiles were removed and the disturbed area has been graded and seeded

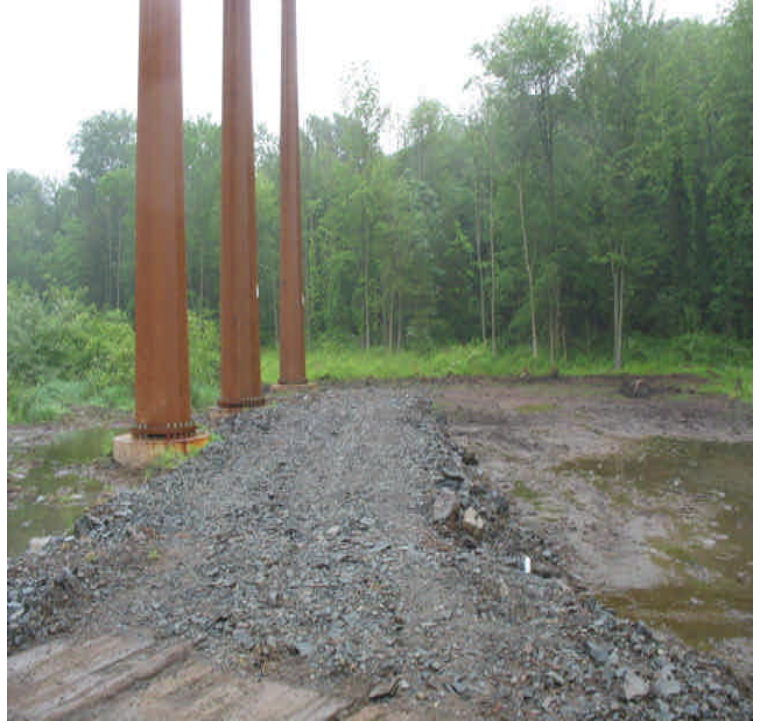
Carpenter Ln: Restoration work is complete within the wetlands. Minor seeding will be done when water subsides. Impacts were reduced from original permitted numbers and narrowed to a spur road.

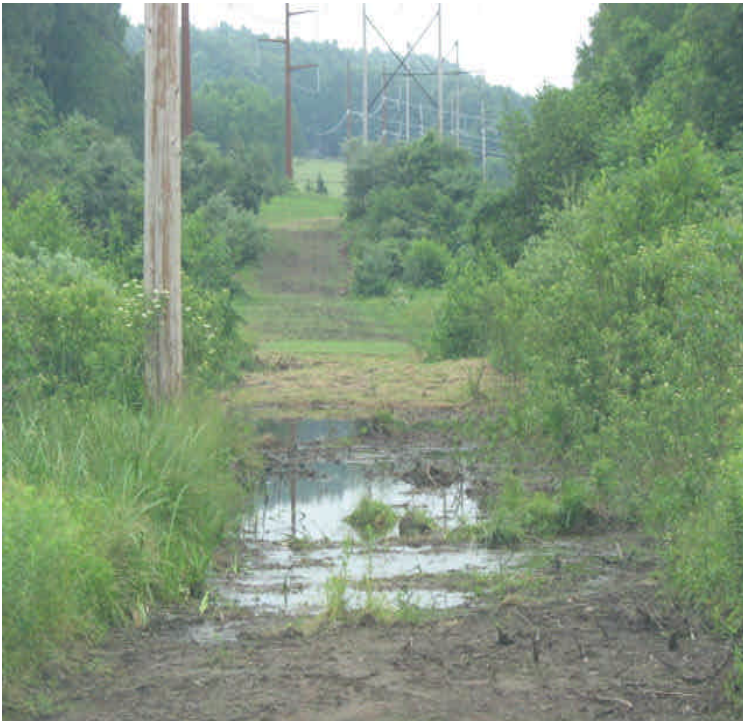
Durham Rd (south): Exposed soils from Durham Rd south need to be stabilized. Controls upgradient of the wetlands are needed.

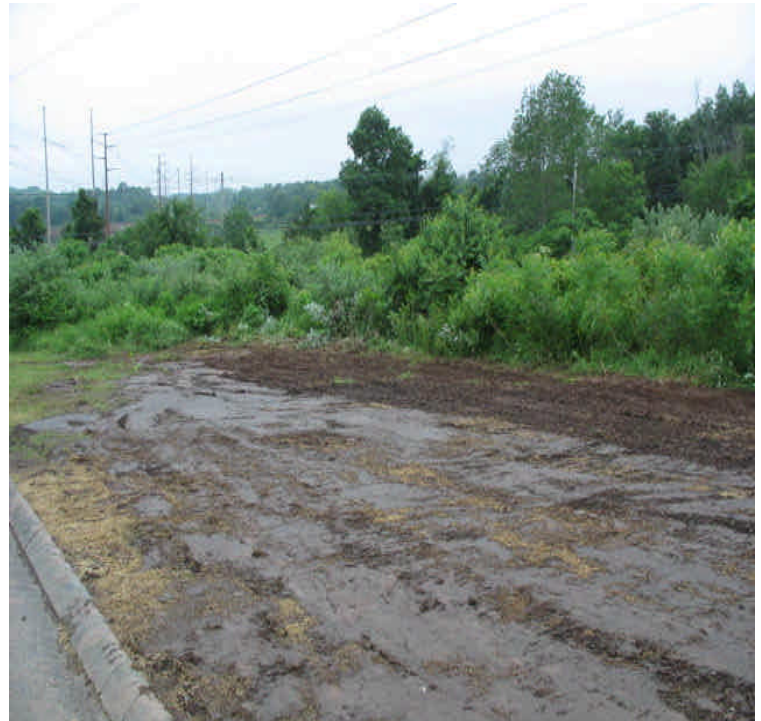
Stony Brook: Final grading/restoration complete. Topsoil, hay and seed have been spread. The area needs additional hay/seed.

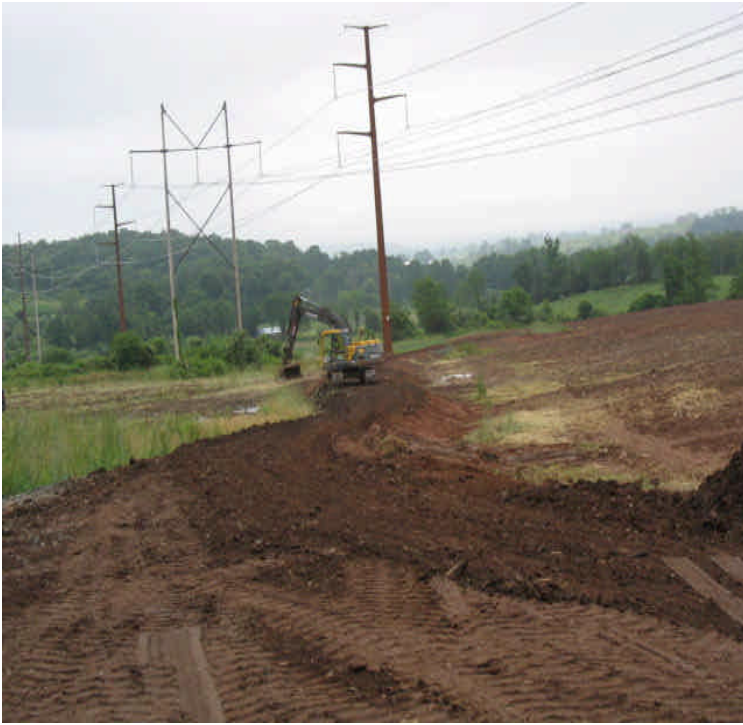
Tamarack Swamp Rd: Access road pads being narrowed and graded.

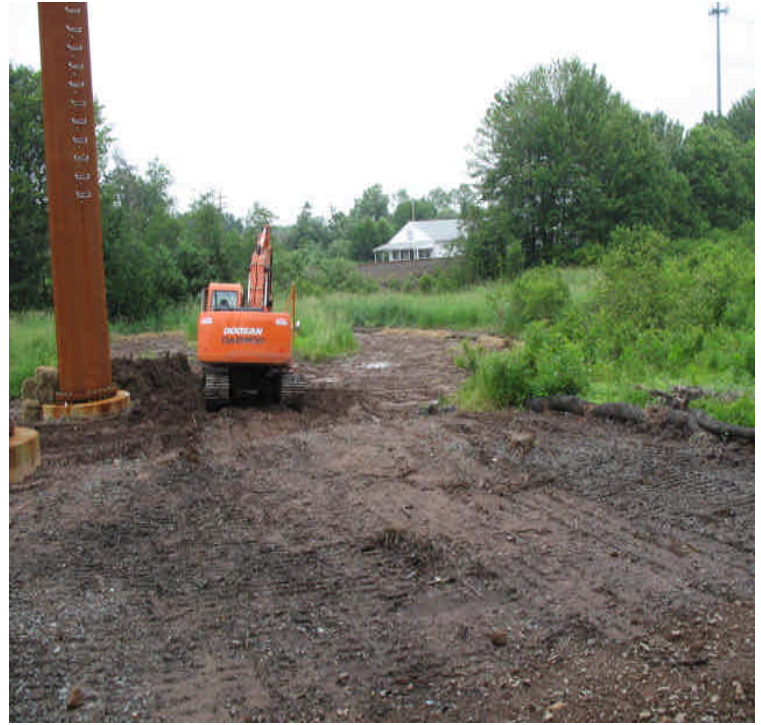
Powers Rd: Final restoration underway within the wetlands. Stone removal underway as needed. Crews are maintaining established vegetation when feasible.

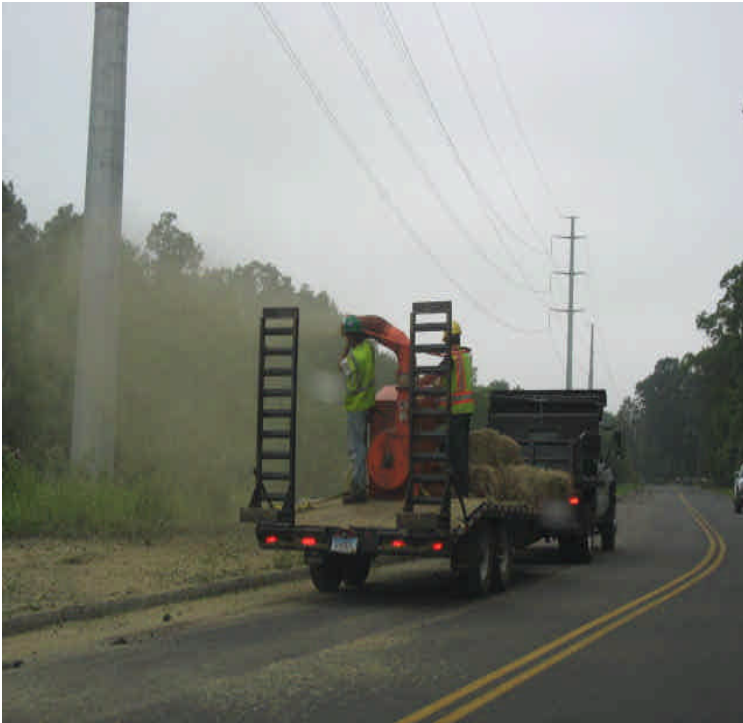
Old Farms Rd: Crews were spreading hay and seed on exposed areas along the roadway shoulder.

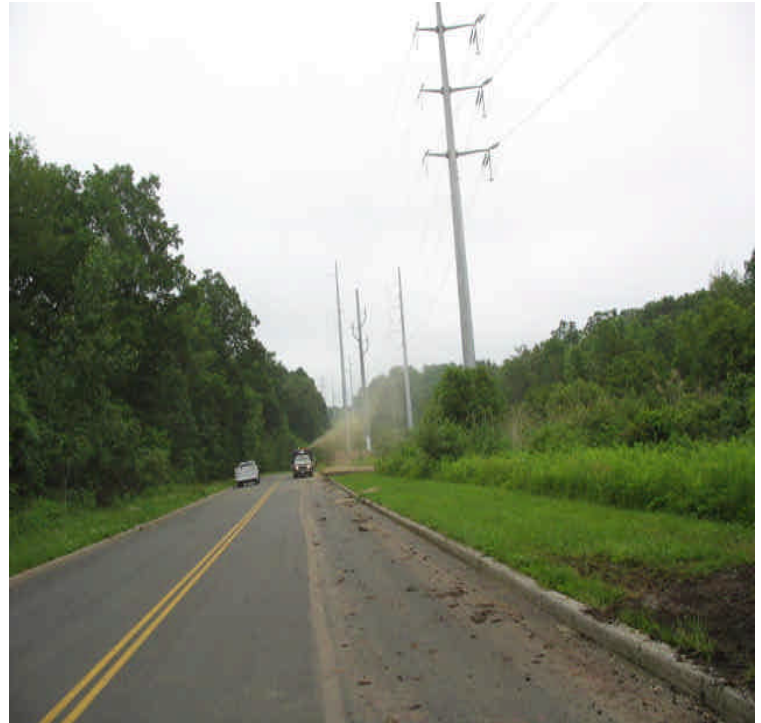
Old Farms Rd: Sediment tracking from the restoration efforts. Clean/sweep roadway as needed.
