Docket No. 272 – Development and Management Plan Inspection

Segment 2a Inspection

Date: June 19, 2007

Location: Segment 2a – Beseck Switching Station to Cheshire/Hamden Town Line

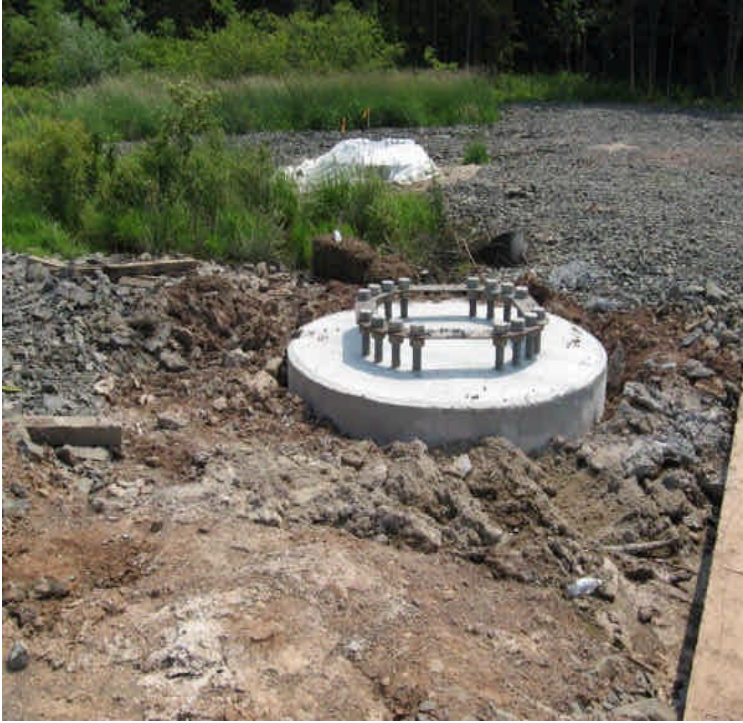
<p>The final foundation was placed in a small stream channel as permitted but is blocking flow. 6/19/07</p>	<p>Redirect or restore the channel to re-establish the hydrology and prevent erosion during storms. 6/19/07/6/19/07</p>	<p>Needs channel restoration.</p>
	<p>A culvert and permanent road remain in the wetland. 6/19/07</p>	<p>Monitor controls and add more as needed. 6/19/07</p>	<p>NA</p>
	<p>Exposed soil remains adjacent to wetlands off Williams Rd. after timber mats were removed. 5/8-6/19/07</p>	<p>See erosion control section. Controls/ stabilization are needed here. 5/8-6/19/07</p>	<p>Needs evaluation</p>
	<p>The stone access road is now in place in wetlands off Powers Rd.. A culvert may be needed. A few controls were in place. 6/12-6/19/07</p>	<p>Monitor area closely and determine if conditions require a culvert. See erosion control section. 6/12-6/19/07</p>	<p>Needs evaluation</p>
	<p>Clearing and access had occurred through two wetlands and a small pond. Stream near Rte 5 was clear 6/19/07</p>	<p>See erosion control and access road sections. 6/19/07</p>	<p>Needs to be monitored</p>

Foundation was placed in a small stream channel off Carpenter Lane. Create a new channel/or provide stream restoration to re-establish the hydrology.

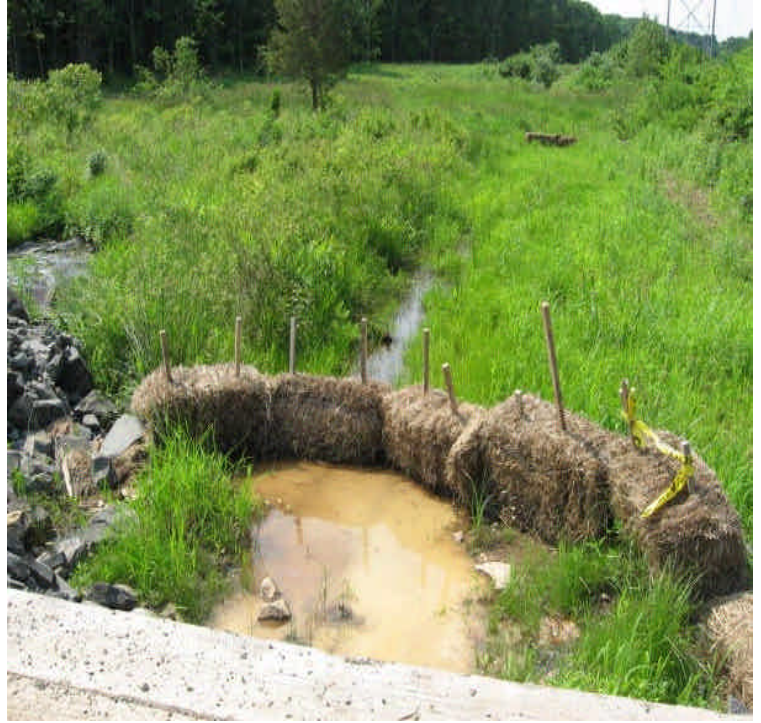
Sediment/turbid run-off was appropriately filtered by a haybale check-dam within wetlands off Carpenter Lane.

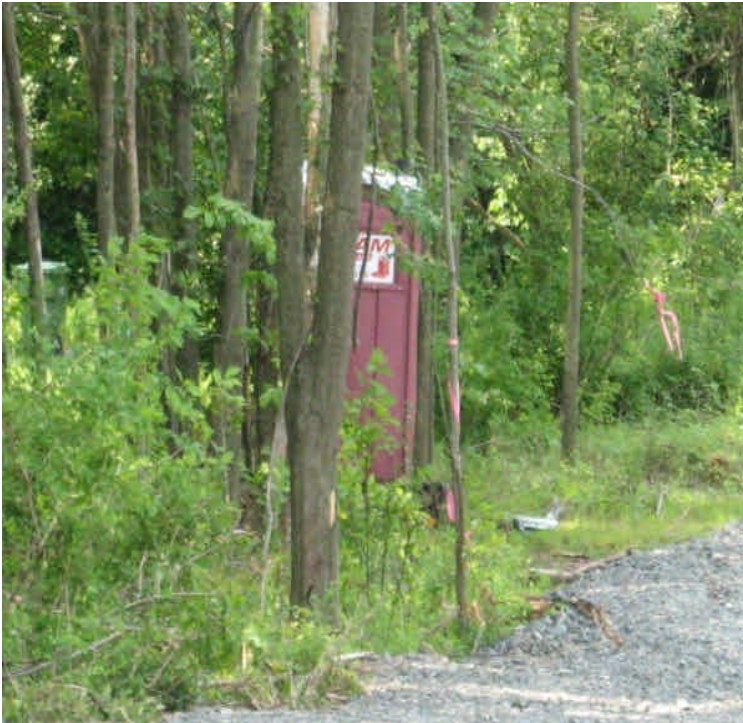
Portable sanitary facility located upgradient from a wetland off Powers Road. Ensure that facilities are placed over 100 feet from wetlands in case of a spill.

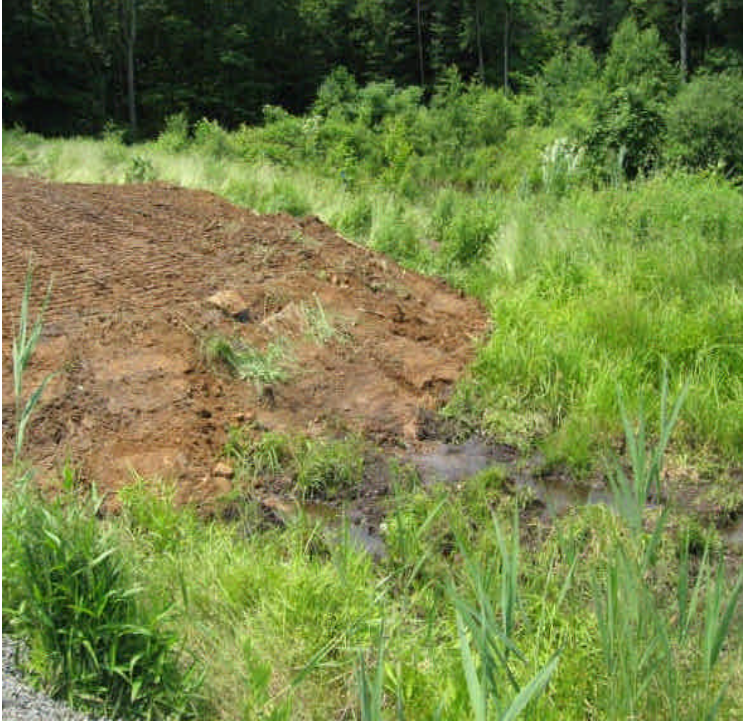
New pad in the wetland, within the apple orchard. Add controls as to protect the undisturbed portion of the wetlands. Avoid storing equipment on the pad within the wetlands

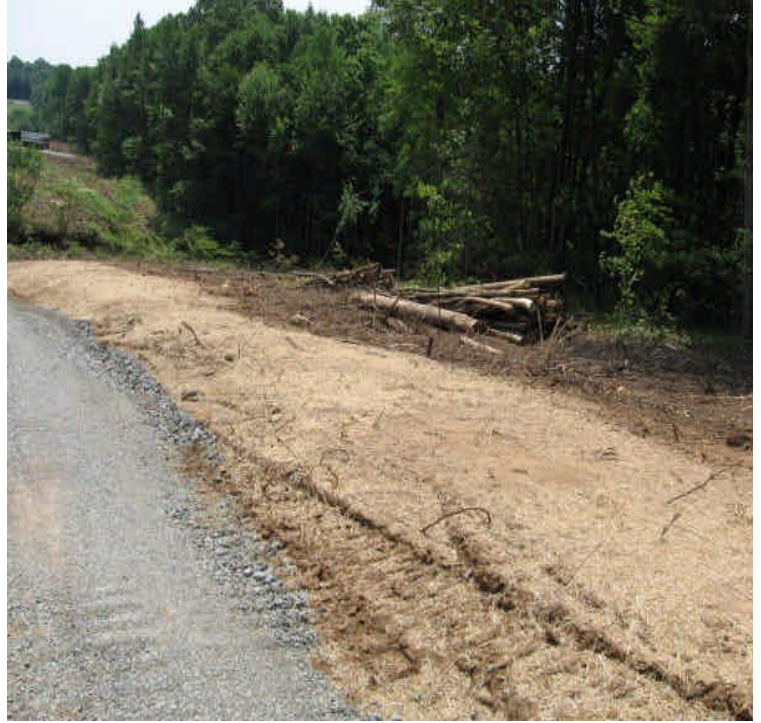
New access road being installed of Tuttle Ave. Ruts noted last week were graded, and hay mulch and seed were applied for stabilization.

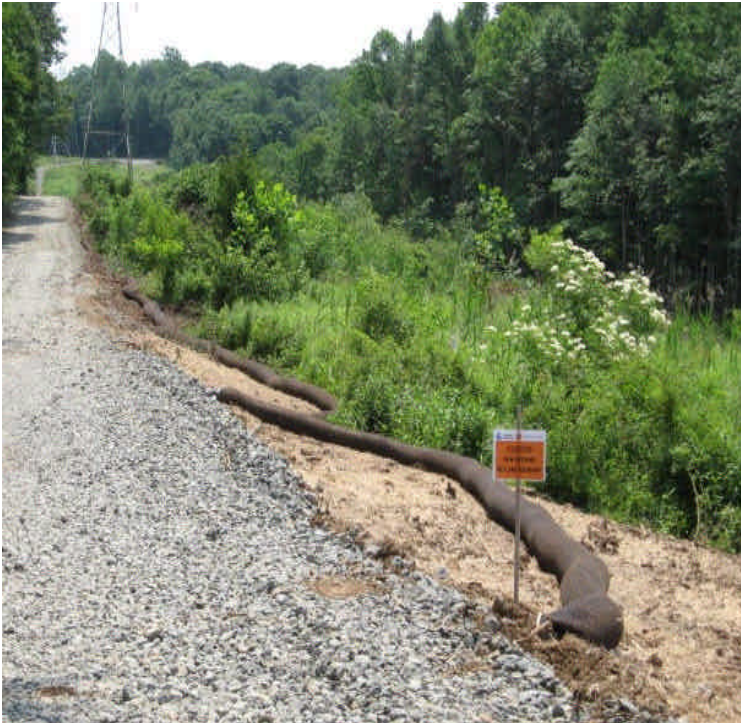
More controls were added upgradient from wetlands off Tuttle Ave.

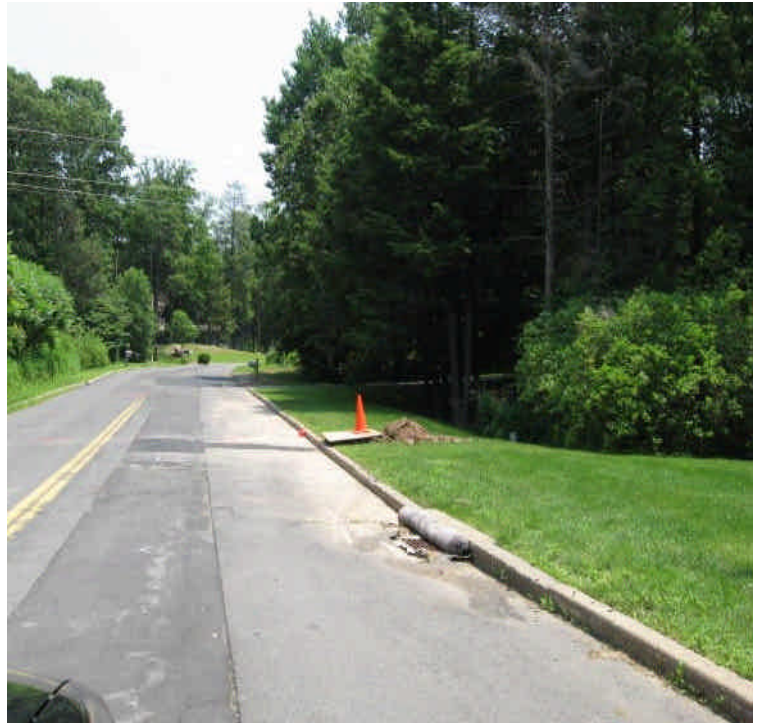
Some minor dust/sediment remains in the roadway after patch work was completed along Old Farms Rd. Sweep as needed.
